UNITED STATES  
DEPARTMENT OF LABOR  
MINE SAFETY AND HEALTH ADMINISTRATION  
Report of Investigation

Underground  
(Coal)

Fatal Powered Haulage Accident  
June 3, 2021

Horse Creek Eagle  
Marfork Coal Company, LLC  
Naoma, Raleigh County, West Virginia  
ID No. 46-09091

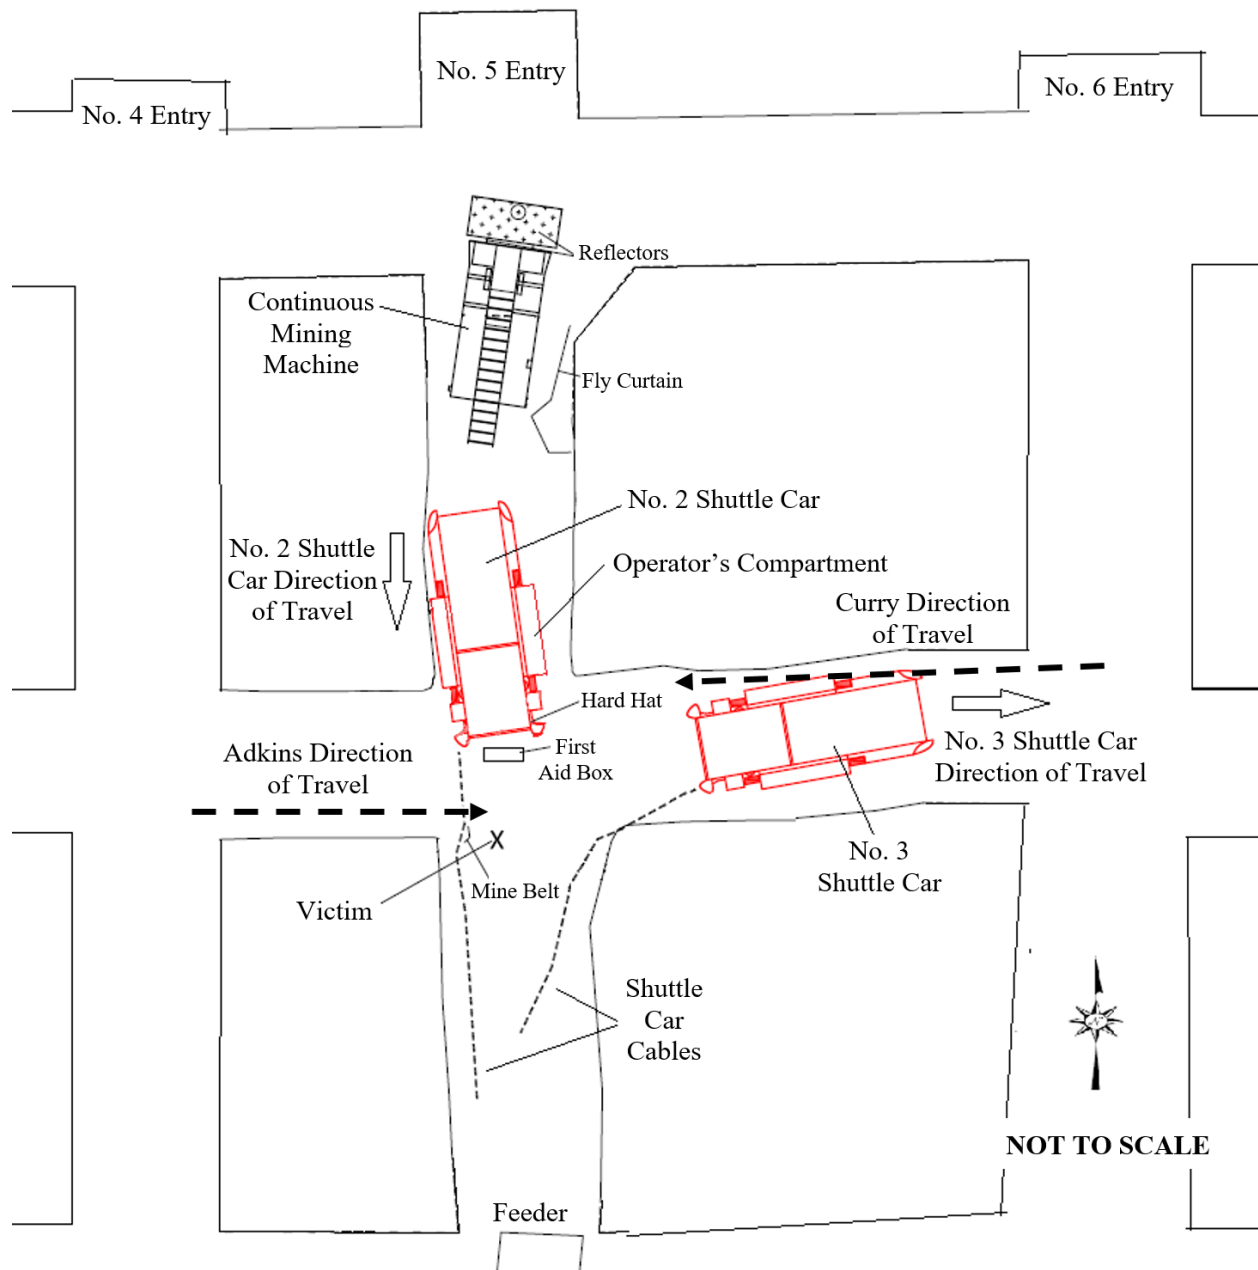
## APPENDIX A - Drawing of the Accident Scene

The day of the accident was the first production day after moving the No. 2 section to a new panel. The new section had two open crosscuts inby the feeder. Adkins and Chris Curry, Section Foreman, had communicated over the wireless radio system and were planning to meet each other to do their 9:00 a.m. production call out to the surface to inform management of the day's production. Adkins was traveling on foot from the No. 4 entry to the No. 5 belt conveyor entry to meet Curry. Curry traveled on foot outby in the No. 6 entry and walked through the crosscut, one crosscut inby the feeder from No. 6 entry to No. 5 entry (see Appendix A).

While Adkins was in the intersection of the No. 5 entry, Page trammed the No. 2 shuttle car towards the feeder and struck Adkins, pinning him between the mine floor and the conveyor boom on the shuttle car. Curry, who was on the other side of the intersection of the No. 5 entry, witnessed the accident and began signaling and yelling at Page to stop the No. 2 shuttle car. Curry went to Adkins and called for help over the radio. Curry directed Page to raise the conveyor boom to free Adkins.

The accident occurred in the No. 5 belt conveyor entry on the No. 2 section one crosscut inby the feeder. The mine height in the intersection where the accident occurred was 57 inches. The section averages 48 to 50 inches in height. The mine floor was dry with a slight uphill grade towards the feeder at the accident scene.
