UNITED STATES  
DEPARTMENT OF LABOR  
MINE SAFETY AND HEALTH ADMINISTRATION  
Report of Investigation

Underground  
(Coal)

Fatal Powered Haulage Accident  
June 3, 2021

Horse Creek Eagle  
Marfork Coal Company, LLC  
Naoma, Raleigh County, West Virginia  
ID No. 46-09091

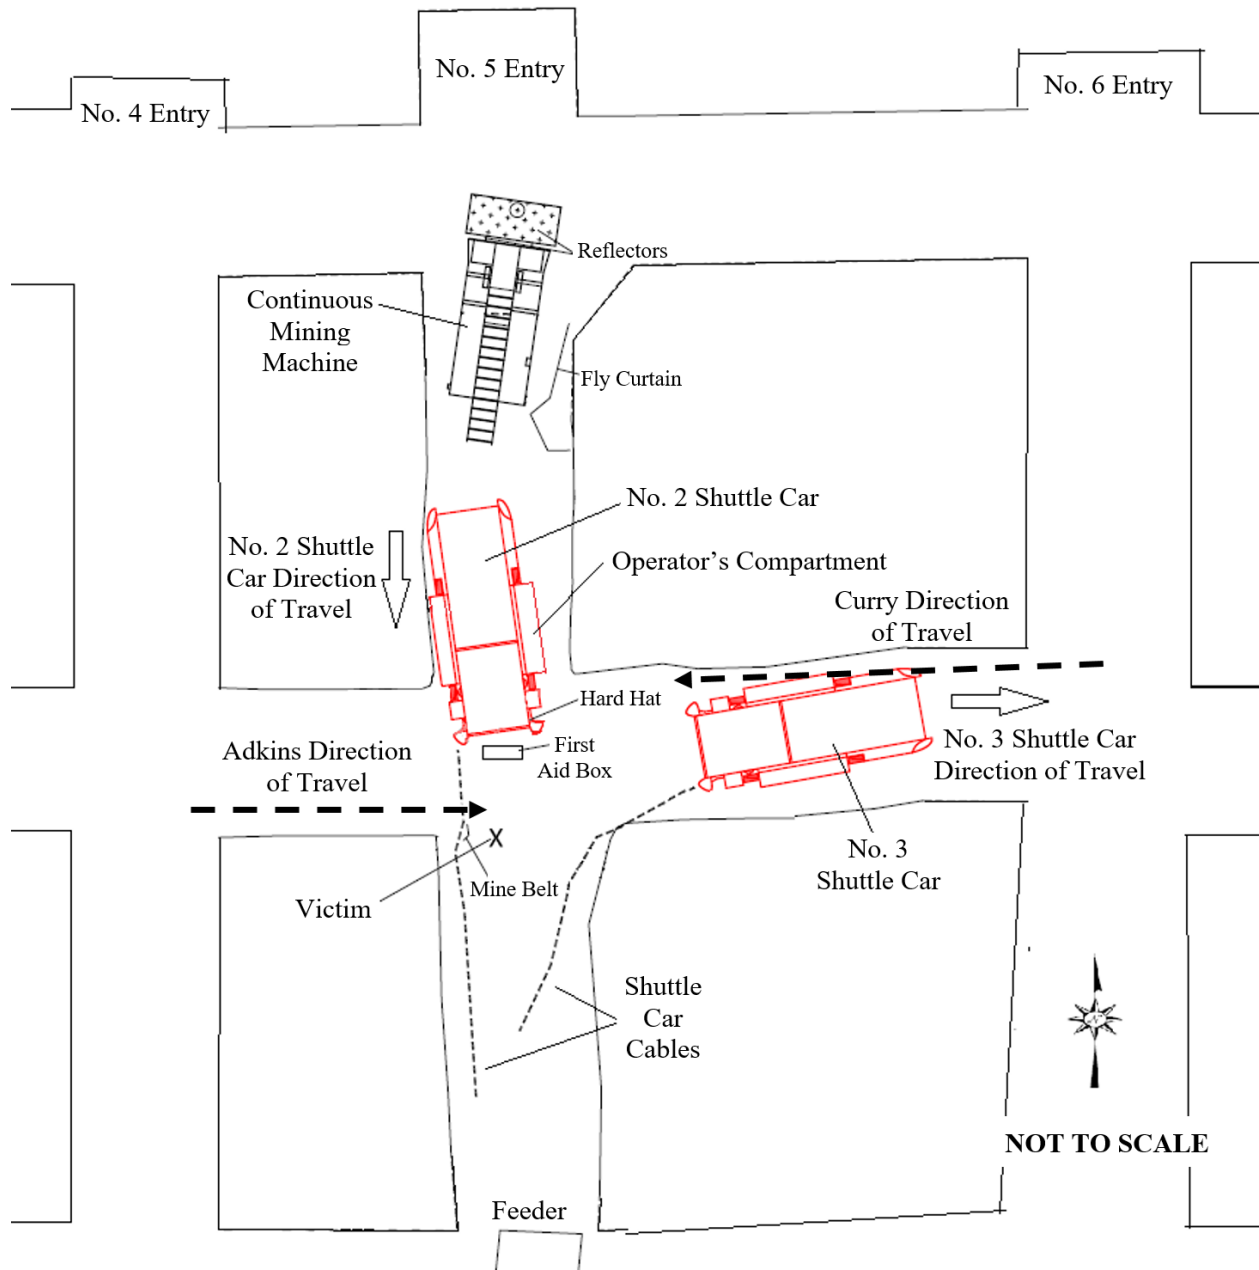
APPENDIX A - Drawing of the Accident Scene

The day of the accident was the first production day after moving the No. 2 section to a new panel. The new section had two open crosscuts inby the feeder. Adkins and Chris Curry, Section Foreman, had communicated over the wireless radio system and were planning to meet each other to do their 9:00 a.m. production call out to the surface to inform management of the day's production. Adkins was traveling on foot from the No. 4 entry to the No. 5 belt conveyor entry to meet Curry. Curry traveled on foot outby in the No. 6 entry and walked through the crosscut, one crosscut inby the feeder from No. 6 entry to No. 5 entry (see Appendix A).

The accident occurred in the No. 5 belt conveyor entry on the No. 2 section one crosscut in by the feeder. The mine height in the intersection where the accident occurred was 57 inches. The section averages 48 to 50 inches in height. The mine floor was dry with a slight uphill grade towards the feeder at the accident scene.
