REPORT OF INVESTIGATION

Fatal Handling Material Accident
June 7, 2021

Plant #10
R.E. Janes Gravel Company
Slaton, Crosby County, Texas
ID No. 41-01111

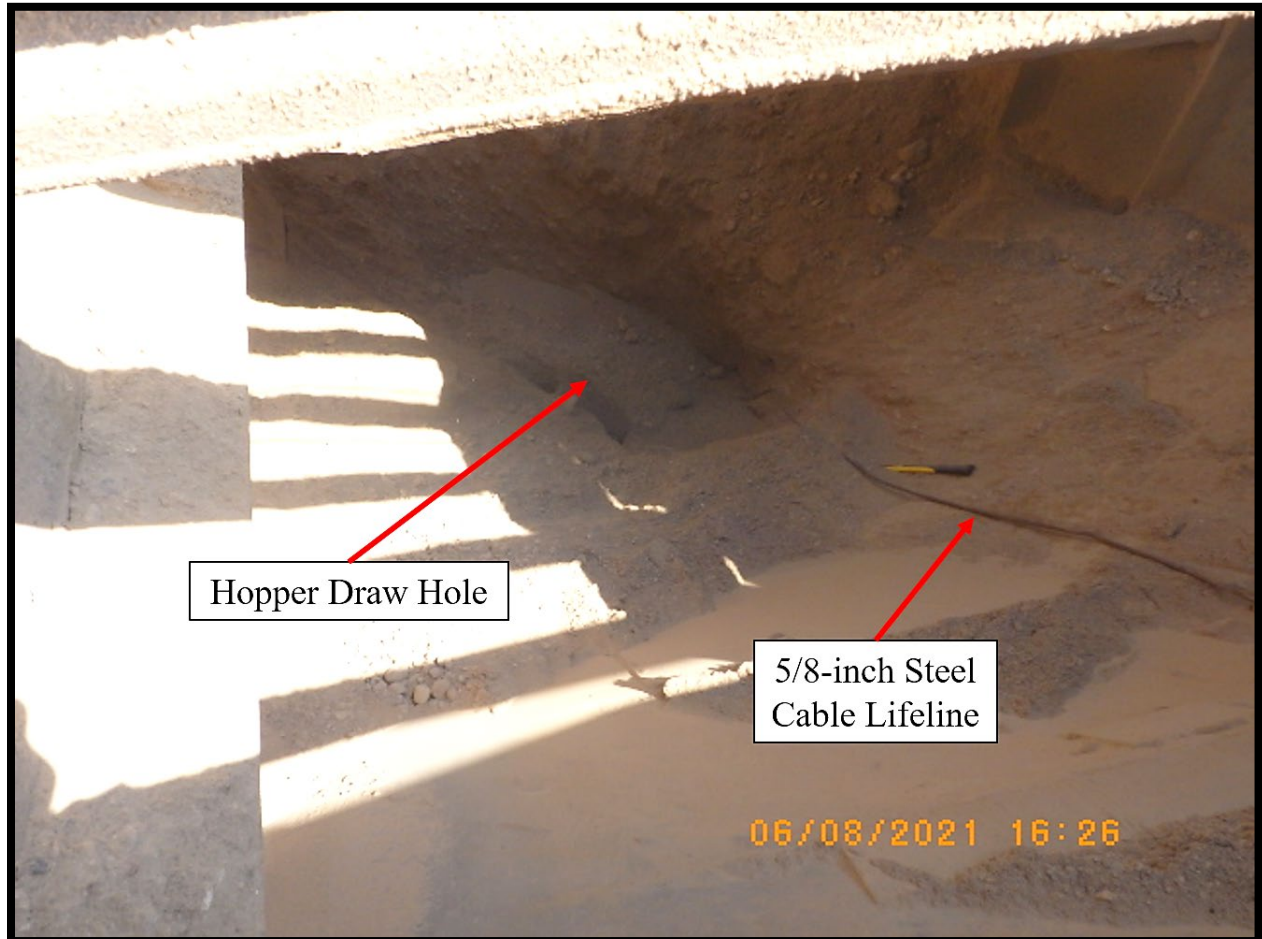
APPENDIX B – Inside View of Grizzly Feed Hopper Area

The accident occurred at the plant's grizzly feed hopper (see Appendix B).

Investigators found the steel cable was loose and not secured properly. There was no ladder, staging, or platforms within the grizzly feed hopper for safe access. It was necessary for employees to maneuver down between gaps in the steel grate beams to enter the grizzly feed hopper and pull themselves out using the 5/8-inch diameter steel cable lifeline anchored to a pipe on the southwest corner of the grizzly feed hopper area.

Garcia-Rivera entered the grizzly feed hopper to clear a blockage without the use of a second person to tend his lifeline, and while material was still present on the sides of the grizzly feed hopper. As he attempted to break up a large rock blocking the material feed, Garcia-Rivera became engulfed in sliding material that was suspended above him on the sides of the grizzly feed hopper.

Corrective Action: The mine operator developed new written policies, procedures, and additional training material to address safety aspects associated with working inside the grizzly feed hopper. The new written policies and procedures require: (1) the hopper to be empty before a miner enters, and (2) the hopper to only be entered for maintenance and inspection purposes. Additionally, the mine operator designed a safe means of access to work around the top of, and inside, an empty grizzly feed hopper. The procedures also included: A) construction of a work platform, B) relocation of the access door and fall protection anchor points, and C) installation of an opening in the grating with ladder access and a fall protection and retrieval system. The mine operator provided training to all affected employees and managers in the revised policies, procedures, and new designs.

Corrective Action: The mine operator implemented a prescreening process in the pit with a scalping screen that reduces the size of the material and removes larger pieces that potentially can cause blockages. The mine operator also developed a new written procedure that requires miners to assure the use of the mechanical vibratory devices to dislodge material. The process of prescreening and using the vibratory devices on the hopper have been tested and determined to be effective. In the event a blockage does occur, the mine operator will remove the blockage in a manner that does not involve a miner entering the grizzly feed hopper.
