UNITED STATES
DEPARTMENT OF LABOR
MINE SAFETY AND HEALTH ADMINISTRATION

REPORT OF INVESTIGATION

Fatal Machinery Accident
March 5, 2021

Dave Clinard Truck Service Inc.
Otter Creek Sand & Gravel Inc.
Havana, Fulton County, Illinois
ID No. 11-01131

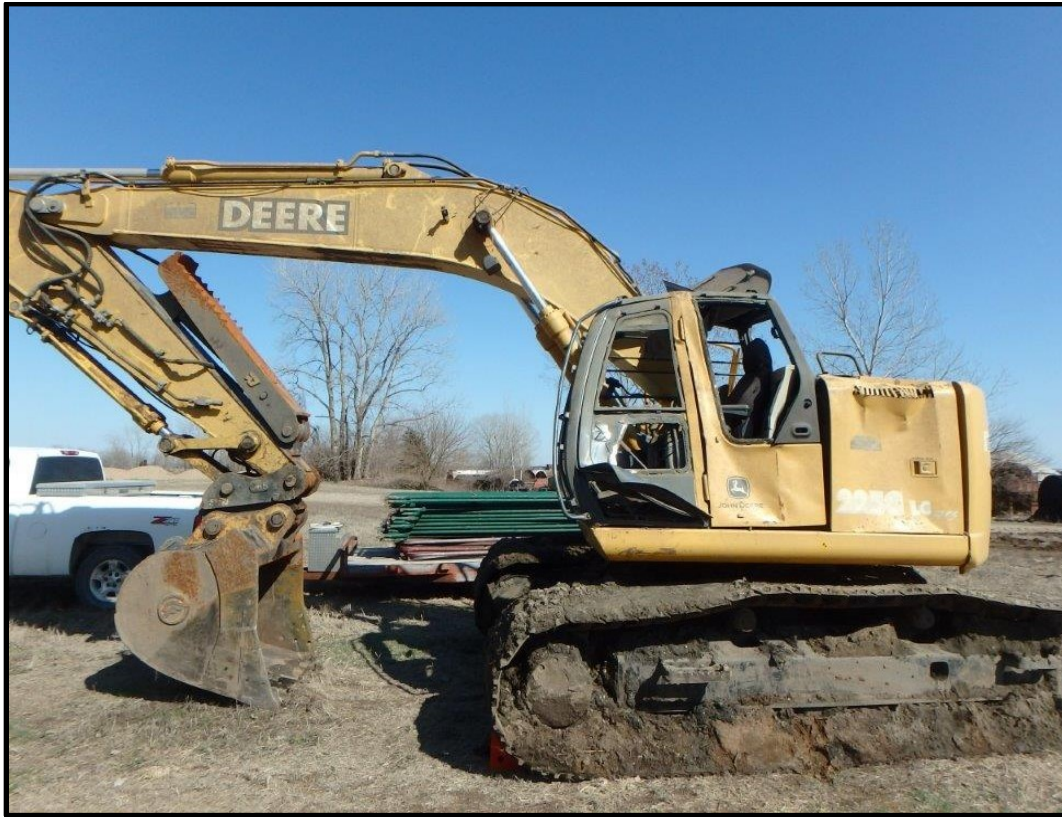
APPENDIX C – JOHN DEERE 225C LC RTS EXCAVATOR

The equipment involved in the accident was a John Deere 225C track mounted excavator (see Appendix C). Investigators determined that the excavator was inoperable when recovered from the pond.

A fatal accident occurred at the mine on March 5, 2021, when a miner operating a John Deere 225C track mounted excavator over-traveled the edge of an elevated roadway, causing the right excavator track to drop and the excavator to roll over into the adjacent dredge pond. Investigators found sections of the elevated roadway to be undercut, creating a portion of unsupported road, and the roadway edge failed. The miner sustained fatal injuries when the excavator rolled into the pond. The mine operator did not provide berms or guard rails on the edge of the elevated roadway where a drop-off hazard existed.

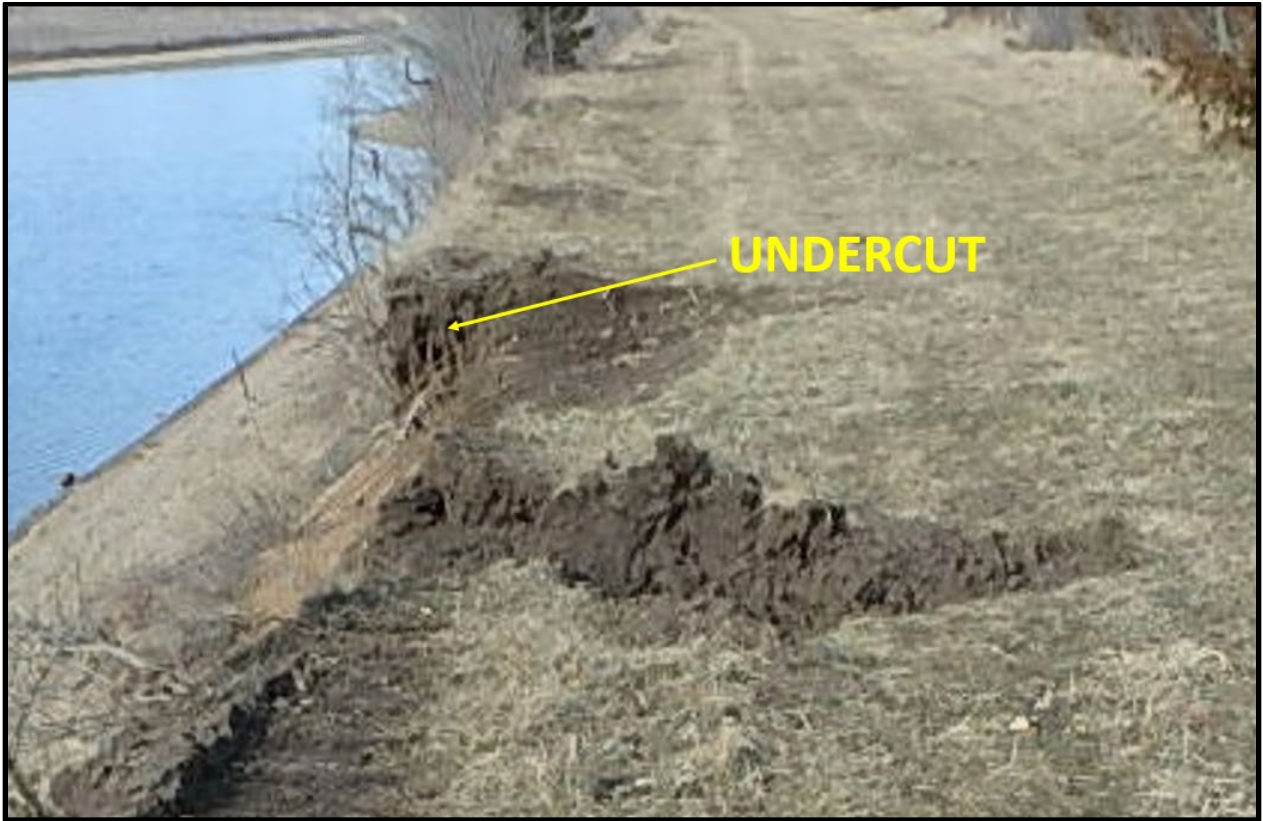
APPENDIX D – HAZARDOUS GROUND CONDITION

Erosion and weathering had severely undercut the elevated roadway (see Appendix D). The undercut bank along the elevated roadway contributed to the fatal accident. Additionally, the mine operator did not provide berms or guardrails on the edge of the elevated roadway where a drop off hazard existed.

1. Root Cause: The mine operator did not provide berms or guardrails on the elevated roadway where a drop off hazard existed.

A fatal accident occurred at the mine on March 5, 2021, when a miner operating an excavator went over the edge of an elevated roadway. Investigators found sections of the elevated roadway were undercut. When the excavator drove over a section of the road that was undercut the excavator track dropped causing the excavator to roll down the bank and into the dredge pond. At the time of the accident, the miner was traveling on the elevated roadway. On days prior to accident, the miner had been clearing brush along this elevated roadway on the pond's perimeter. The mine operator had not conducted a workplace examination prior to the miner performing work in the area.

Corrective Action: The mine operator has installed earthen berm barriers at both entrances to the pond to prevent vehicle access to the elevated roadway along the pond's perimeter from the mine site. The mine operator will develop and provide MSHA with a plan that will assure the safety of drivers and vehicles on the elevated roadway before any vehicle is allowed to travel on the elevated roadway, and will train miners in that plan.
