REPORT OF INVESTIGATION

Fatal Machinery Accident
March 12, 2021

Dredge Chesterfield
Gateway Dredging and Contracting LLC
St. Louis, Missouri
ID No. 23-00889

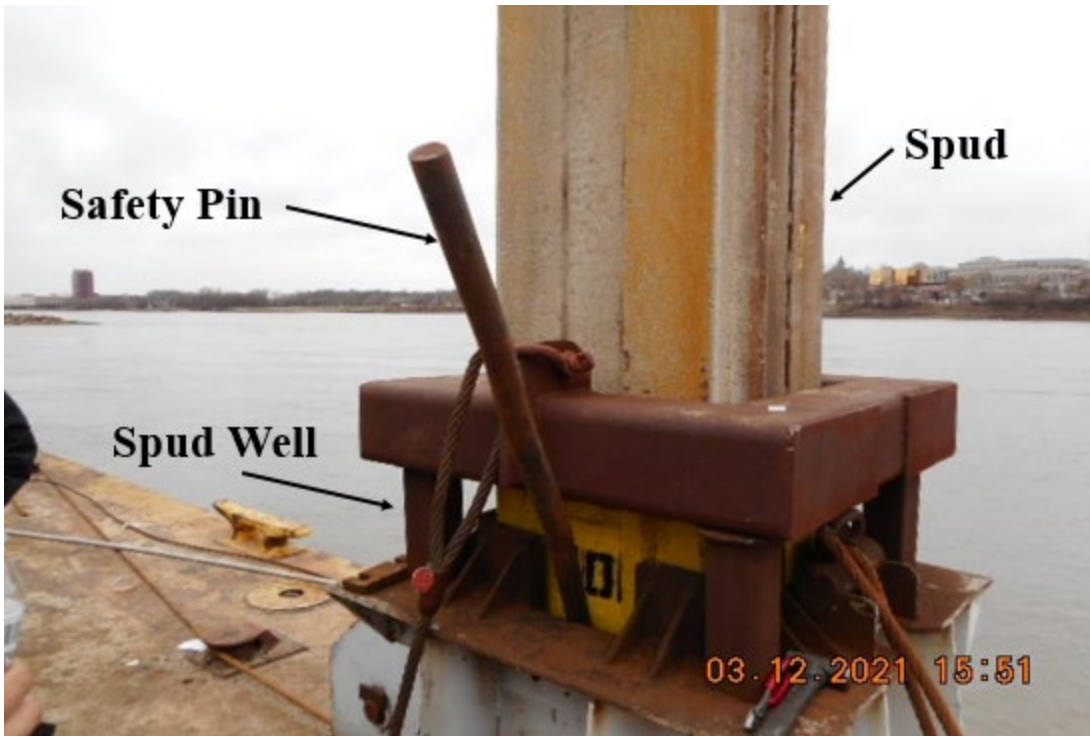
On March 12, 2021, at 11:53 a.m., Jonathan S. Castloo, a 35-year-old equipment operator with approximately eight years of mining experience, was fatally injured when a 43-pound safety pin struck him. Castloo attempted to insert the safety pin into a spud beam while the beam dropped into the spud well. Castloo was unable to place the entire safety pin into the spud beam, and as a result, the safety pin struck the spud well casing causing the pin to suddenly pivot upward and strike him.

Prosser signaled to Miller to raise the spud beam so Castloo could insert the safety pin. Castloo signaled Prosser that the hole in the spud beam was positioned too high above the spud well and signaled Prosser to lower the spud beam into the spud well. Prosser then directed Miller to begin lowering the spud beam. According to Prosser, Castloo did not signal him to stop the motion of the spud beam when the hole was properly aligned to insert the safety pin. While Miller was lowering the spud beam into the spud well, Castloo attempted to insert the safety pin through the spud beam. Castloo did not fully insert the safety pin through the spud beam, and the safety pin struck the spud well casing causing the pin to pivot upward (see Overview picture). As the safety pin pivoted upward, it struck Castloo.

A fatal accident occurred at this mine on March 12, 2021 at approximately 11:53 a.m., when an equipment operator was struck by a spud's safety pin while trying to insert it into a spud beam on work barge BV-1. The spud beam was still in motion when the miner attempted to insert the spud's safety pin. The partially inserted spud's safety pin contacted the spud well casing causing the pin to pivot upward, striking the miner, and resulting in fatal injuries.

Corrective Action: The mine operator implemented written policies and procedures for installing, repositioning, and removing the spud beam and safety pin. The mine operator has trained all management and miners on these written policies and procedures.

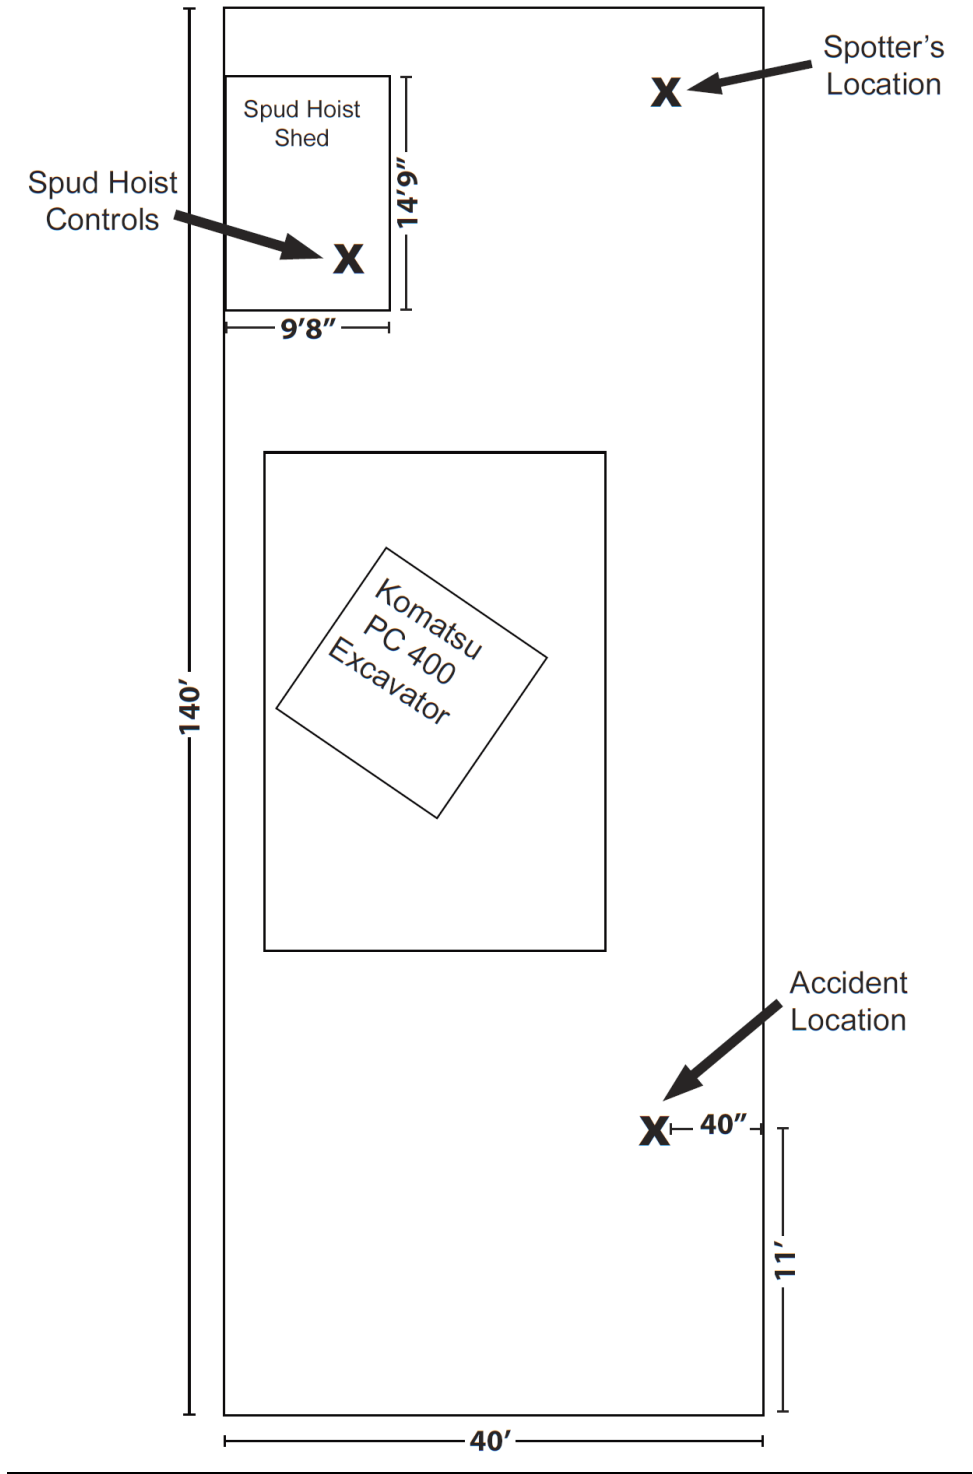
APPENDIX A – Sketch of Work Barge BV-1

Grove was operating the crane on barge BB-1. Miller was operating the spud hoist mounted on the bow and port side of work barge BV-1. Prosser was the spotter, and Castloo was tasked with securing the 43-pound safety pin, measuring two inches in diameter and 49 inches in length. Grove used the crane to lift and swing the new spud beam from barge BB-1 onto work barge BV-1. Castloo, Prosser, and Miller were on the deck of work barge BV-1 installing the spud cable through the sheave of the spud beam. Grove lowered the spud beam into the spud well until the spud cable took the weight. From his location at the controls of the spud hoist, Miller could not see Castloo. Prosser was 33 feet from Miller and 95 feet from Castloo where Prosser could see both Miller and Castloo and communicate with them (see Appendix A for sketch of work barge BV-1).

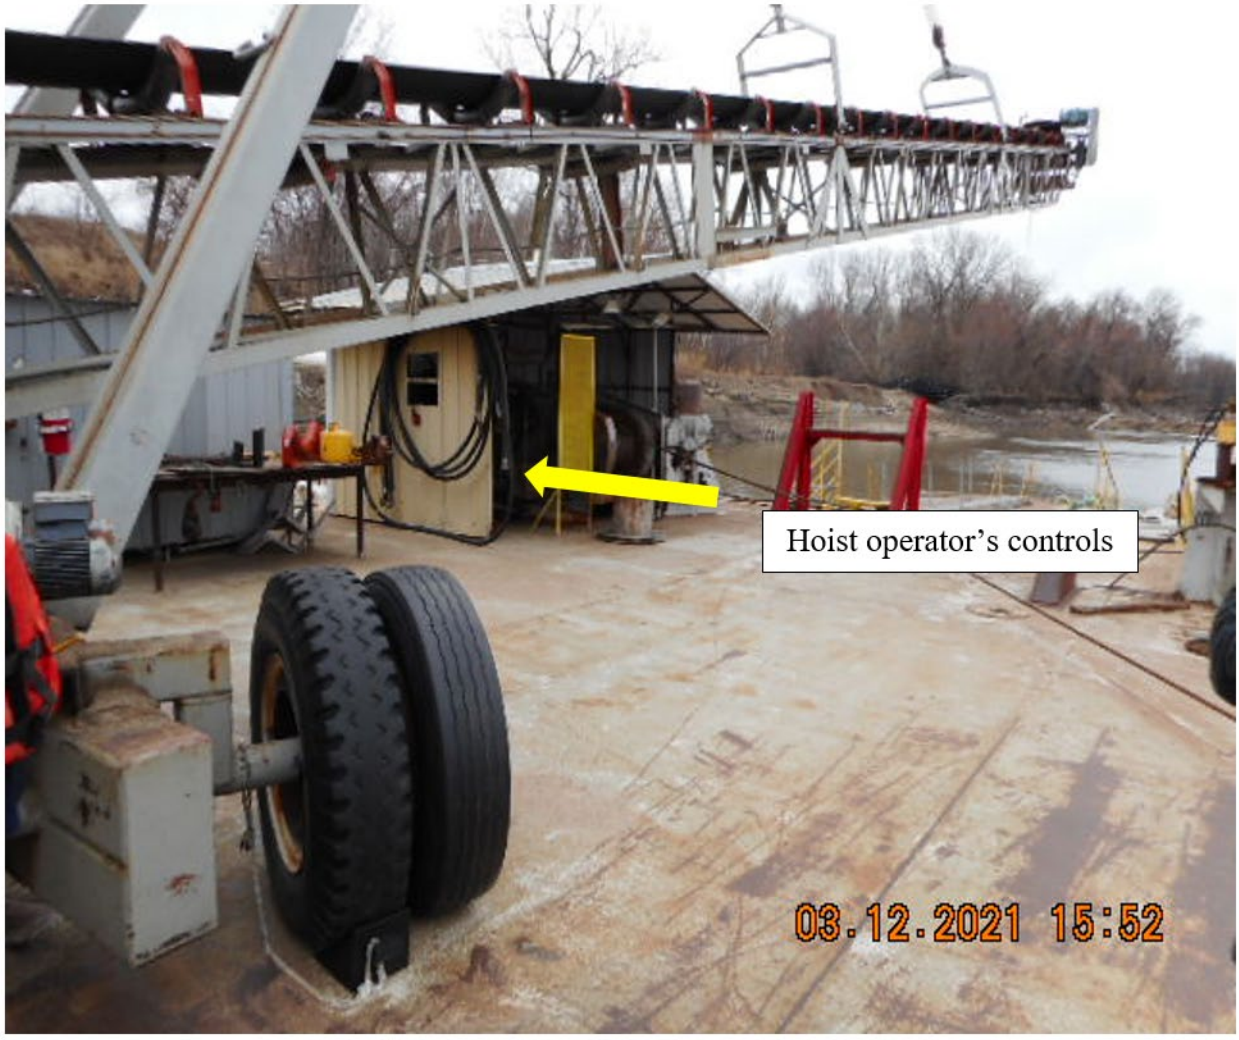
APPENDIX B – Spotter's View of Hoist Operator

Prosser witnessed the safety pin strike Castloo and immediately went to his location. Miller set the brake on the hoist after Prosser left his position as spotter (see Appendix B and C for spotter's location and view of accident). Miller then went to Castloo's location with Prosser. Grove heard Prosser shouting and also went to Castloo's location. Miller told Prosser and Grove to call 911. Prosser called 911 at 11:45 a.m. and went to the front gate to meet Emergency

The spotter was located 33 feet from the hoist operator and 95 feet from the victim's location. This is the only location where the spotter could see both the hoist operator and the victim. The company uses American National Standards Institute hand signals that are used across several industries.
