UNITED STATES
DEPARTMENT OF LABOR
MINE SAFETY AND HEALTH ADMINISTRATION

REPORT OF INVESTIGATION

Fatal Fall of Roof or Back Accident
May 14, 2021

Kocjancic
Rosebud Mining Company
Brockway, Jefferson County, Pennsylvania
ID No. 36-09436

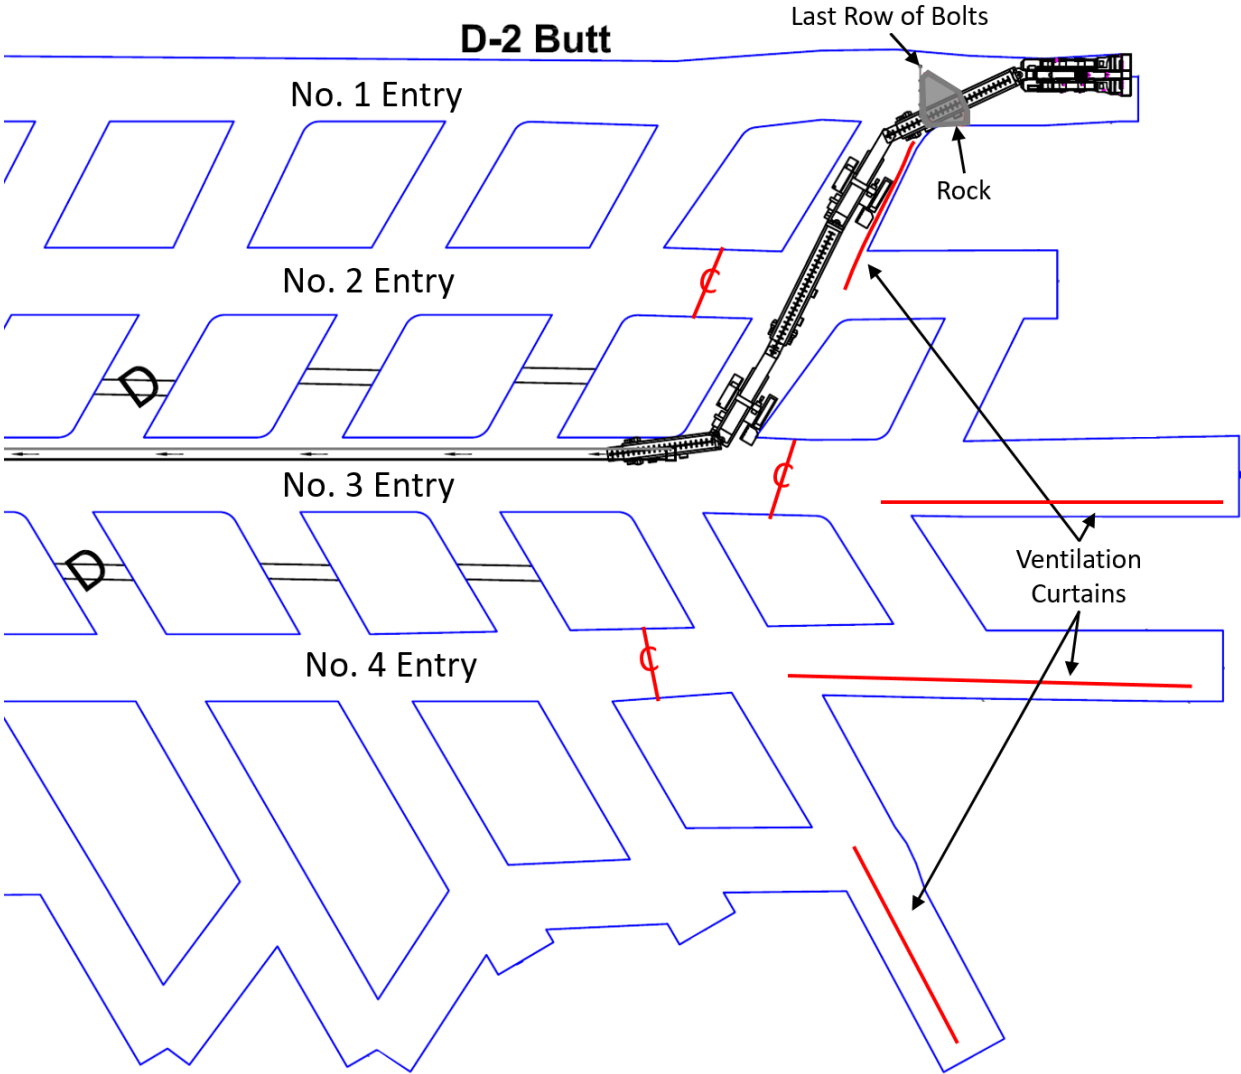
APPENDIX A – D-2 Butt Section Map

The accident occurred in the D-2 Butt section of the mine. The immediate roof in this area has a bed of clay and silt shale (black draw rock) approximately ten inches to twelve inches thick. The main mine roof above the immediate roof was black silt stone, 38 to 40 feet thick. The entry was approximately 19.5 feet wide, 42 inches high, and relatively dry. The section of roof that fell on the victim was triangular in shape, approximately twelve feet long by nine feet wide, and three to five inches thick.

The approved roof control plan states that the maximum depth of cut, beyond the last row of permanent roof support, is 30 feet. Investigators measured the depth of the cut in the No. 1 entry to be 60 feet. The victim had traveled approximately four feet in by permanent roof support (roof bolts) when he was struck by the fallen rock. The length of the CMM is 26 feet. Therefore, the maximum cut depth is indicated when the bumper of the CMM is four feet in by the last row of bolts. If the bumper of the CMM is more than four feet in by the last row of bolts, the cut depth is greater than 30 feet.

Additionally, the approved ventilation plan contains a drawing showing 30 feet from the last row of permanent roof support to the face. Investigators found the line brattice to be 12 feet out by the last row of bolts in the crosscut between No. 1 entry and No. 2 entry, approximately 72 feet from the face.
