REPORT OF INVESTIGATION

Fatal Machinery Accident

May 18, 2021

Young Mine  
Nyrstar Tennessee Mines, Strawberry Plains LLC  
New Market, Jefferson County, Tennessee  
ID No. 40-00168

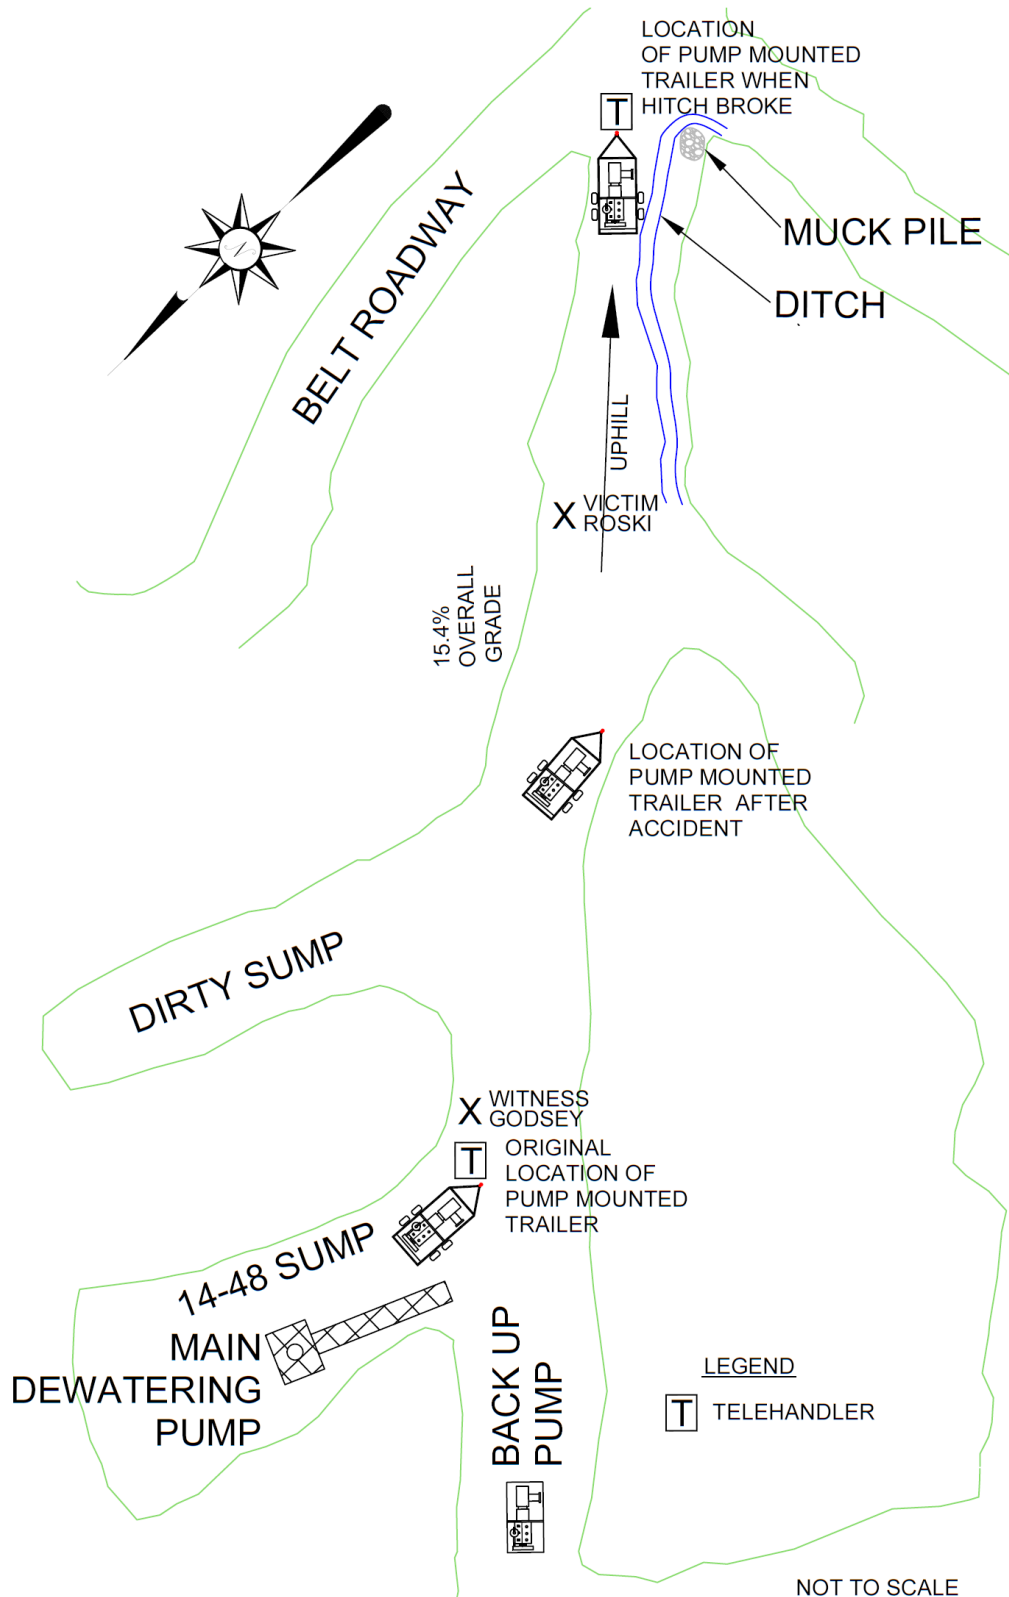
## APPENDIX A - Overview of Accident Scene

At approximately 4:15 p.m., Gipson met with the contract miners on both crews to set a back-up pump in the 14-48 sump area, which is on a downward slope from the belt roadway (see Appendix A). A diesel pump mounted on a dual-axle trailer was parked beside the back-up pump prior to the contract miners working in the 14-48 sump area. Contract miners attached a basket to the forks of the Telehandler and loaded the back-up pump into the basket. Because of the diesel pump's placement in relation to the Telehandler and back-up pump, Isom was unable to extend the stabilizing jacks on the front of the Telehandler. Consequently, the contractor crew decided to move the trailer with the diesel pump out of the area to allow more room to work on the back-up pump. Isom set the basket, which was loaded with the back-up pump, down, and turned the Telehandler around in order to move the trailer with the diesel pump.

The accident occurred at an area of the Young Mine referred to as the 14-48 sump area. The sump is located 216 feet from the belt roadway. The roadway leading from the belt conveyor to the sump is on a downward, 15.4 percent grade. The roadway entry is approximately 18 feet high and 25 feet wide. A steady stream of water was flowing down the right side of the roadway towards the sump.

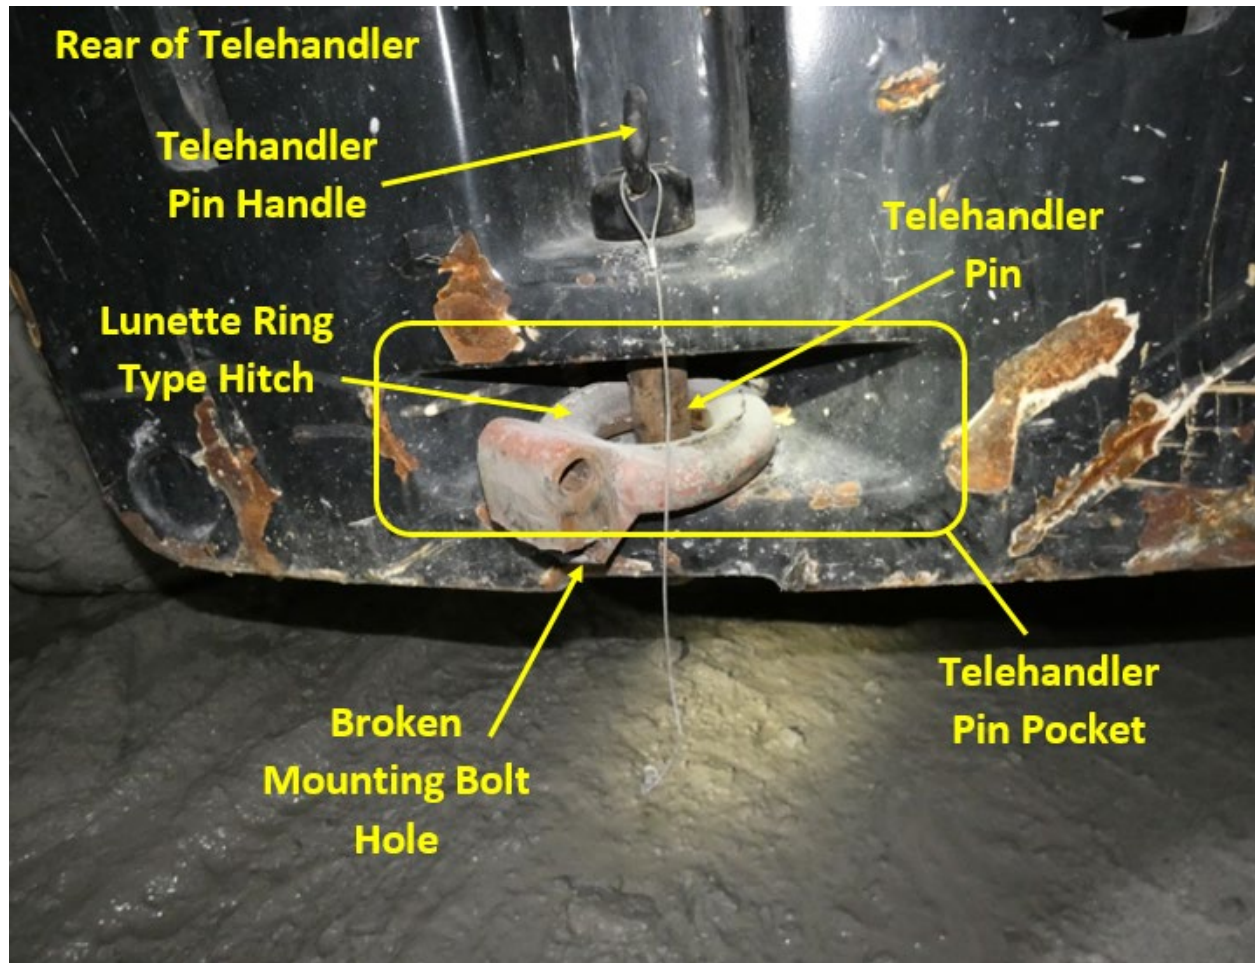
APPENDIX B - Lunette Ring on Telehandler

The trailer was equipped with a lunette ring and the Telehandler was equipped with a hitch pocket and pin. Due to the muddy ground at the sump area, the jack on the trailer was unable to lift the trailer's lunette ring high enough to connect it to the Telehandler's hitch. Isom placed the forks of the Telehandler under the lunette ring and lifted the tongue of the trailer. While Isom lifted the trailer, Lucas placed blocks under the jack to keep it elevated. Gipson and Lucas then connected the trailer to the Telehandler by placing the pin through the lunette ring (see Appendix B). The trailer was equipped with safety chains and a breakaway trailer brake system (see

Russell Stackpole, II, Mechanical Engineer, examined, measured, tested, and analyzed the items. Stackpole's findings were consistent with the investigation team's findings that the trailer's hitch system was incompatible with the Telehandler's hitch pocket and pin.

The manufacturer designed the lunette ring for towing with equipment outfitted with a pintle hitch receiver (see Appendix G). During the towing process, a pintle hitch allows the lunette ring to move freely in each direction and prevents applied pressure to the side of the ring. A pintle hitch receiver also has connection points for the safety chains and brake cable. The hitch on the Telehandler was a simple pin style, which is not designed to tow the lunette ring. When the trailer was connected to the Telehandler, the pin was inserted through the lunette ring. This connection did not allow the lunette ring to move laterally or vertically, placing additional stress on the already vulnerable connection.

Corrective Action: The contractor developed procedures for safely towing loads and trained all contract miners on these procedures. The mine operator also developed procedures for safely towing loads. The mine operator trained all miners and will verify that all contract miners are trained on:

- a. the use of towing equipment, safety chains, and breakaway modules.
  - b. the selection and use of hitches used at the mine
  - c. how to examine hitches, cables, straps, safety chains, safety hooks, tires on the trailer, and all equipment involved in towing.
2. Root Cause: The contractor did not conduct an adequate pre-operational examination before towing the trailer.

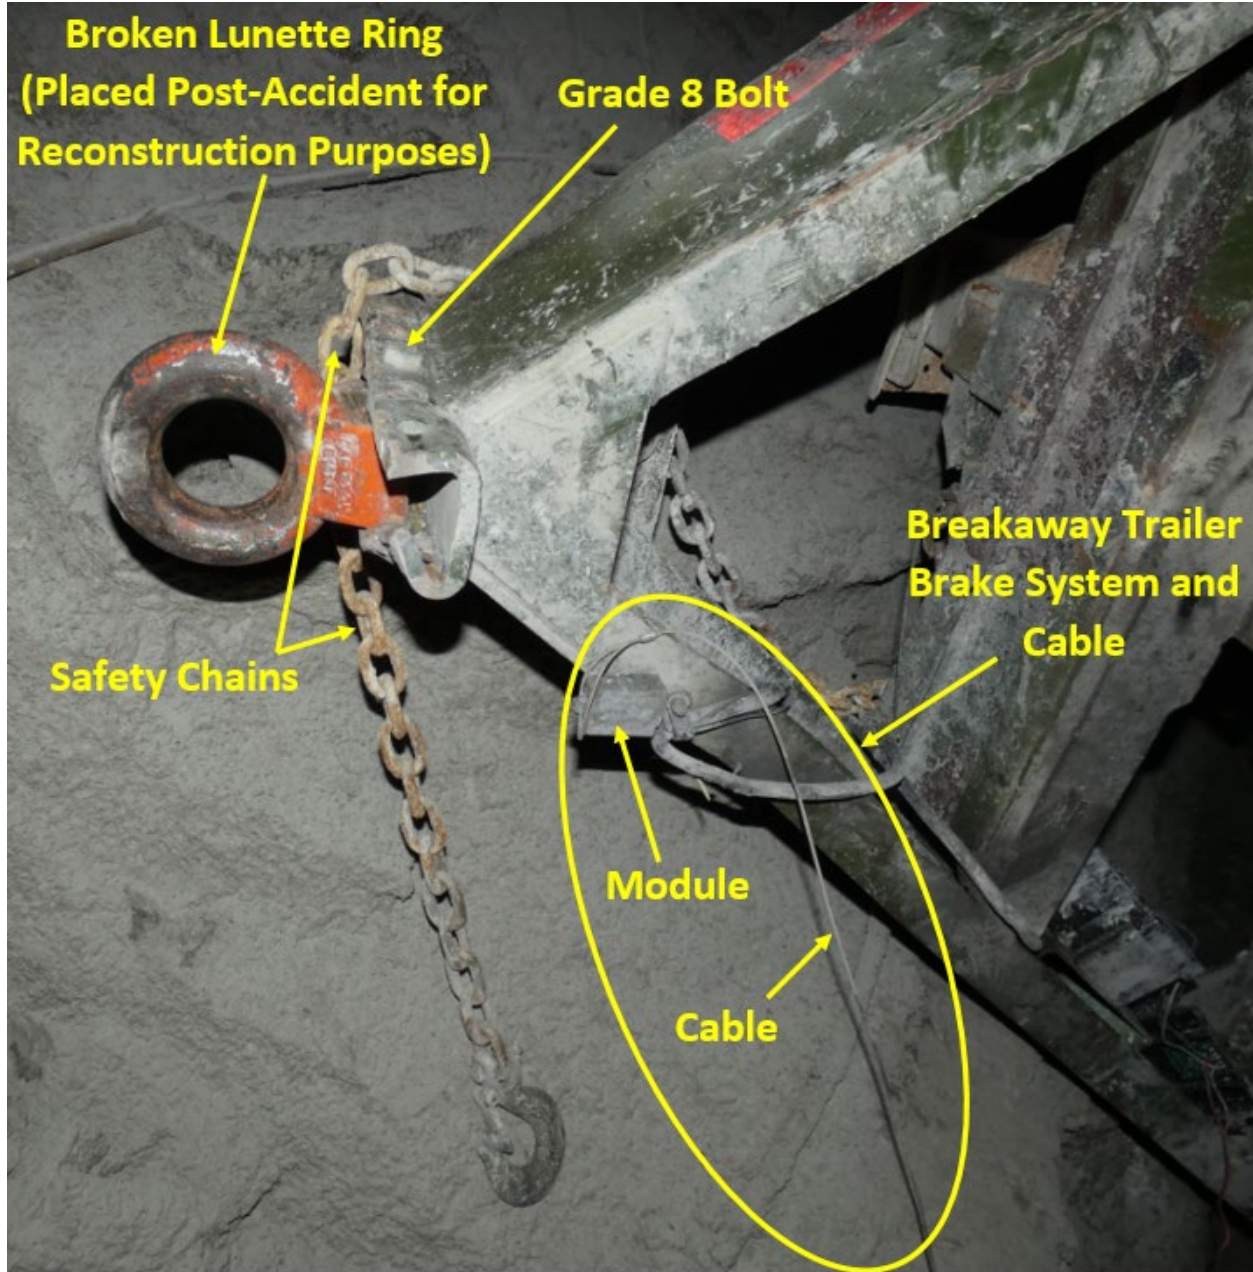
APPENDIX C - Post-Accident Photo of Trailer on its Side

Appendix C), but the crews could not use these safety features because the Telehandler was not equipped with connection points for the safety chains.

The trailer was equipped with two safety chains. The chains connect to a towing vehicle in order to prevent runaway in the event of a primary tow rigging failure. The use of safety chains is not specific to any industry, however, the contractor could not use the safety chains because the Telehandler did not have an adequate connection point for them.

The breakaway trailer brake system cable was not connected because the Telehandler did not have an adequate connection point. This breakaway braking system is designed to set the trailer brakes if the trailer becomes disconnected from the towing vehicle.

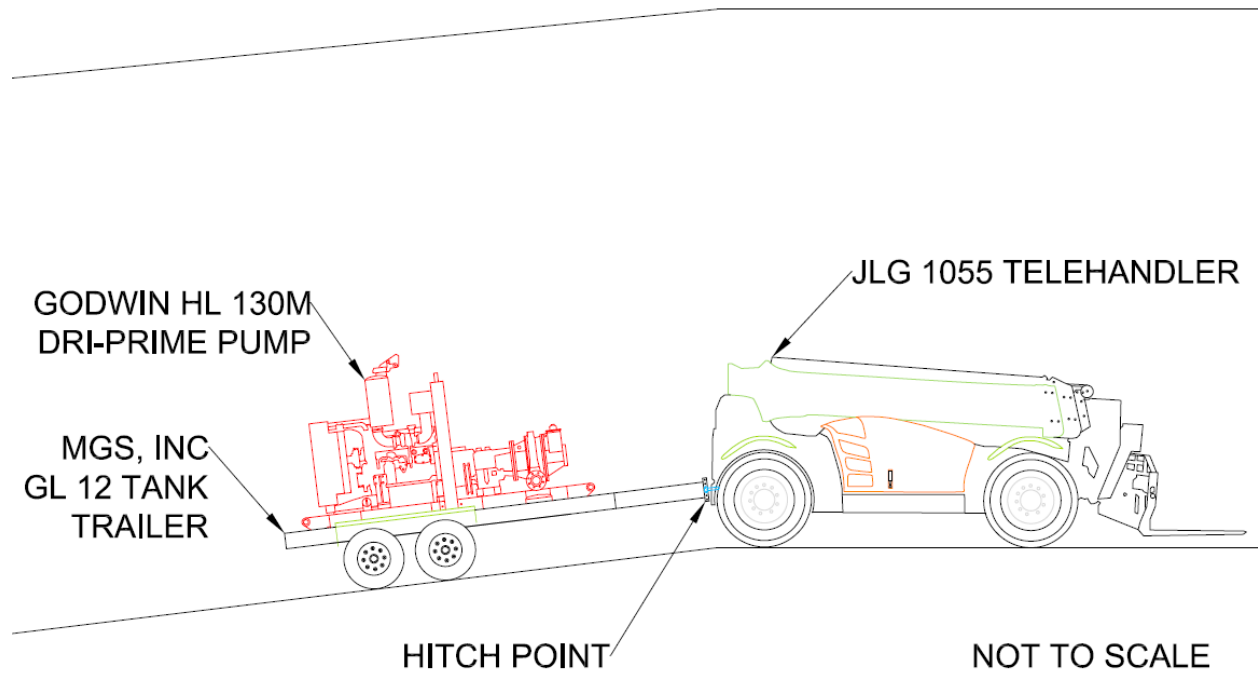
# APPENDIX D - Sketch of Telehandler and Trailer at Apex of Incline

As the Telehandler reached the top of the incline, Isom swung the Telehandler wide toward the left rib to turn onto the right roadway. This placed the Telehandler on the level roadway while the trailer with the diesel pump remained on an inclined section of the roadway (see Appendix D). The positioning of the Telehandler and trailer with the diesel pump on different planes put stress on the lunette ring. The lunette ring's lug broke, causing it to lose connection with the trailer. According to interviews, the contract miners heard a loud popping sound which was later verified as the lunette ring breaking. At the time that the connection broke, Roski was located approximately ten feet behind the trailer. Gipson stepped out from the sump area after he heard the loud popping sound, saw the trailer with the diesel pump rolling toward the contract miners, and yelled for them to move out of the way. The contract miners then huddled on the catwalk adjacent to the sump. While the trailer rolled down the incline, Godsey stepped out of the sump area to see what was happening and saw Roski crouched down to brace for impact as the trailer struck him. After hitting Roski, the trailer struck the left rib, flipped, and then came to rest on its side along the right rib, approximately 120 feet from the Telehandler. Gipson, Godsey, and Lucas rushed to check on Roski. Realizing Roski's injuries were critical, Gipson obtained a nearby personnel carrier and drove to the top of the incline to find help.

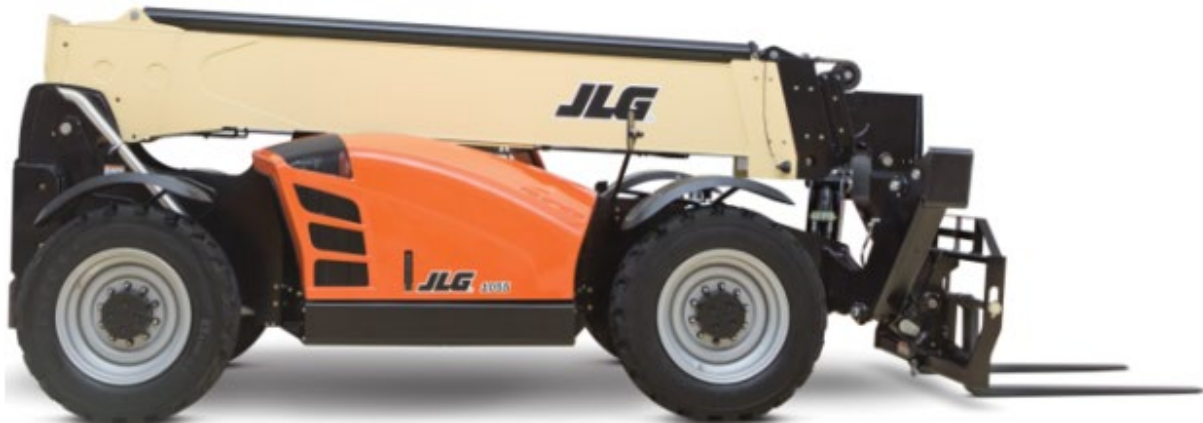
APPENDIX F - Example of JLG 1055 Telehandler

At the time of the accident, the contract miners were using a leased JLG Telehandler, model 1055 (see Appendix F).

MSHA determined the Telehandler was not manufactured for towing and an ineffective hitching system was used to tow the trailer. According to JLG's Operation and Safety Manual, the hitch pocket and pin in the frame of the Telehandler were retrieval devices used for recovering the machine in the event it became disabled, not for trailer towing.

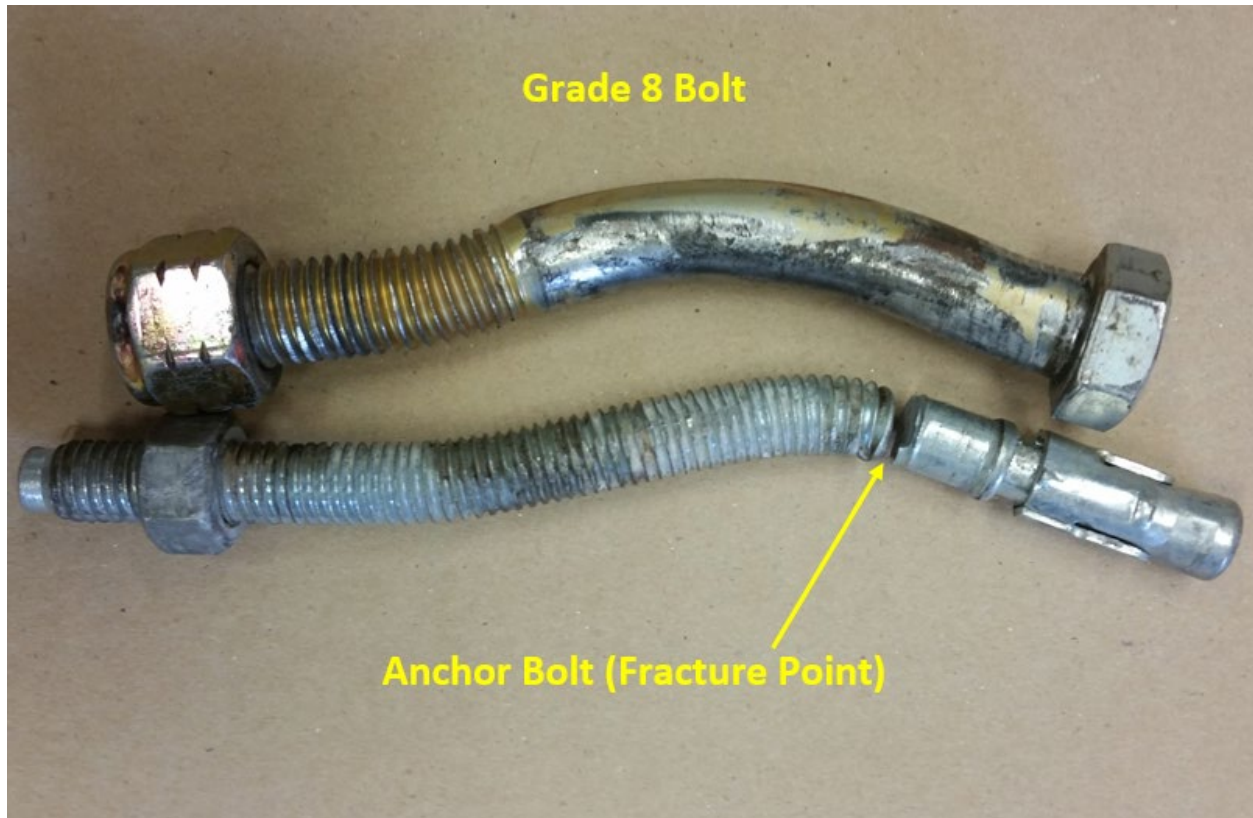
## APPENDIX H - Comparison of Grade 8 Bolt and Anchor Bolt

Additionally, the lunette ring is designed to be secured to the tongue of the trailer by two grade 8 bolts. Only one severely bent grade 8 bolt was recovered after the accident. The operator stated that an anchor bolt was used instead of a grade 8 bolt. During the accident investigation, a severely bent and fractured anchor bolt was found along the trailer's travel path. This anchor bolt did not have the required strength, nor the proper size as the required grade 8 bolt (see Appendix H).
