REPORT OF INVESTIGATION

Fatal Powered Haulage Accident
November 1, 2021

Mountaineer II Mine
Mingo Logan Coal LLC
Sharples, Logan County, West Virginia
ID No. 46-09029

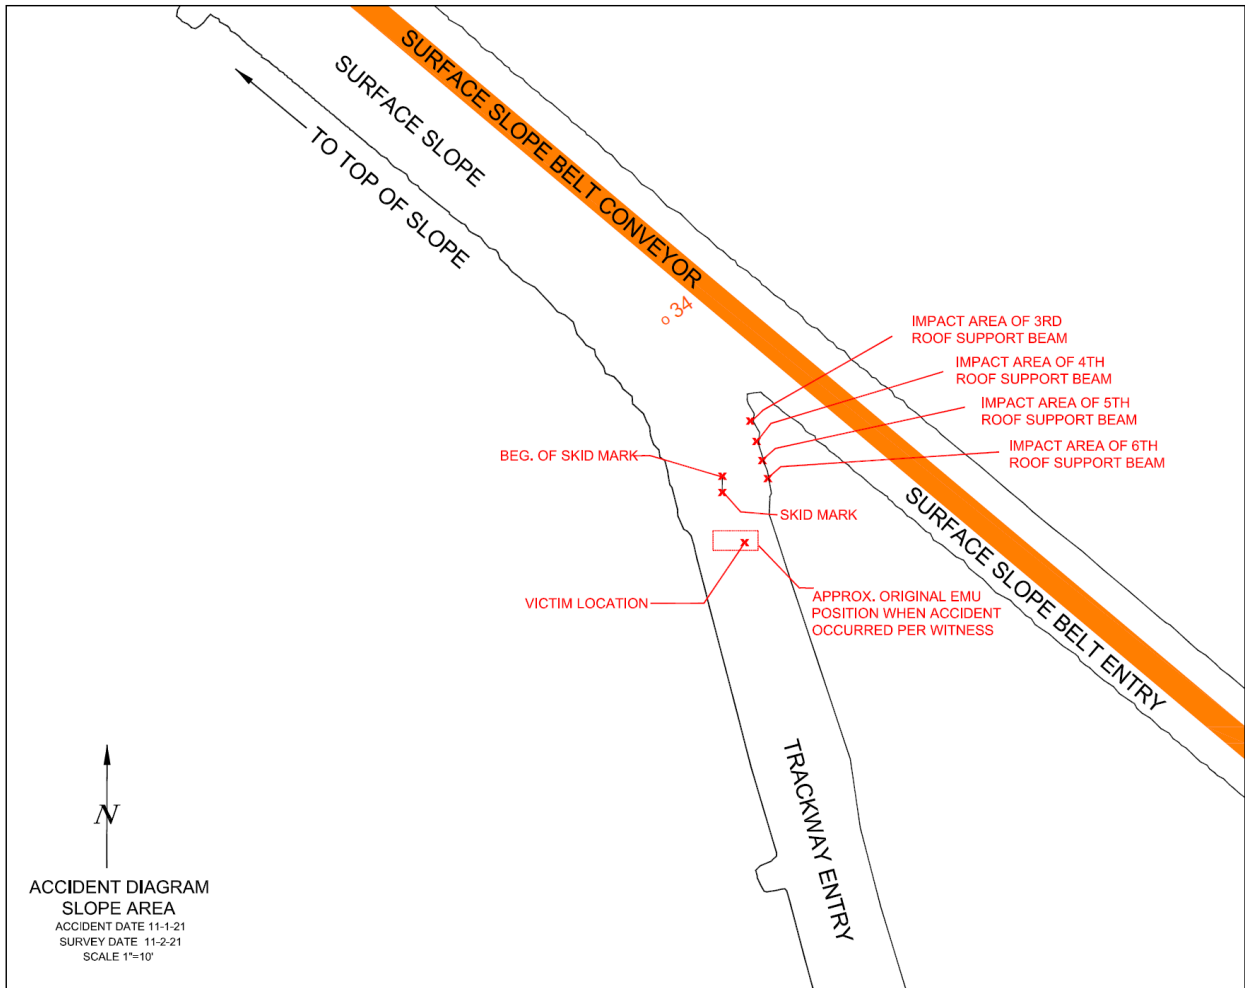
APPENDIX B – Drawing of the Accident Scene

The accident occurred at the bottom of the Surface Slope, which extends from the surface down to the Alma Coal Seam level. The Slope is 1,536 feet long, with an average 12-degree grade. The No. 7 EMU came to rest approximately 50 feet in by Survey Station No. 34 at the bottom of the Slope (see Appendix B).
