REPORT OF INVESTIGATION

Surface
(Construction Sand & Gravel)

Fatal Powered Haulage Accident
November 17, 2021

East Coast Mines Ltd
East Coast Mines Ltd
East Quogue, Suffolk County, New York
ID No. 30-00865

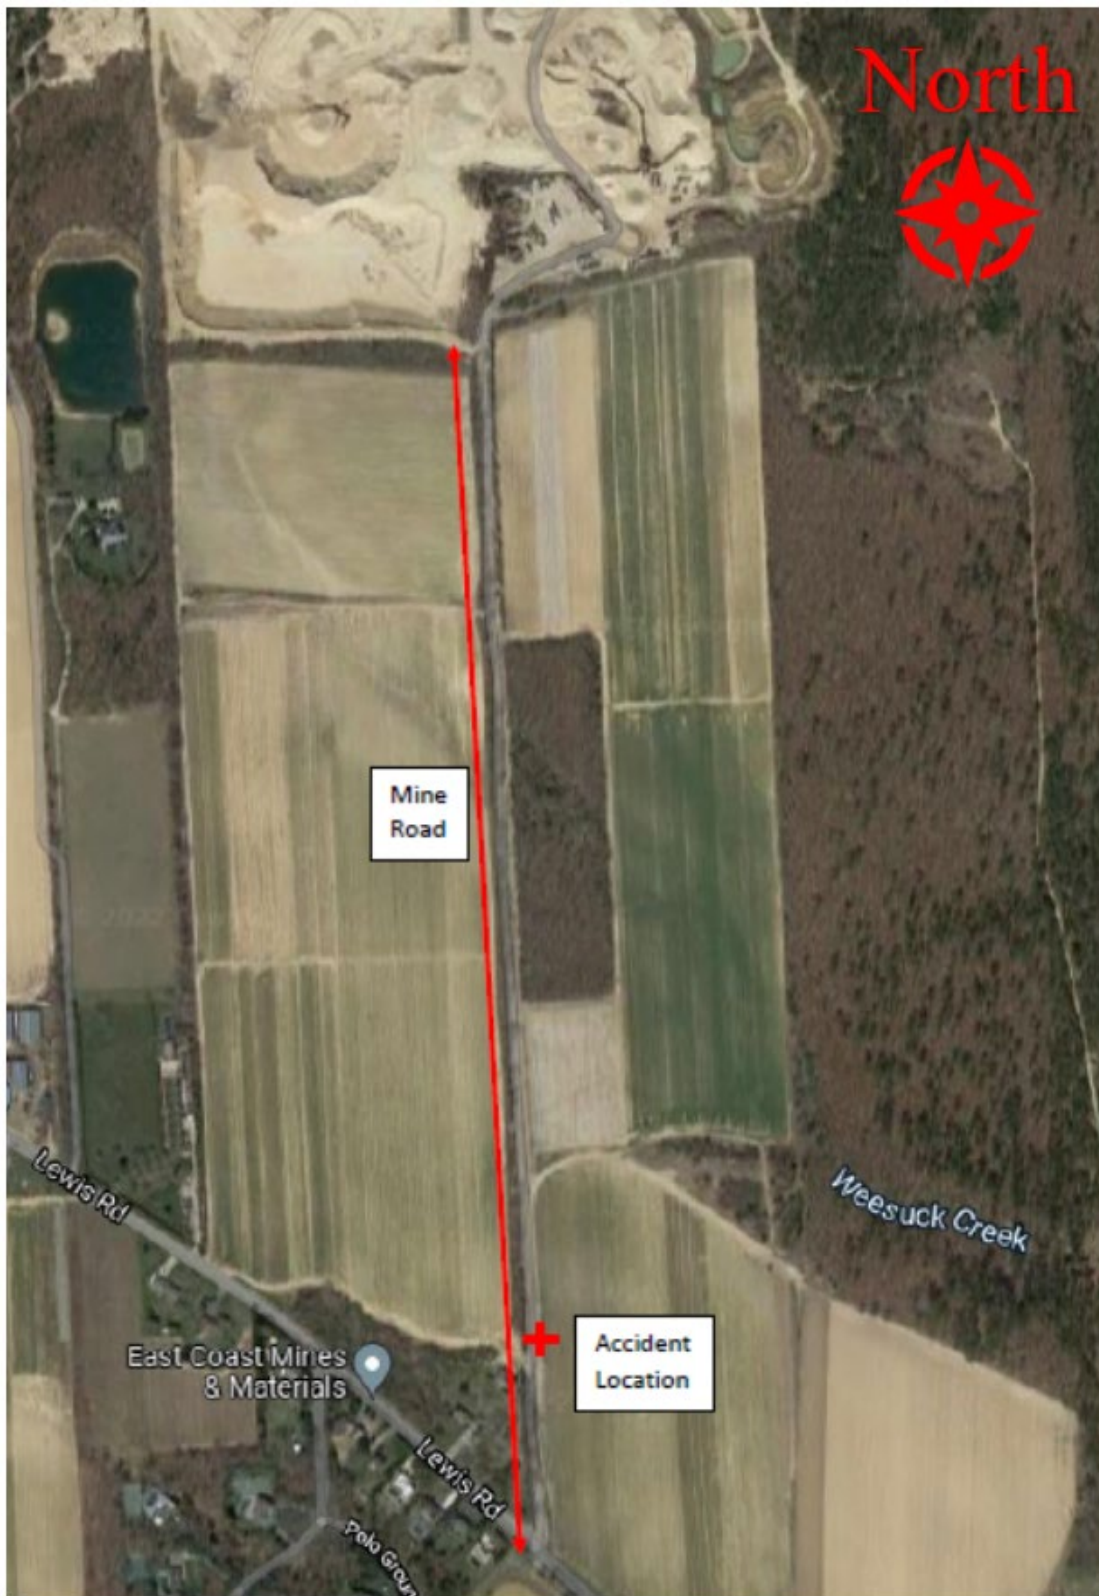
APPENDIX B – Aerial View of the Accident Location

The mine road is a single lane dirt road approximately 3,500 feet long extending from Lewis Road to the pit and scale area (see Appendix B). Overhead high-voltage power lines, which supply electrical power to the mine, are installed along the length of the mine road on the east side of the roadway. The mine road was in good repair. The accident occurred on the east side of the mine road approximately 630 feet north of Lewis Road at pole number 3 under the overhead high-voltage power lines, which measured 25.5 feet above ground level. The mine operator did not post signs warning truck drivers of the overhead high-voltage power lines.

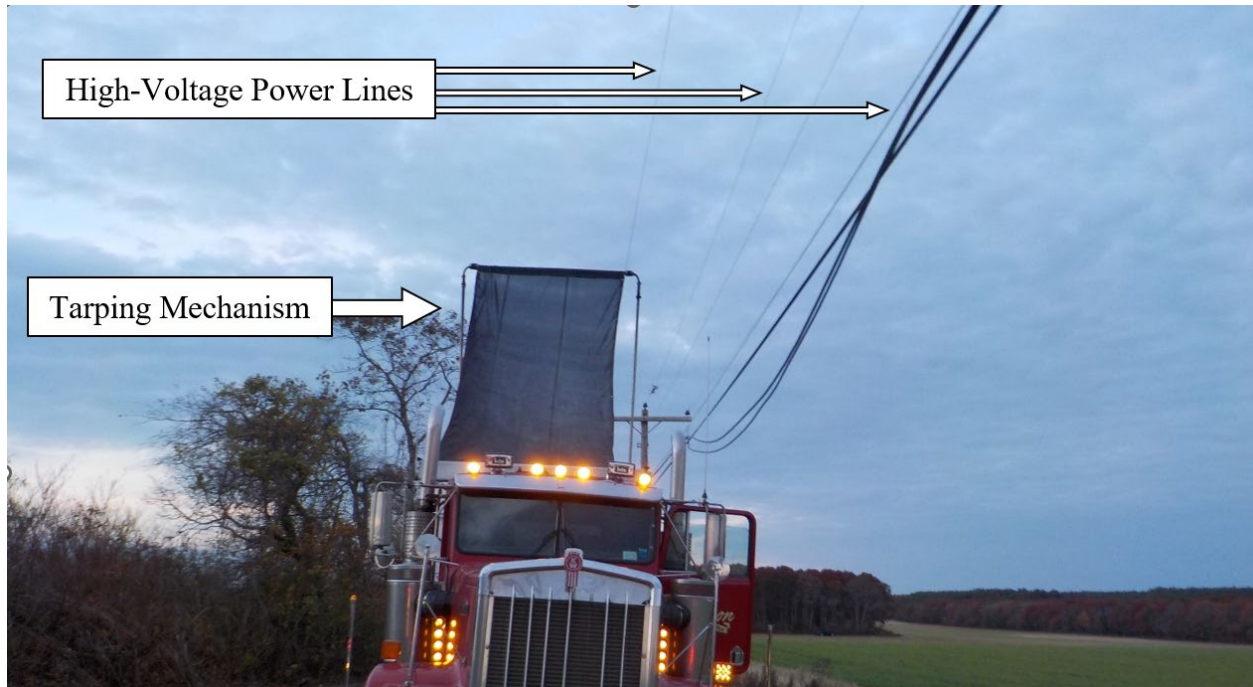
APPENDIX C – Photograph of the Equipment Involved

The equipment involved in the accident was a Kenworth W900 truck which towed an aluminum end-dump trailer (see Appendix C). The maximum height of the truck and trailer was 13 feet. Due to the damage caused by the power line, investigators were unable to start the truck, but were able to conduct a visual examination. The tarping mechanism was stuck in the open position and could not be tested.

With the tarping mechanism open, the total height of the customer truck extended beyond the height of the overhead high-voltage power lines. The mine operator did not have a tarping procedure requiring trucks to tarp their loads before exiting the mine and entering the mine road, which would have prevented contact with the overhead high-voltage power lines. Investigators determined that this contributed to the accident.

Corrective Action: The mine operator installed site-specific hazard awareness training signage that include a policy for tarping loaded trucks leaving the mine.
