REPORT OF INVESTIGATION

Underground  
(Coal)

Fatal Powered Haulage Accident  
November 23, 2020

American Eagle Mine  
Panther Creek Mining, LLC  
Cabin Creek, Kanawha County, West Virginia  
ID No. 46-05437

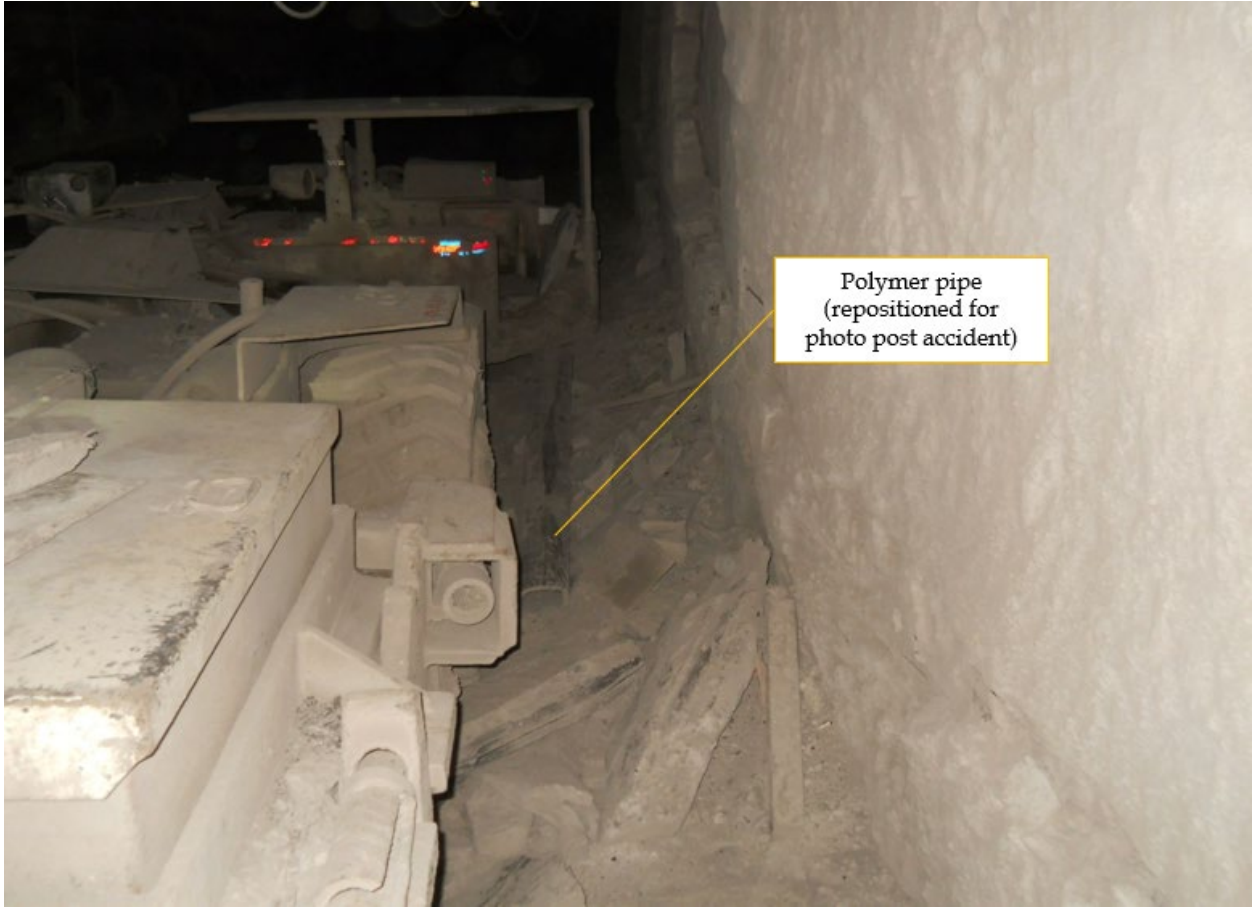
Appendix A – Photo of Scoop

On November 23, 2020, Halstead started his shift at 7:00 a.m. He traveled from the Coal Fork Portal to the Dawes slope where he assisted several miners in removing accumulations and spillage on the Dawes slope. At approximately 11:00 a.m., Jeffery Edwards, Foreman, directed Halstead and Casey Burkhamer, Laborer, to retrieve belt conveyor structure located at the end of the Dawes slope track. They needed the structure to make repairs on the slope belt conveyor. Halstead, Edwards and Burkhamer traveled to the No. 537 battery scoop charging area to get a scoop to assist with moving the structure. Edwards directed Halstead to operate the scoop. Edwards and Burkhamer traveled to the end of the track where the belt conveyor structure was loaded on rail cars. They waited at the end of the track approximately 10 minutes for Halstead to arrive with the scoop before becoming concerned, at which point they went looking for him. Edwards and Burkhamer found Halstead approximately one crosscut away, pinned in the scoop by a piece of polymer pipe. The polymer pipe had been laying in the track entry roadway. Halstead was traveling towards the rail cars with the battery end of the scoop leading. As the scoop traveled over the polymer pipe, the weight of the scoop raised it, and it entered the operator's compartment and struck Halstead (see Appendix A).

The scoop involved in the accident was rebuilt in 2009 by C.A.I. Industries. The scoop was originally manufactured as a model 488 scoop by S&S. This is an older scoop that was not equipped with a door to the operator's compartment. There is no supporting evidence that the scoop had ever been retrofitted with a door.
