REPORT OF INVESTIGATION

Surface
(Sand and Gravel)

Fatal Handling Material Accident
October 1, 2021

Ovyn #1 Pit
Dennis Ovyn Trucking Inc
Withee, Taylor County, Wisconsin
ID No. 47-03016

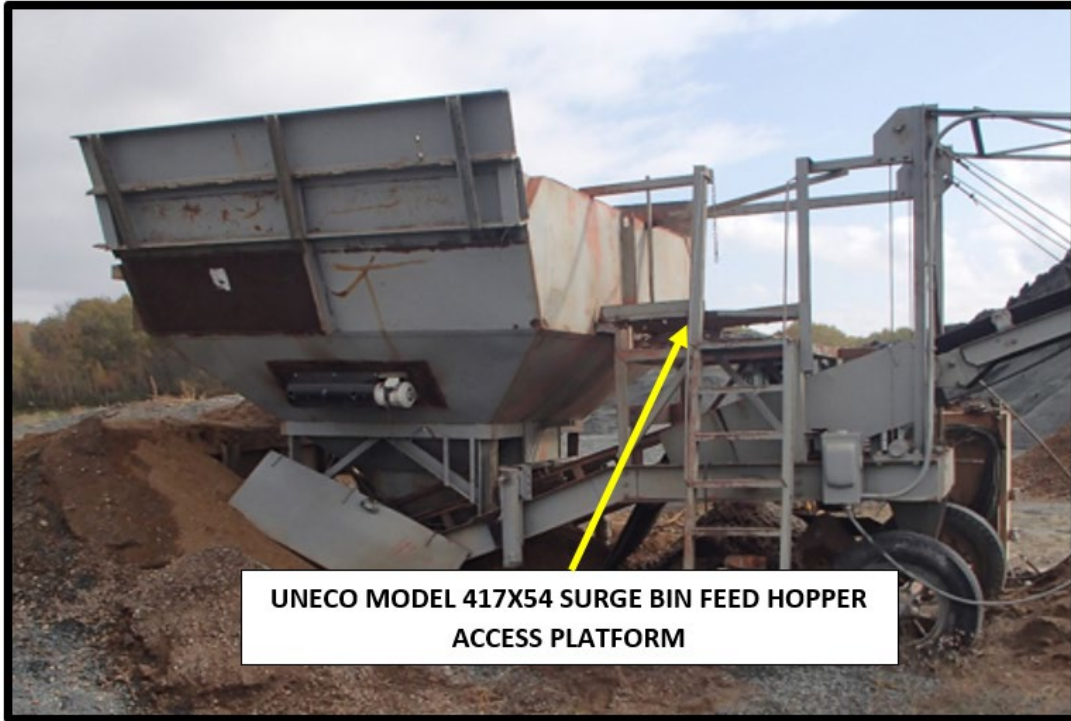
APPENDIX C – Photograph of the Equipment Involved

The equipment involved in the accident was a UNECO 417X54 surge bin and belt conveyor that the mine operator modified for use as a feed hopper (see Appendix C). The top opening of the surge bin feed hopper is ten and a half feet by 11 feet and tapers to a one and a half feet by three inch opening at the bottom. The distance from the top opening to the bottom opening is between seven and eight feet. The mine operator installed automated vibratory equipment on the surge bin feed hopper to help minimize material obstructions. Investigators tested the automated vibratory equipment and found that it operated properly.

The surge bin feed hopper had a work platform that provided safe access when material was required to be removed manually. Although there were no guard rails, the edge of surge bin feed hopper sidewall was 36 inches above the work platform. The edge of the surge bin feed hopper served as a barrier to prevent access to the bin. Tools to remove material that obstructs the flow through the surge bin feed hopper were provided. Obstruction removal tools included a three-foot and 5/8-inch long spade nose D-handled shovel, a 1½-inch wide by 3/8-inch thick by six-foot long metal strap, and an eight-foot metal poker with a “T” handle 3/4-inch in diameter (see Appendix D). The shovel and strap were typically stored on the work platform and were found with Peleschak inside the surge bin feed hopper. The poker was stored at ground level next to the surge bin feed hopper. Information obtained by investigators during interviews indicate that the miners would dislodge materials from the surge bin feed hopper from the access platform using the tools provided.

Based on evidence gathered during the investigation, investigators could not determine how Peleschak entered the surge bin feed hopper. However, the mine operator developed and implemented written procedures when miners have to access bins, hoppers, silos, and tanks. The mine operator's procedures require that no person shall enter the facility until the supply and discharge of materials have ceased, and the supply and discharge equipment is locked out. Persons entering the facility shall wear a safety belt or harness equipped with a suitably fastened lifeline. A second person, similarly equipped, shall be stationed near where the lifeline is fastened and shall constantly adjust it or keep it tight as needed, with minimum slack. The mine operator trained miners on these procedures and will maintain handrail heights sufficient to prevent incidental falls into the feed hopper.
