REPORT OF INVESTIGATION

Underground Mine
(Coal)

Fatal Powered Haulage Accident
October 13, 2020

Cardinal Mine
Warrior Coal, LLC
Madisonville, Hopkins County, Kentucky
ID No. 15-17216

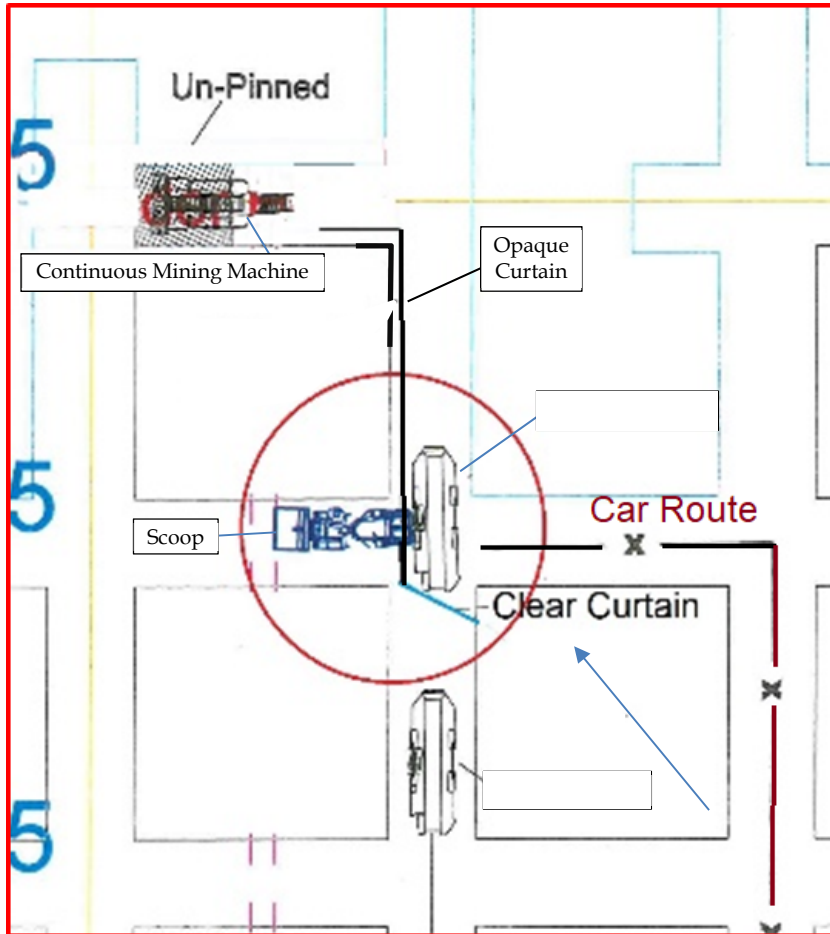
APPENDIX A
Accident Scene

Burns exited his shuttle car and began adjusting the ventilation curtain in the area of the last open crosscut. At 8:45 p.m., Ramsey trammed the shuttle car out by in the No. 6 entry, stopped in the last open crosscut, and turned off the lights on his shuttle car. Ramsey began to exit his shuttle car to assist Burns with adjusting the ventilation curtain. At that moment, Blythe trammed the scoop through the ventilation curtain because when Blythe didn't see Ramsey's lights, he thought Ramsey had turned his shuttle car into the last open crosscut and was traveling his normal route to the feeder. The scoop crushed Ramsey between the scoop's batteries and the shuttle car (see Appendix A).

Ramsey trammed shuttle car No. 2087 from the CMM located in No. 6 left crosscut at 18+45 to the intersection of the No. 6 entry at 17+75 stopping parallel to the ventilation curtain. Burns trammed shuttle car No. 2086 from the dumping point in the No. 5 entry at crosscut 15+65 and stopped between crosscuts 17+05 and 17+75 in the No. 6 entry (see Appendix C). Miners ventilated the No. 6 left crosscut with opaque white curtain, which was installed from the CMM location and extended outby across the intersection at the 17+75 crosscut, and a clear curtain installed at an angle across the No. 6 entry. The opaque white curtain prevented Blythe from seeing the shuttle car parked on the other side with its lights turned off.

2. Root Cause: The mine operator's policies, procedures, and programs did not address the installation of opaque line ventilation curtain in an intersection. The non-transparent line ventilation curtain prevented the scoop operator from seeing the shuttle car parked on the other side.

Ramsey (victim) operated shuttle car #2087,
Burns operated shuttle car # 2086, and
Blythe operated the scoop

Corrective Actions: The mine operator developed and implemented the following written policy regarding line ventilation curtains and provided training for miners: all line face ventilation curtains extending into the last open crosscut will be transparent curtain, scoops will not travel through line brattice face ventilation curtains on active working sections except when performing cleaning and rock dusting activities, and shuttle cars will not travel through line face ventilation curtains in intersections on active working sections.

Corrective Action: The mine operator developed and implemented the following written policy and provided training for miners: all rubber tired mobile equipment operators are to position their equipment to prevent the deck from being struck by other equipment if they have to stop or park in an intersection beside or behind ventilation curtains.

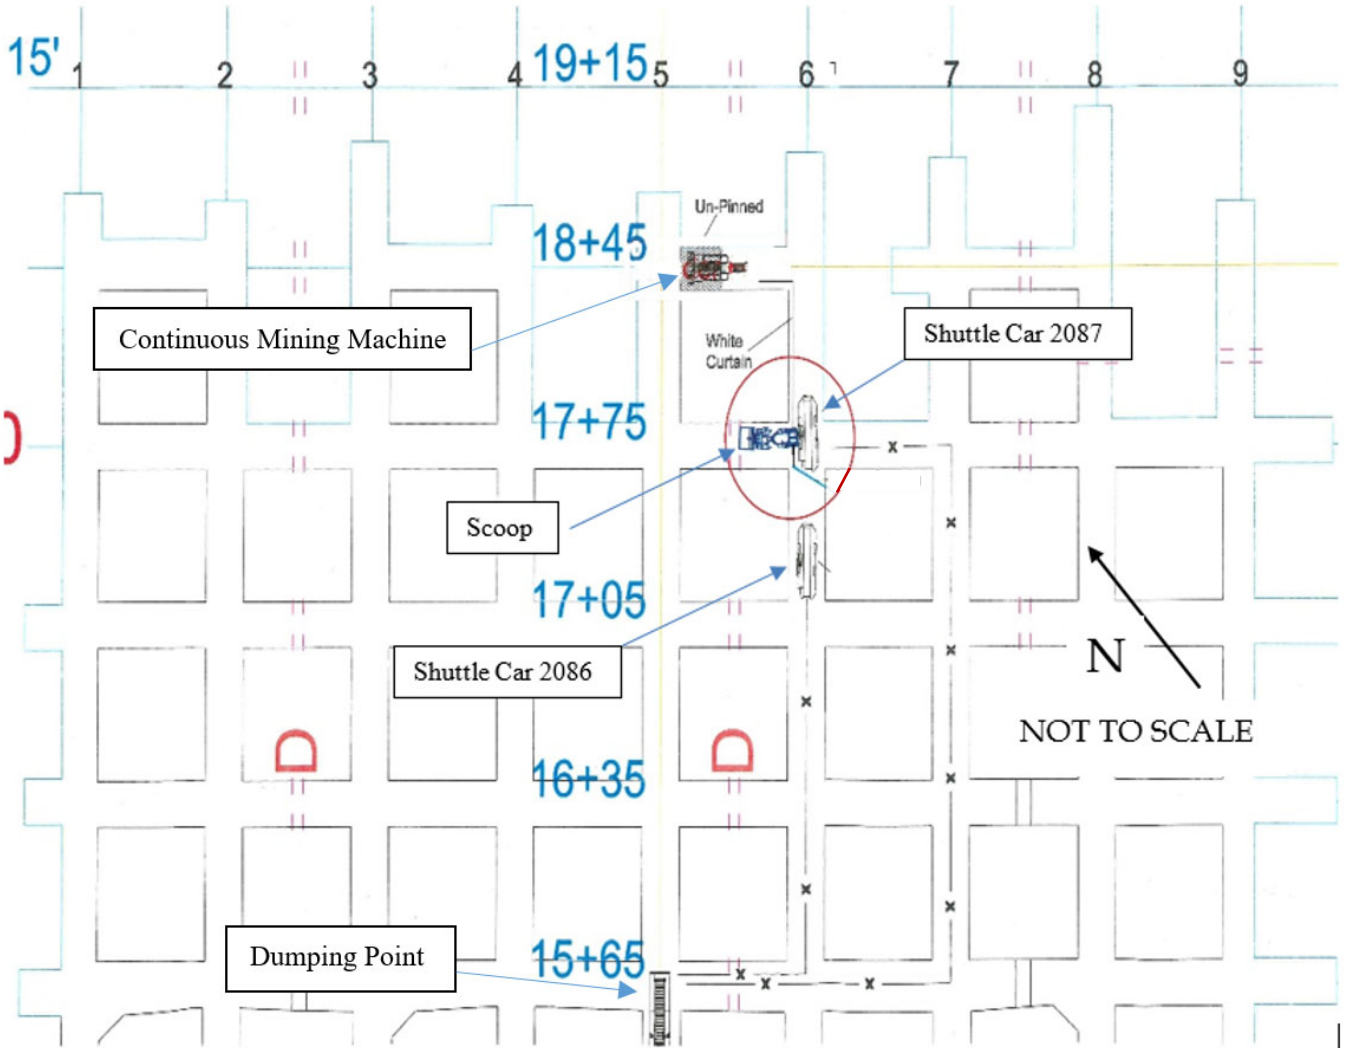
APPENDIX C
Shuttle Car Travel Routes

At approximately 8:40 p.m., Ramsey received a partial load of coal in his shuttle car as the continuous mining machine (CMM) finished mining a crosscut to the left of the No. 6 entry. Kevin Blythe, Scoop Operator, contacted William Burns, Shuttle Car Operator, via two-way radio to ask if he had received his last full load of coal from the crosscut. Burns replied that he had and trammed his shuttle car to the dumping point at the feeder in the No. 5 entry. After dumping the load of coal, Burns trammed his shuttle car into the No. 6 entry and parked just in by the intersection as seen in Appendix A.

Ramsey (victim) operated shuttle car #2087,
Burns operated shuttle car # 2086, and
Blythe operated the scoop
