REPORT OF INVESTIGATION

Fatal Powered Haulage Accident
October 14, 2020

Columbia Quarry
Vulcan Construction Materials, LLC
Columbia, Richland County, South Carolina
Mine ID No. 38-00013

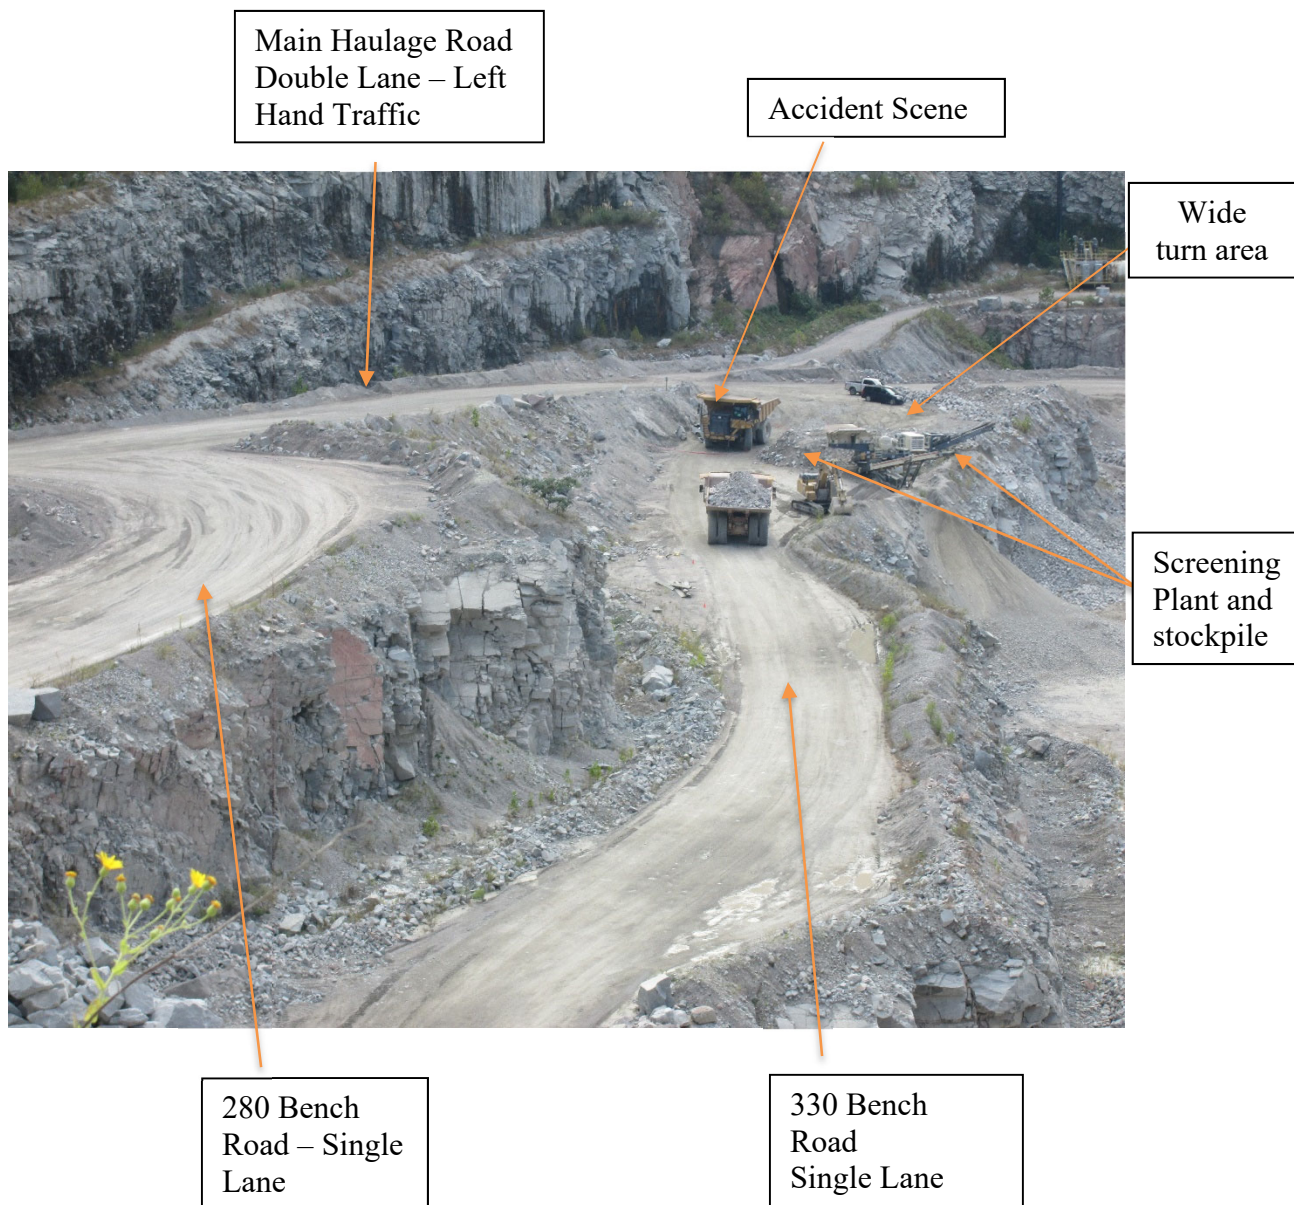
APPENDIX B
Photograph of Accident Scene

The accident occurred on the bench road, which is a single lane road off the pit's main haulage road (see Appendices B & C). The main haulage road measured approximately fifty-one feet in width and had a grade of fourteen percent. To access the bench road safely from the main haulage road, the entrance to the bench road was widened to approximately eighty feet. On January 19, 2019, the mine operator installed a screening plant at the edge of the bench road, visible on the right hand side of the haul road (see Appendix B). There was also a stockpile to supply the screening plant. The installation of the screening plant and the stockpile narrowed the bench road at the turning area down to twenty-eight feet.

The haul truck contacted the pickup truck approximately thirty feet from where the haul truck turned off the main haulage road onto the bench road. Based on observations of the accident scene, investigators believe the haul truck pushed or dragged the pickup truck approximately twelve feet (there was the presence of a shallow rut consistent with the pickup truck's tires). The haul truck and the pickup truck came to rest on the bench road at a two percent downhill grade. The bench road was dry, hard packed, and properly maintained.

Truck drivers were instructed verbally to make a wide right turn from the main haulage road to the bench road, and follow the berm to the narrower portion of bench road near the screening plant. Three truck drivers did this, but Lawhorn did not. Instead of making a wide turn, he made a sharp turn and drove directly to the narrower portion of the bench road. Also, investigators determined that although normally followed, the established radio communication policy was not followed pertaining to entering/exiting pit roads and/or bench roads at the time of the accident

Corrective Action: Mine management installed new equipment, developed new written policies and procedures governing traffic control, and trained all miners. Additionally, mine management relocated the screening plant and widened the bench road in that area from 28 feet to 78 feet. The new equipment and revised policies and procedures include the following:

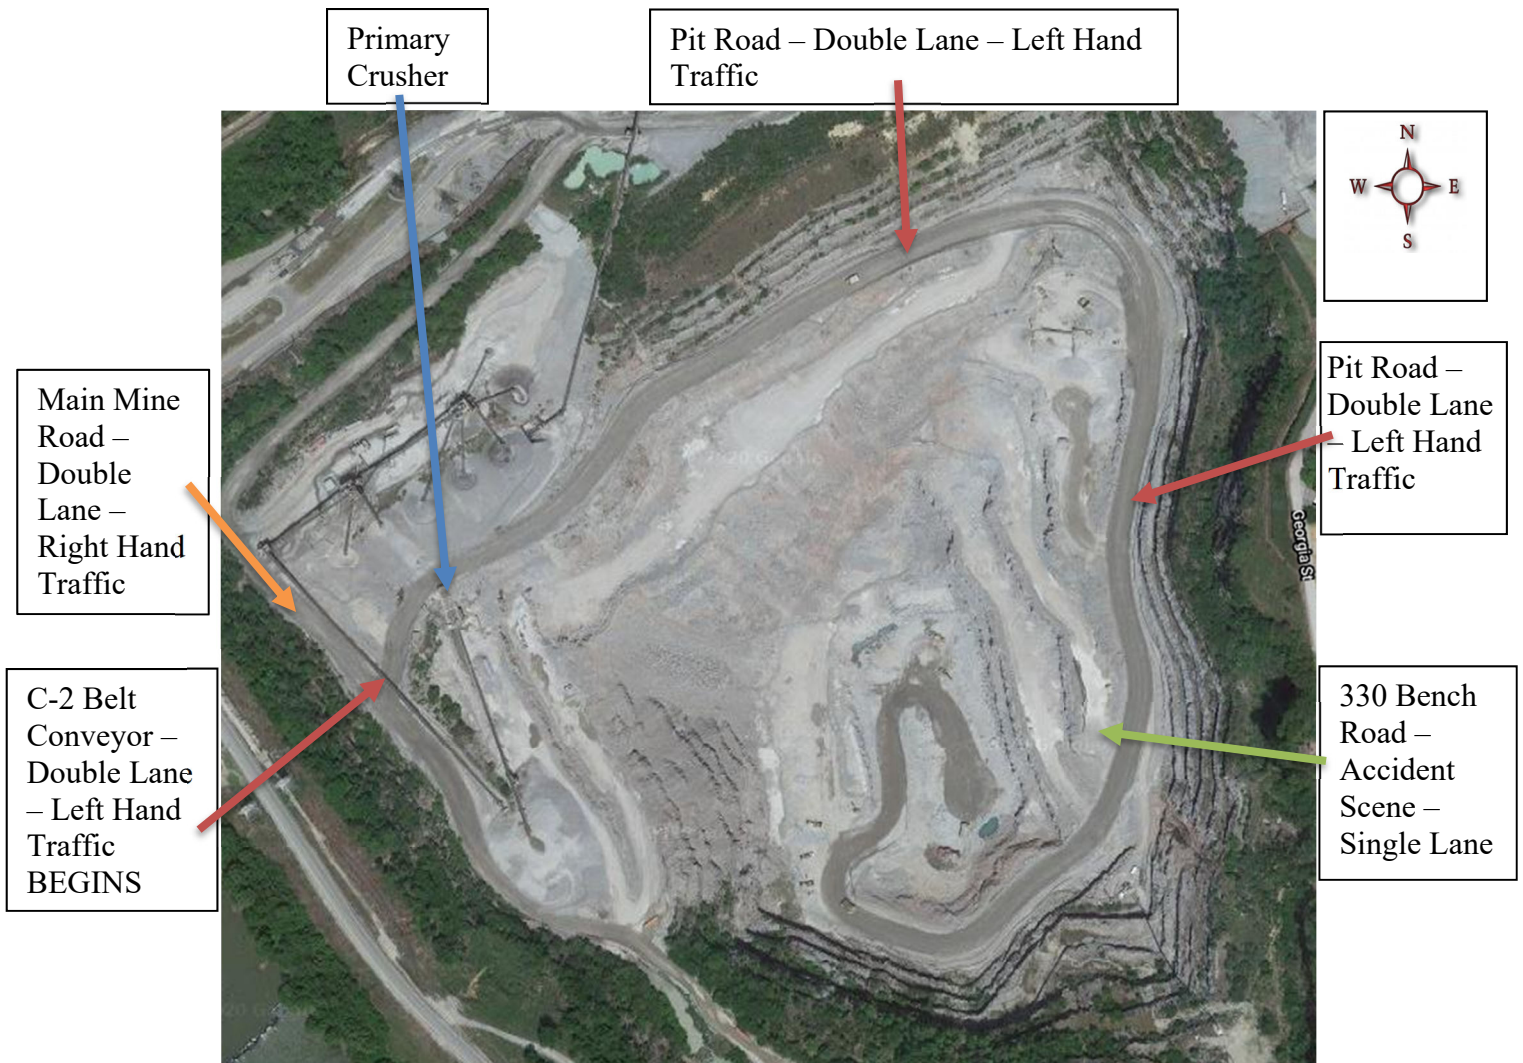
APPENDIX C
Aerial Photograph - Pit

Most mine roads at Columbia Quarry have a right-hand traffic pattern with the exception of pit roads and bench roads. The main pit roads have a left-hand traffic pattern. Bench roads are single-lane where empty haul trucks yield to loaded haul trucks. An empty haul truck, such as the haul truck

driven by Lawson at the time of the accident, traveling to be loaded would be in a left-hand traffic pattern on the main pit road, then make a right hand turn onto a single lane bench road.
