REPORT OF INVESTIGATION

Surface Mine
(Crushed and Broken Sandstone)

Fatal Machinery Accident
October 19, 2020

Mobile
Rubble Inc.
Lyons, Larimer County, Colorado
ID 05-04470

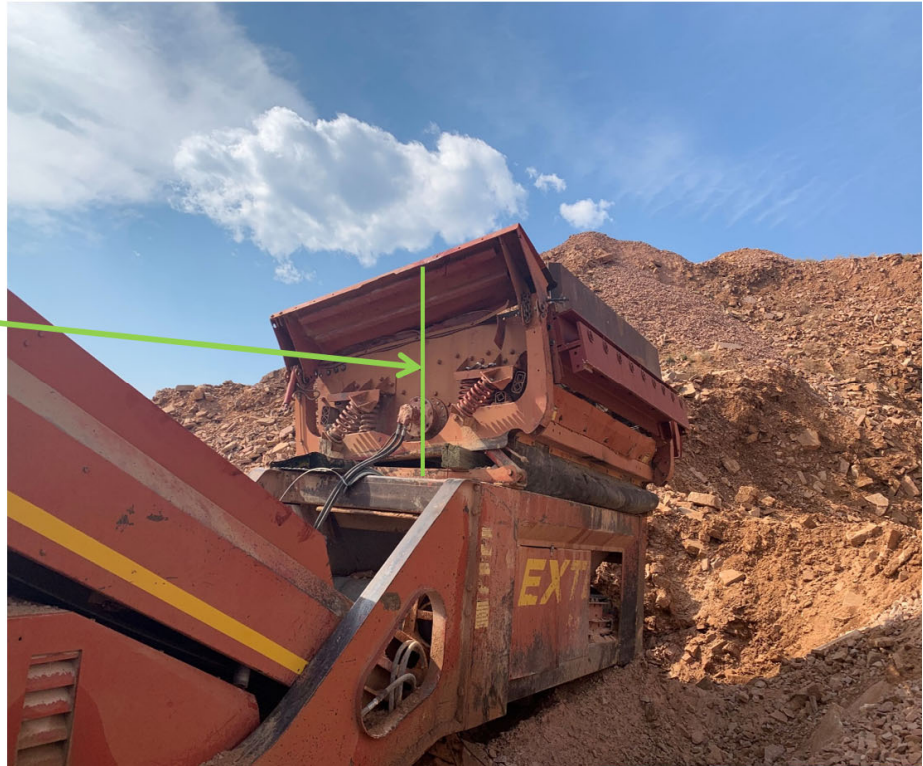
Appendix B
Victim's Location at Time of the Accident

At about 11:30 a.m., Virgil decided to check Castle's progress since he could not see Castle from the operator's cab of the excavator. Virgil swung the excavator bucket over the screen plant just above the feed hopper, striking Castle and crushing him between the excavator bucket and the winged section of the feed hopper. Virgil swung the excavator bucket away from Castle, and Castle fell onto the material feed belt of the screen plant. Virgil parked the excavator bucket, exited the excavator, and ran to Castle. Castle was unresponsive.

The mine is located six miles from Lyons, Colorado. The victim was standing on the east side of the screen plant's feed hopper.

Victim was standing in this area when he was struck with the excavator bucket.

Corrective Action: The mine operator created a policy for operating equipment that prohibits operating or swinging booms and buckets over areas where persons are working.
