REPORT OF INVESTIGATION

Fatal Powered Haulage Accident  
October 19, 2021

Buckingham Mine  
CCU Coal and Construction LLC  
Glouster, Perry County, Ohio  
ID No. 33-04526

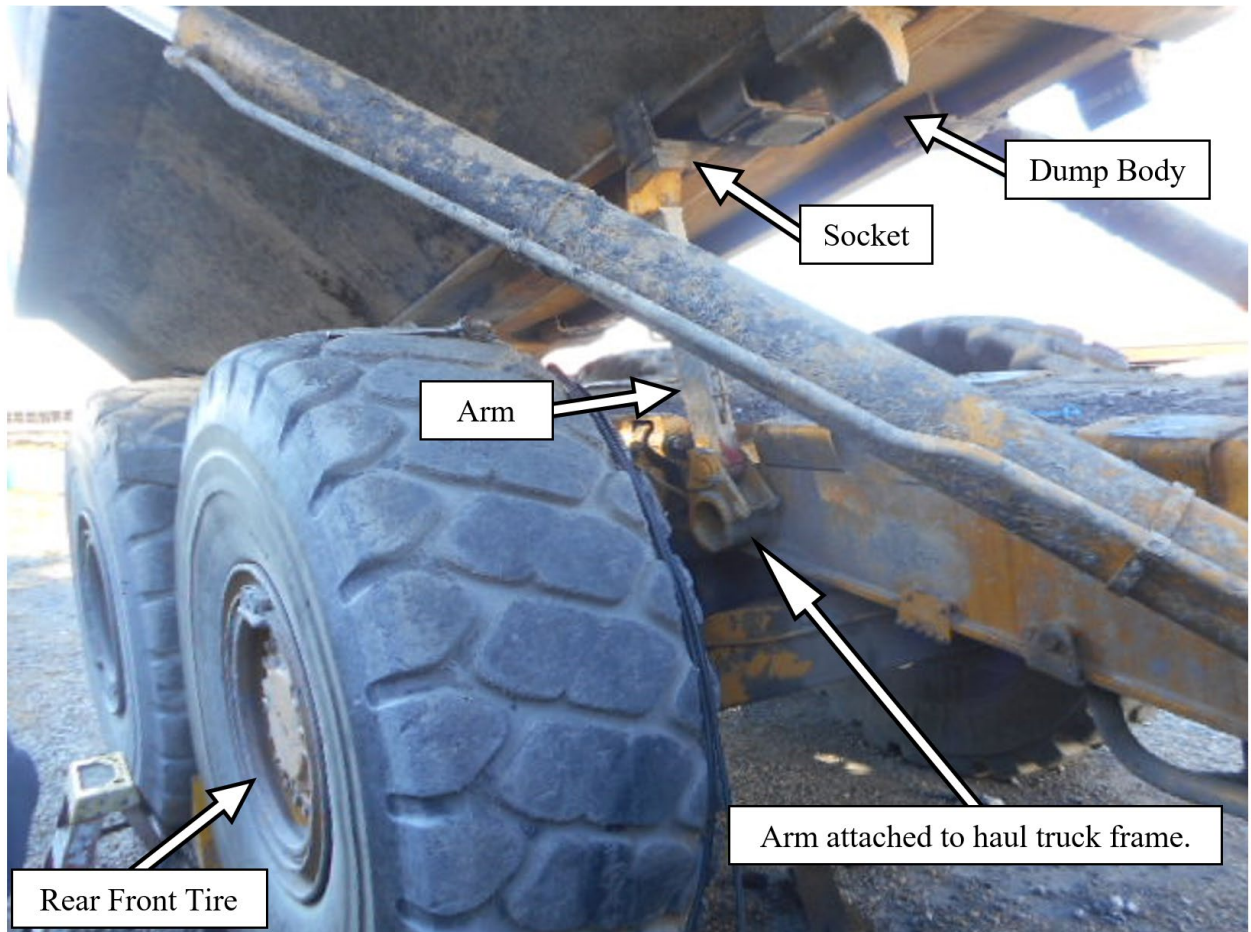
APPENDIX A – Photo of the Haul Truck Involved in the Accident

Steen was laying on the truck frame near the rear front tire on the right side of the truck. He was positioned between the truck frame and the dump body (see Appendix A). McDonald observed that the haul truck dump body and the metal support (arm) of the body prop assembly were raised. Steen asked McDonald to get him a hammer so Steen could strike the pin while McDonald operated the porta-power. McDonald began operating the porta-power and Steen began striking the pin. McDonald heard Steen strike the pin several times with the hammer and then heard a loud bang. McDonald looked up and saw the haul truck dump body falling onto Steen. Steen yelled for McDonald, who ran to the cab of the haul truck, started the engine, and used controls located in the cab to raise the dump body off Steen.

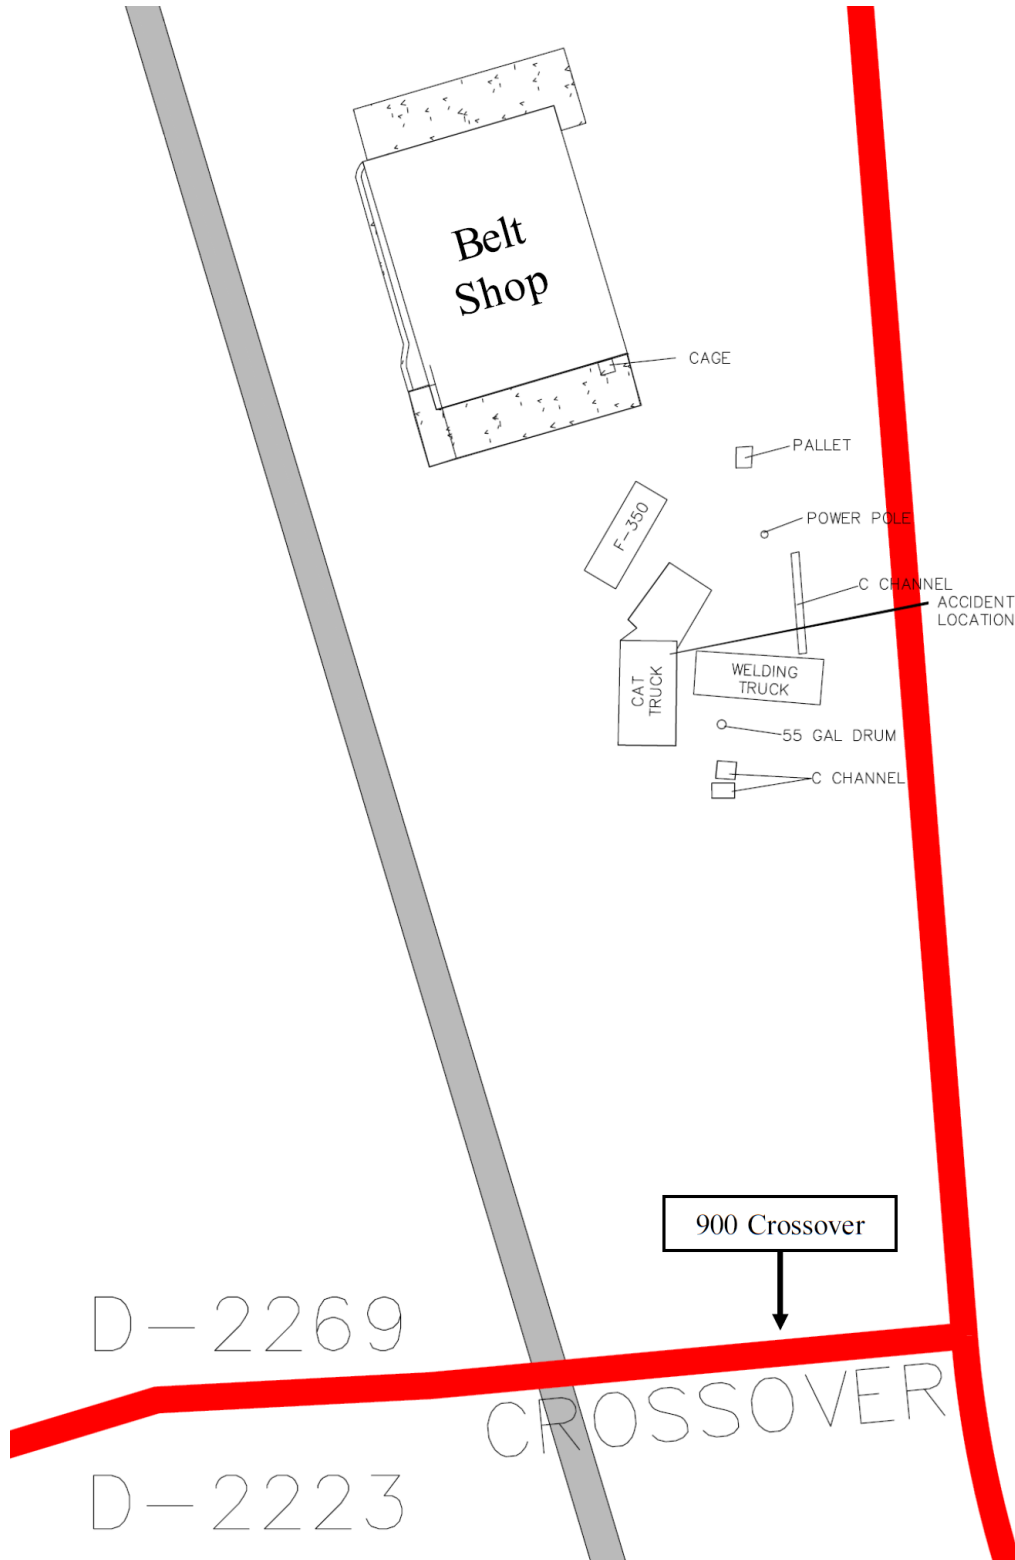
# APPENDIX C – Drawing of Accident Scene

The accident occurred south of the belt shop, adjacent to the haul road (see Appendix C). The area was flat, dry, and covered with gravel.

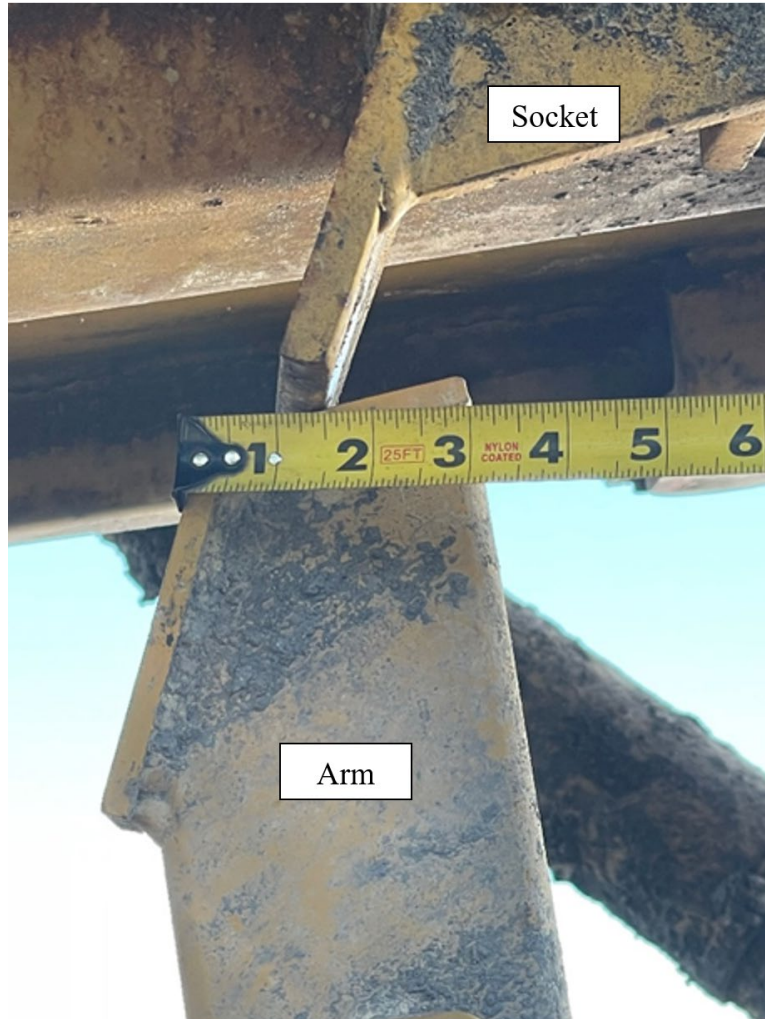
APPENDIX D – Photo of Arm Misaligned with Socket

The haul truck's body prop assembly consists of an arm attached to the haul truck frame and a socket on the underside of the dump body. The assembly is located on the right side of the haul truck near the rear front tire. When the dump body is in a raised position, the arm fits into the socket. The body prop assembly supports the dump body in conjunction with the hydraulic lift cylinders. Investigators determined that the arm was not properly aligned in the socket at the time of the accident. Investigators observed that the top of the arm was misaligned from the socket by one and one-half inches when the arm was fully upright (see Appendix D). The improperly aligned arm fell from either a hammer striking the arm, or a combination of the weight of the truck's dump body and the vibrations from Steen hammering the pin. The dump body fell onto the victim when the arm fell. Investigators conducted repeated tests of the haul truck with the arm of the body prop assembly not properly aligned in the socket. Each time, the tests caused the haul truck dump body to fall in the same way it did in the accident.

The mine operator was present and helped Steen perform maintenance under the raised dump body while the dump body was not properly blocked against motion. The haul truck had a warning label near the body prop assembly that was unreadable due to wear. The manufacturer's manual from Caterpillar contains a copy of this label which states, "Install dump body prop before working under raised dump body to prevent it from falling, which could result in personal injury or death." During the investigation, Caterpillar told MSHA that the truck's dump body was not the original dump body manufactured with the truck. Investigators determined this is why the arm did not properly align with the socket. MSHA was unable to determine when the dump body was replaced.

1. Root Cause: The mine operator did not assure that the equipment was blocked against motion before the miner performed maintenance.

Corrective Action: The mine operator developed a new written procedure for blocking against motion. The procedure requires a supervisor to confirm the blocking arm is properly placed in the socket when the dump body must be raised to perform work on or around an articulated haul truck. The mine operator trained all miners on the new procedure.
