UNITED STATES
DEPARTMENT OF LABOR
MINE SAFETY AND HEALTH ADMINISTRATION

REPORT OF INVESTIGATION

Fatal Machinery Accident
October 20, 2021

Wegenhoft Plant
Alleyton Resource Company, LLC
La Grange, Fayette County, Texas
ID No. 41-02916

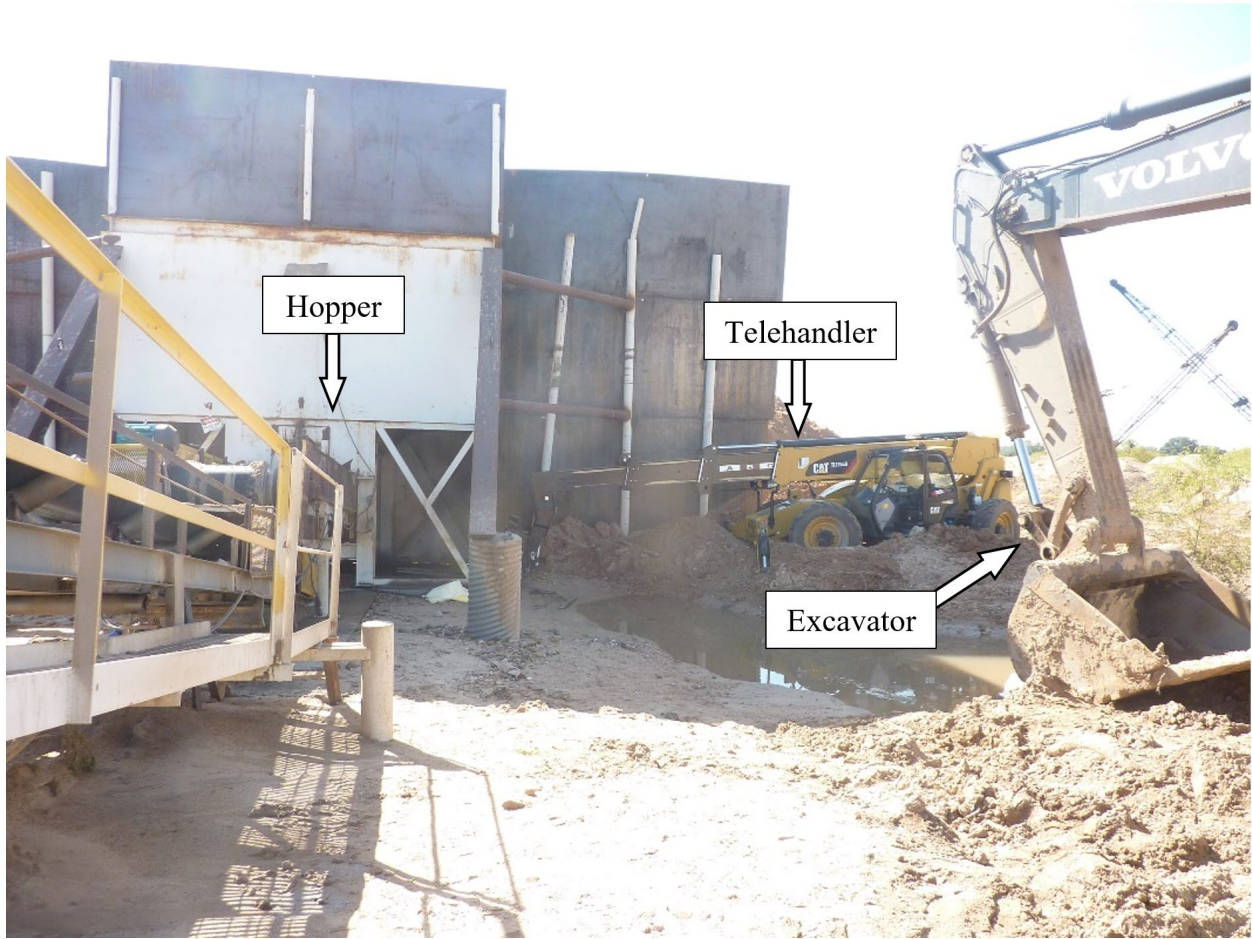
APPENDIX B – Location of the Accident

The accident occurred at the WP mine's #1 Plant hopper (see Appendix B).

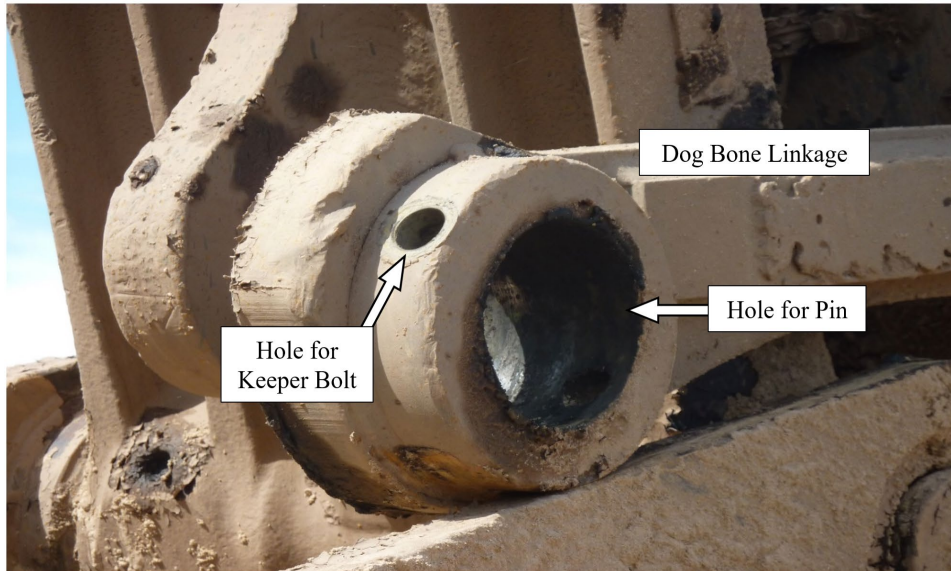
APPENDIX C – Dog Bone Linkage

A Volvo EC480EL Excavator with an 84-inch wide 5.5 yard bucket was involved in the accident. The excavator's bucket is connected to a hydraulic cylinder by a "dog bone" linkage (see Appendix C). Investigators observed that the linkage's keeper bolt was missing on the left side of the bucket, causing the linkage to slip off. The missing keeper bolt could not be located. Investigators determined that the missing keeper bolt contributed to the accident.

Additionally, another keeper bolt on a different part of the bucket assembly was missing. The second missing keeper bolt could not be located.

The excavator was used on multiple projects before the accident occurred. Since Aguirre did not document any missing keeper bolts during his pre-operational inspection, investigators believe the work performed with the excavator before the accident may have damaged the keeper bolts and caused them to fall out of the pins and linkages.

A fatal accident occurred at this operation on October 20, 2021, when a miner was crushed between an excavator bucket and a telehandler. The mine operator did not assure that the Volvo EC480EL Excavator was properly maintained, in that two of the keeper bolts were missing on the bucket connections. The “dog bone” linkage that connects the hydraulic cylinder to the excavator bucket slipped off the pin because the keeper bolt was missing. This allowed the bucket to rotate forward, approximately 2.5 inches, crushing a miner between the excavator bucket and the telehandler.

Keeper Bolt and Pin Missing

Corrective Action: The mine operator examined all the excavators on the property to assure that they were in safe operating condition and retrained all of the employees on how to recognize defects and maintain excavators in safe operating condition.

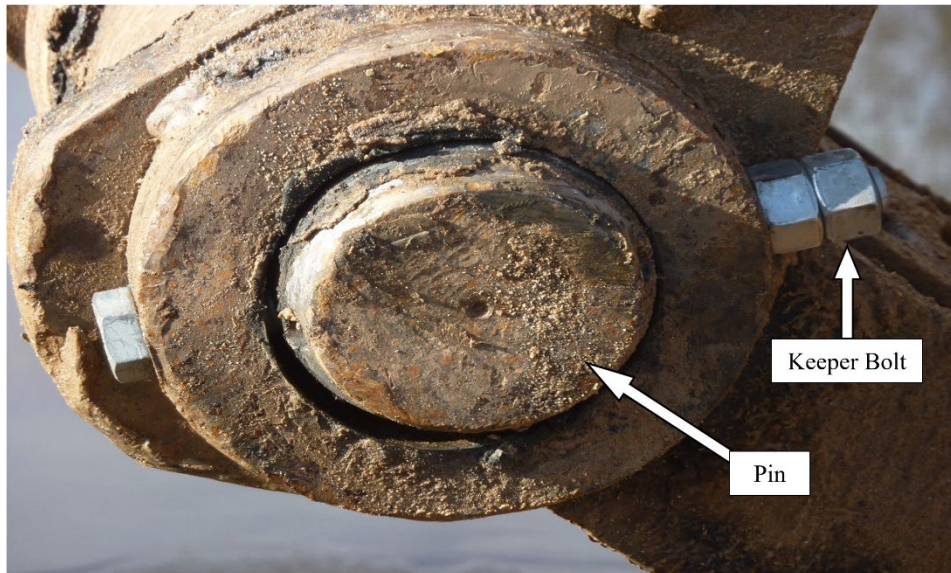
Proper Installation of Keeper Bolt
