REPORT OF INVESTIGATION

Underground Mine
(Anthracite)

Fall of Roof or Back Accident
October 27, 2020

Williamstown Mine #1
Kimmel's Mining, Inc.
Williamstown, Dauphin County, Pennsylvania
Mine ID No. 36-09435

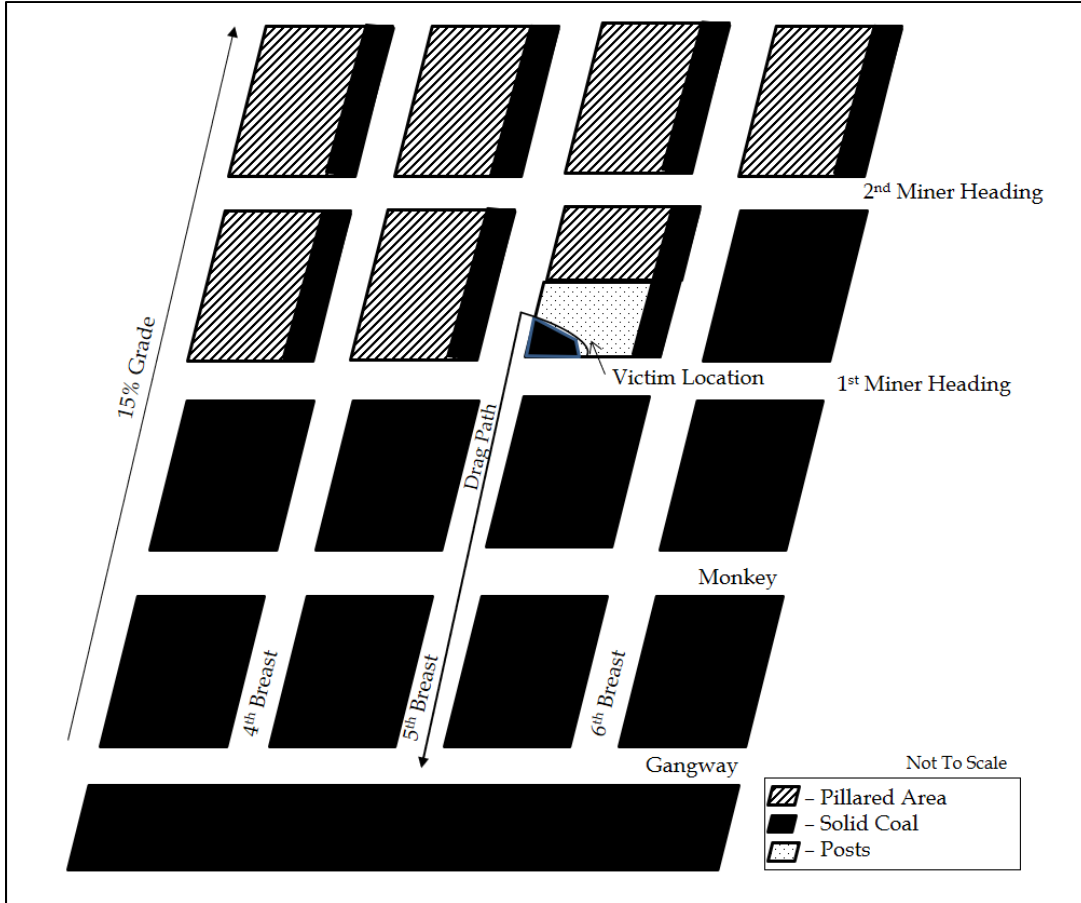
Appendix A – Mine Map

The accident occurred at the 5th Breast, between the 1st and 2nd miner heading West pillar section. The mining height is 3.0 feet, the area is dry. The seam is on a 15 to 20 degree grade.

Root Cause: The mine operator did not adequately support or otherwise control the mine roof.

Corrective Action: Mine management revised, and MSHA approved, changes to the Roof Control Plan. New or revised statements and provisions in the roof control plan include the following:

- Descriptions of adverse roof conditions and specific actions when these are encountered.
- Specific safety provisions and requirements when pillaring, including a requirement to leave a block of solid coal between the miner heading and the pillaring face.
- Requirements to use metal jacks (minimum of 5-ton capacity) as temporary roof support prior to installing a wooden post as permanent support in areas with adverse roof conditions. Temporary supports will be installed within 3 feet, on each side, of where permanent support will be installed.
- Additional instructions on proper methods to examine the roof, including a requirement to examine the roof after blasting.
- Specific instruction on how to correct and record roof hazards.
- Requirements to post warning signs or other devices when hazards are encountered.
