REPORT OF INVESTIGATION

Fatal Machinery Accident
October 9, 2020

Puckett Creek Hydroseeding (C1419)
Middlesboro, Kentucky

Mine #3
Double Mountain Mining, LLC
Fonde, Bell County, Kentucky
MSHA I.D. No. 15-19268

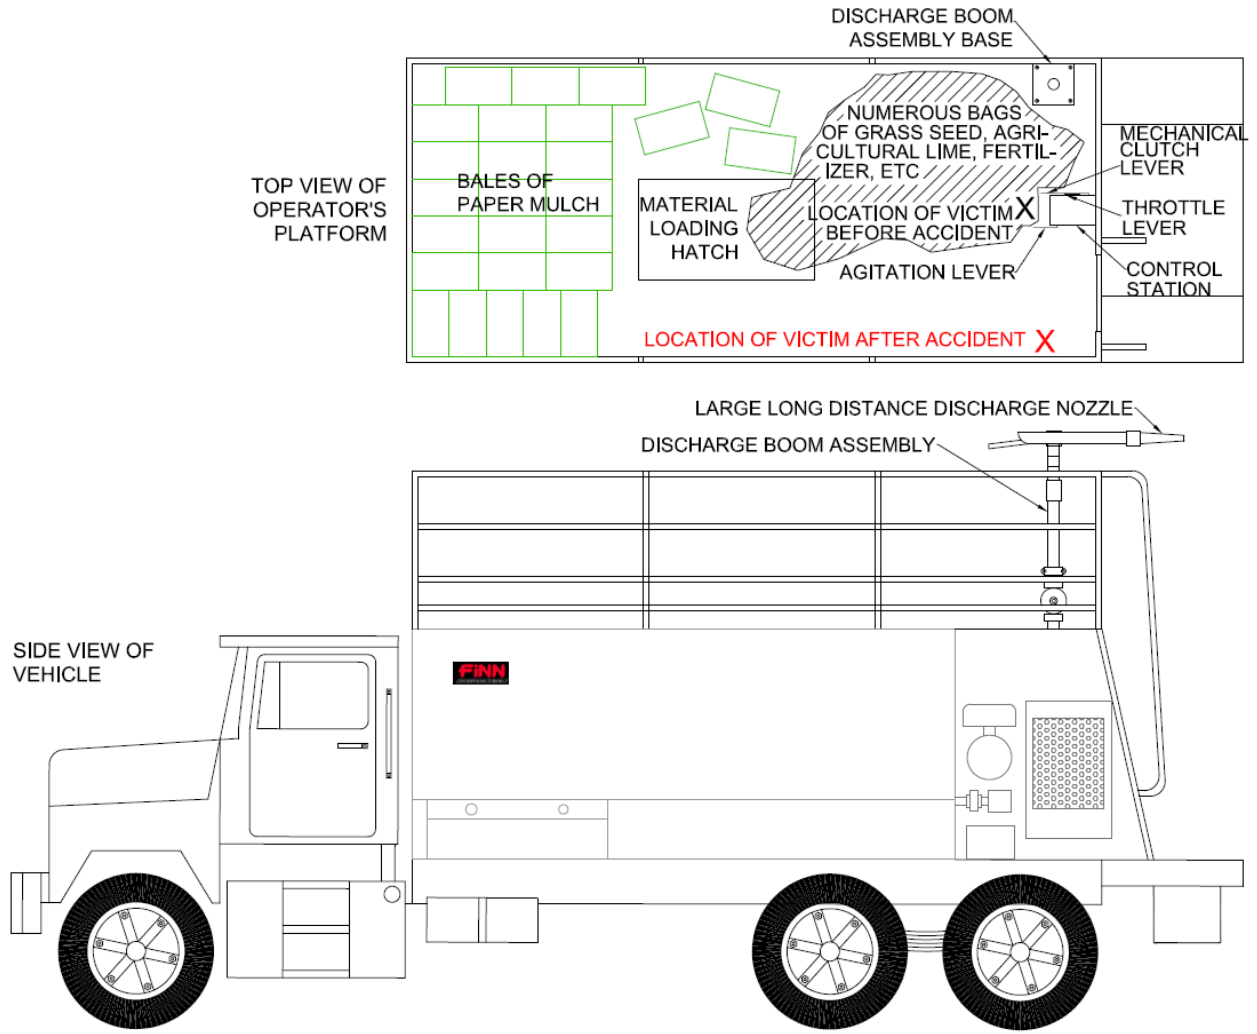
Appendix C - Sketch of Accident Scene

While standing on the ground near the rear of the truck, Spade observed Slusher in the process of changing the discharge nozzle while the hydroseeder engine was running at full throttle. After changing the discharge nozzle, Slusher engaged the clutch with the end of the discharge nozzle pointing directly at him. Immediately, the hydroseeder unit began spraying the mixture at a force of approximately 106 pounds per square inch (psi). The ejected mixture pushed Slusher into the railing located around the top of the hydroseeder unit.

Spade observed Slusher strike the railing and slump down near the railing as the uncontrolled discharge boom assembly spun around striking the clutch handle, stopping the release of the mixture. Spade motioned to Asher notifying him something was wrong. Asher turned off the truck and exited. Spade instructed Asher to assess the condition of Slusher. Asher ascended the access ladder and was unable to get a response from Slusher.

The investigation by Technical Support indicated that there was no damage to the hydroseeder discharge pipe prior to the accident and there were no obstructions limiting the flow to the nozzle or the system. With the hydroseeder engine at full throttle, a pressure measurement of slurry in the system was 106 psi.

Corrective Action: The owner of Puckett Creek Hydroseeding established a written plan of action for safety procedures to ensure blocking and securing mobile equipment or components prior to repairs or maintenance and trained all the employees in accordance with the plan.
