REPORT OF INVESTIGATION

Fatal Falling, Sliding, or Rolling Rock or Material of Any Kind Accident
September 14, 2021

Butte Gulch
Higher Ground Resources
Murray, Shoshone County, Idaho
ID No. 10-02336

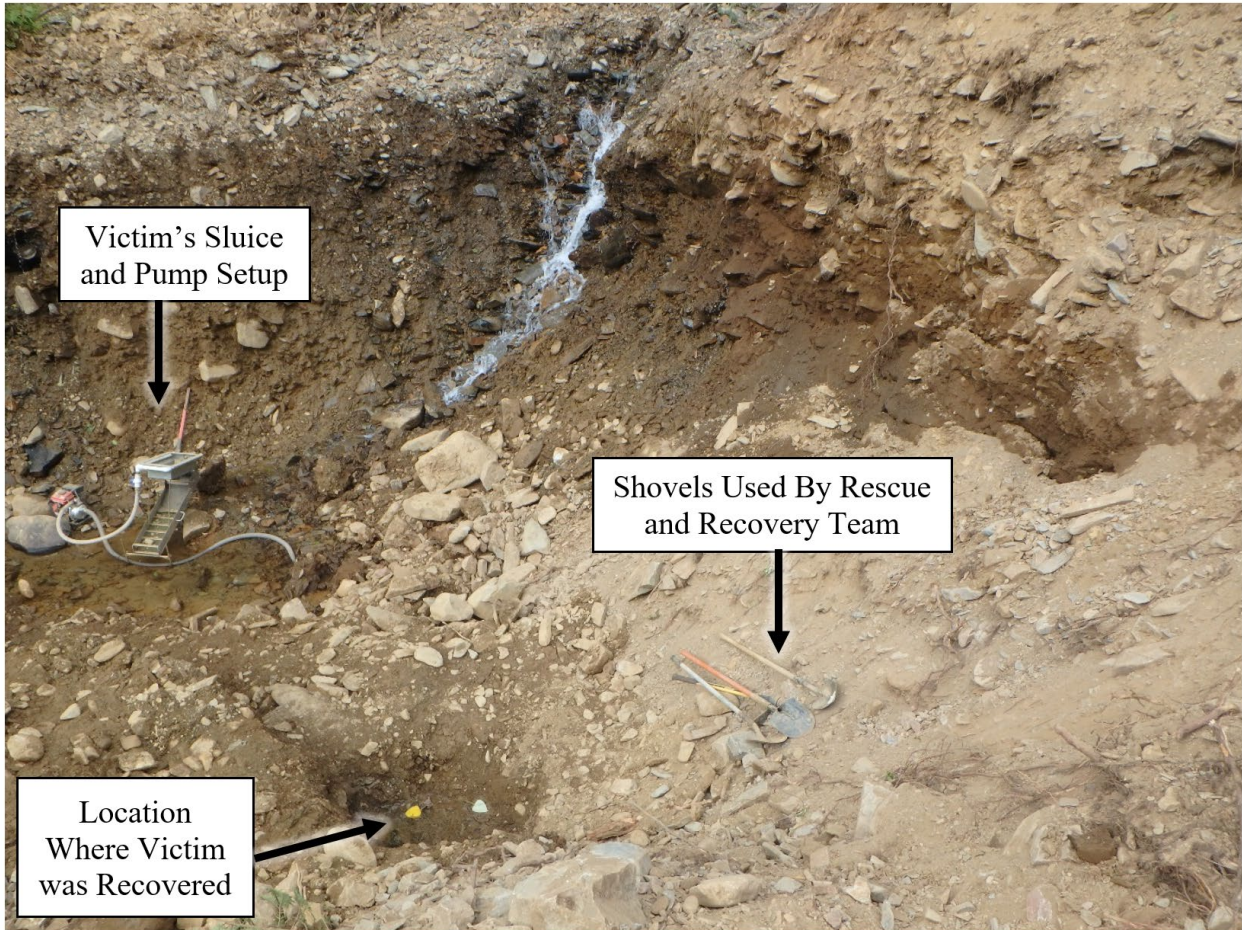
APPENDIX A – Photograph of the Accident Scene

At the time of the accident, the north bank of the pit contained a trench approximately four to five feet wide, 50 feet long, with walls 20 feet high. Ground conditions in the trench were hazardous because the walls of the trench consisted of unconsolidated material, were angled too steeply for stability, and were not supported. When the excavator operator left the area, there were no warnings, signs, or barricades installed at the entrance point to the trench to impede unauthorized entry. The mine operator did not have policies or procedures in place for taking down, sloping, supporting, or otherwise stabilizing bank edges.

A fatal accident occurred on September 14, 2021, when the approximately 20-foot highwall bank fell engulfing the guest on-site prospecting for gold. The company did not have policies or procedures in place to assure hazardous ground conditions were taken down or supported prior to persons entering, and warnings were not posted nor barriers installed to impede unauthorized entry.

Corrective Action: The mine operator developed a new written procedure for restricting access or providing safe access to hazardous areas of the mine. The mine operator trained all miners in this new written procedure.
