REPORT OF INVESTIGATION

Fatal Confined Space Accident  
September 15, 2021

PVB Fabrications, Inc. (U314)  
Tucson, Arizona

Freeport-McMoRan Morenci Inc.  
Freeport-McMoRan Morenci Inc.  
Morenci, Greenlee County, Arizona  
ID No. 02-00024

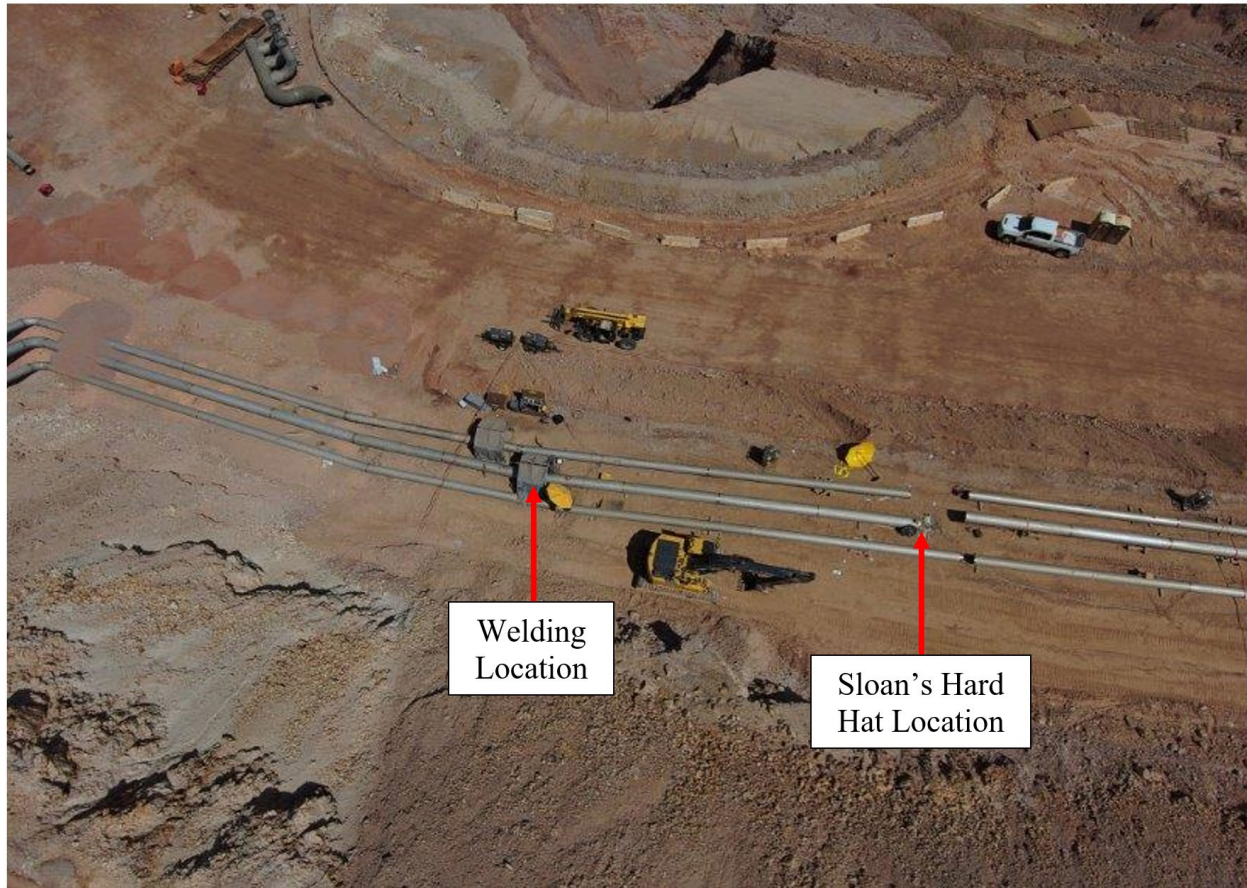
## APPENDIX B – Aerial View of the Accident Scene

The accident occurred inside a 30-inch diameter pipe at the Lower Shannon Booster pipe project area. There, three different runs of pipes were being lengthened with sections of stainless steel pipes welded together (see Appendix B).
