REPORT OF INVESTIGATION
Surface Mine
(Sand)

Fatal Powered Haulage
September 16, 2020

Woodland Plant
Clayton Sand Company
Chatsworth, Burlington County, New Jersey
Mine ID No. 28-00715

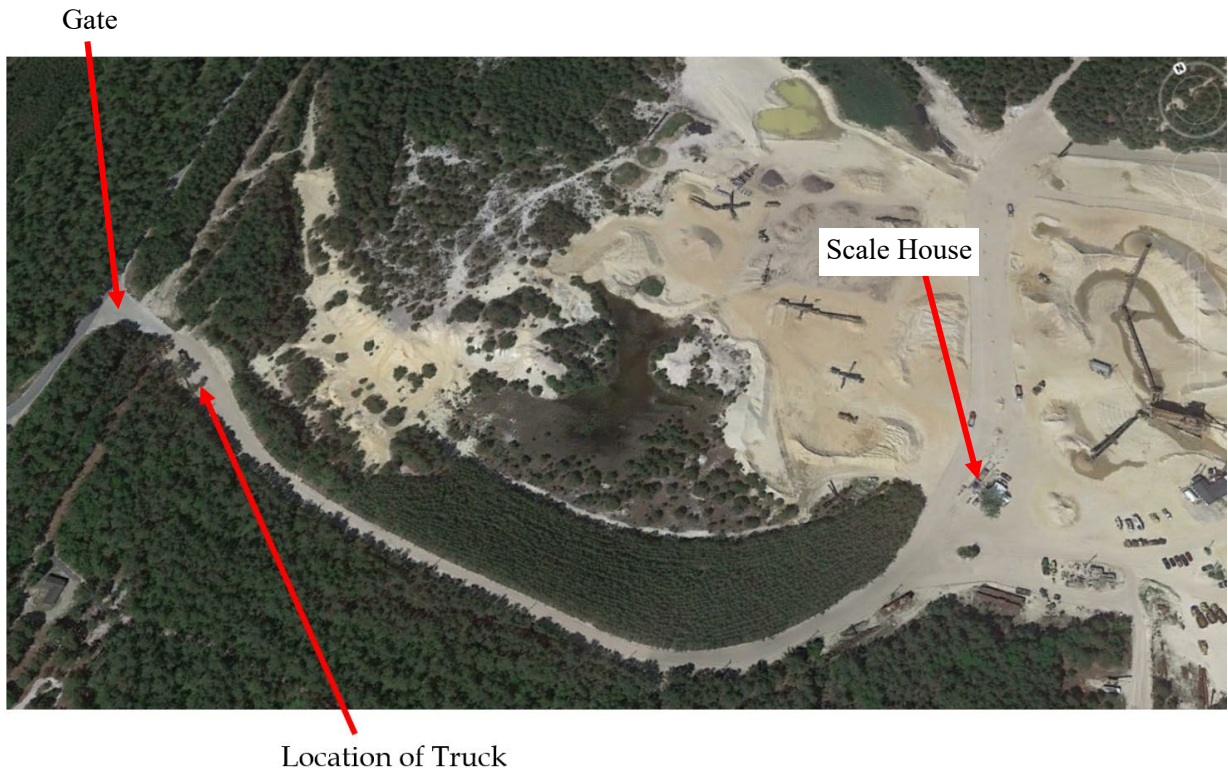
APPENDIX B
Accident Location

The accident occurred on the mine haul road, approximately 250 feet inside Woodland Plant's main entrance (see Appendix B). The victim stopped his truck at the side of the level haul road, consisting of stable sand.

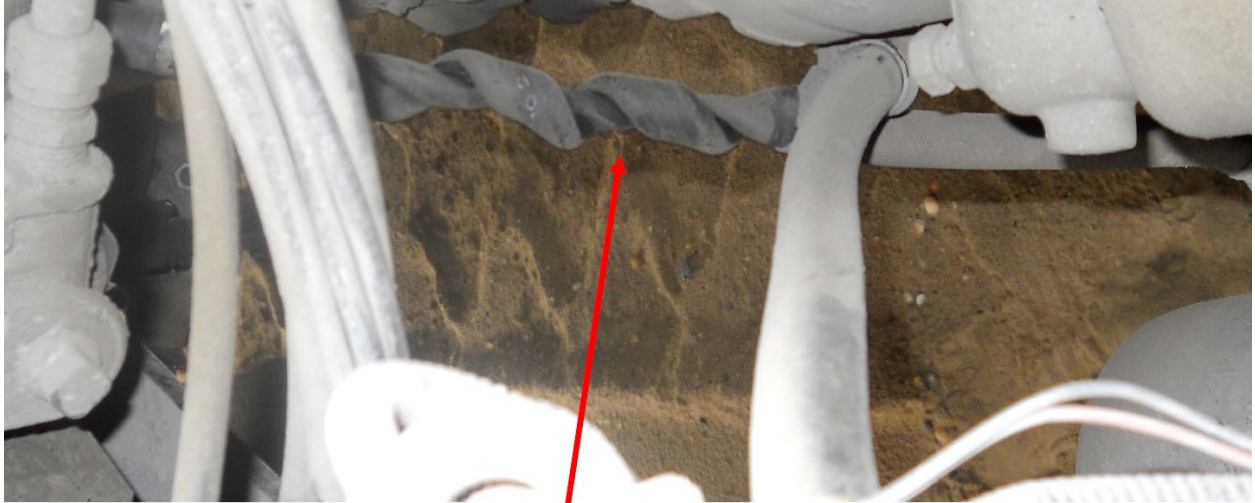
APPENDIX C
Coiled/Collapsed Brake Line

Investigators inspected the chamber in question and found one of its airlines to be coiled/collapsed with a localized abraded area (see Appendix C). Investigators determined that the fittings were improperly installed, which caused the brake line to coil and collapse when the fittings were tightened. When installed properly, the brake line will not coil and collapse.

Investigators tested the truck with the twisted brake-line in place, and determined that the parking brake was not releasing properly. The victim was having difficulty driving the truck because the parking brake was not fully disengaged while he was driving the truck.

The parking brake is spring-applied and air-released. The spring is the component that forces the brake shoes against the inside of the brake drum. Actuating the park brake releases all air pressure allowing the springs to force the brake shoes against the inside of the brake drums, which prevents the wheel-ends from turning. The twisted brake-line reduced the air pressure in the line below the pressure needed to release parking brake in that chamber.

Investigators tested the brake system again after installing a new brake line and with the fittings properly installed. With the line replaced and the slack adjuster returned to within the recommended maximum stroke limit, the brakes released/applied as designed when actuated.
