REPORT OF INVESTIGATION

Fatal Powered Haulage Accident
September 21, 2021

Lara Truck (C2723)
Albuquerque, NM

Bonito Pit
Black Rock Services
Los Lunas, Valencia County, New Mexico
ID No. 29-02450

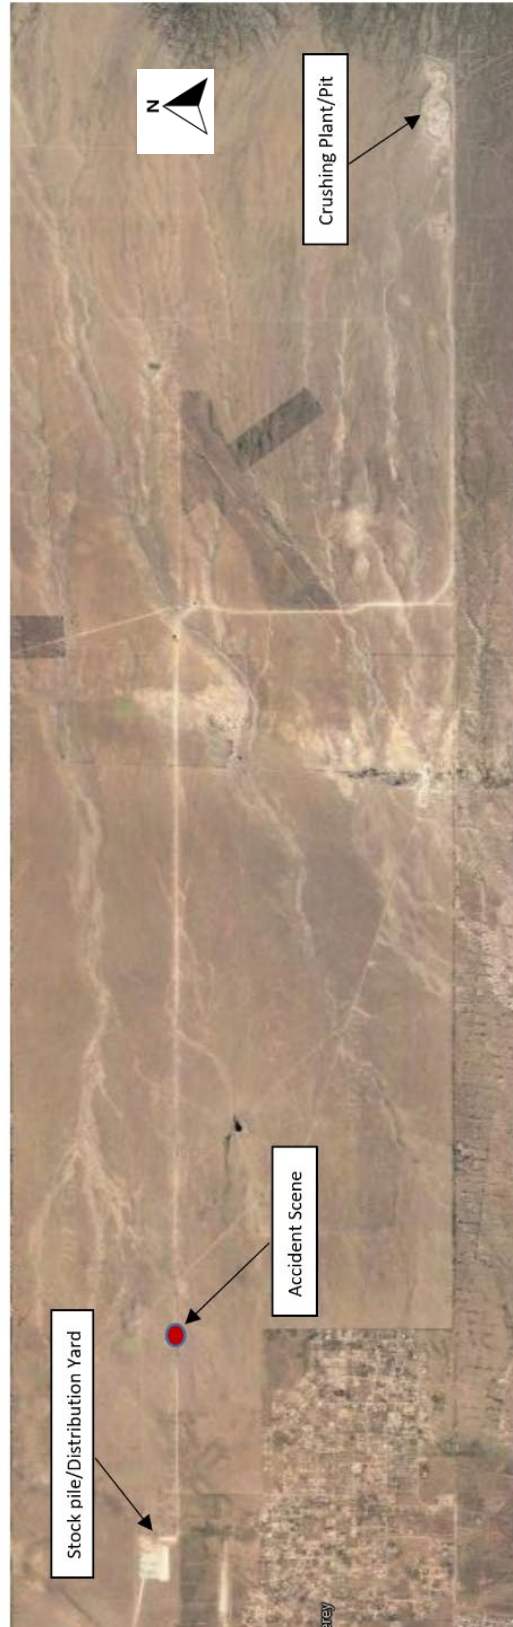
APPENDIX B – Aerial View of the Main Haul Road

The accident occurred on the main haul road, approximately a quarter of a mile east of the three-mile marker (see Appendix B). The main haul road runs east to west and is 41 feet wide and 11 miles long. The main haul road was constructed of hard packed caliche (a natural cement-like substance formed when calcium carbonate binds to other particles such as clay and silt) and is bordered on both sides with shallow drainage swells. The mine operator maintained the main haul road to a consistent grade with a slight center crown and even surfaces. Investigators observed no road hazards. The traffic pattern on the road is right-hand traffic, with a posted 40 mile per hour speed limit.

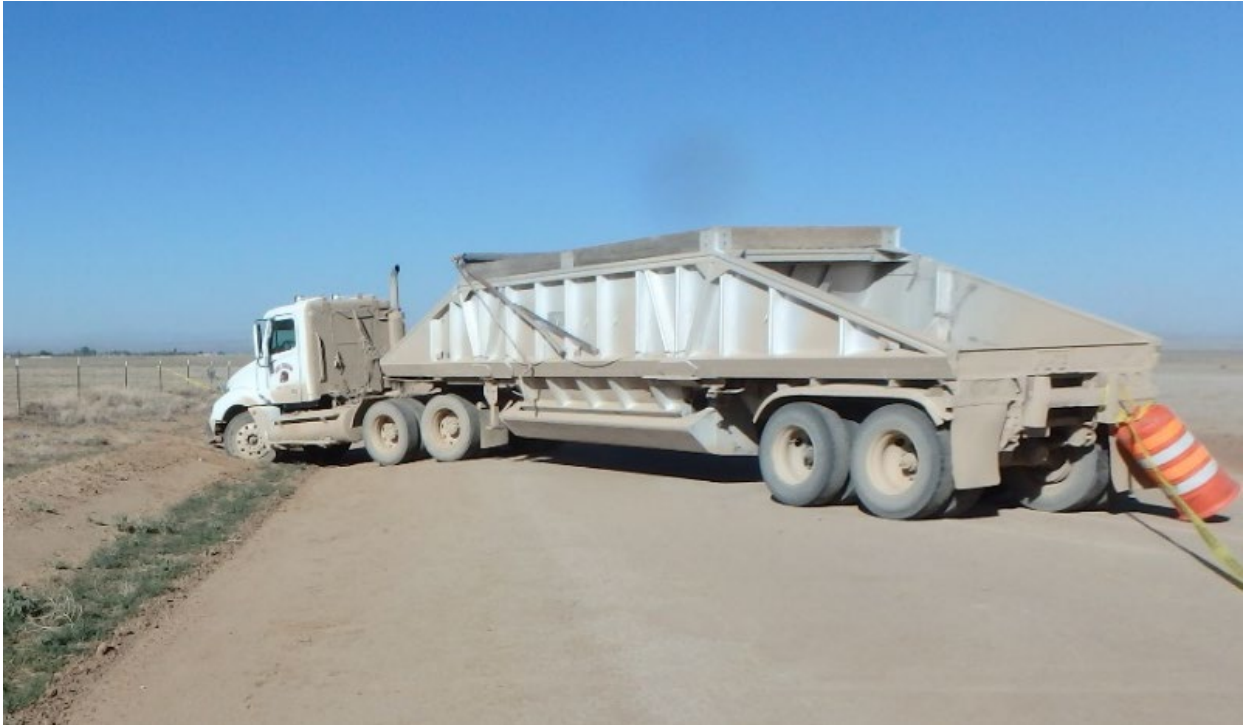
APPENDIX C – Photograph of the Equipment Involved

The haul truck involved in the accident is a 2006 Freightliner Columbia Truck/Tractor attached to a MATE bottom dump trailer (trailer) (see Appendix C). Lara Truck rented the trailer from another trucking company two days before the accident. Lara Truck told investigators that the trailer was in good working order at the time they rented it, which would include the condition of the brakes. There were no inspection records found for the trailer stating its operating condition. The trailer has four brakes. MSHA investigators, along with Cesar Miranda, Owner of Daniel's Road Service, a third-party mechanic, found that the four trailer brakes did not function when tested due to mechanical defects. Investigators found all four brakes were not properly adjusted so that the brake pads would not contact the brake drum. One brake was missing a clevis pin (a fastener similar to a bolt) in the brake cam and another brake cam had a bolt inserted into the area where the clevis pin should have been. Also, investigators found a small air leak in the system. The examination of the braking system led investigators to conclude that these conditions existed when the trailer was acquired by Lara Truck. The brakes functioning properly

on the trailer is essential when operated in tandem with a haul truck. If the brakes on the trailer are not engaging properly, when the haul truck attempts to slow down quickly, the haul truck and trailer may jack knife. These brake defects contributed to the accident.

Corrective Action: Lara Truck informed MSHA that the trailer involved in the accident will never be placed into service on mine property. Lara Truck is no longer a contractor or providing haulage services at mines. As an additional precaution, the mine operator developed written procedures to assure that contractors perform adequate pre-operational inspections on mobile equipment, including inspecting brakes. The mine operator will observe contractor truck drivers perform inspections of their haul trucks and brakes as soon as they enter the mine property.
