REPORT OF INVESTIGATION

Underground
(Coal)

Fatal Powered Haulage Accident
August 17, 2022

Tunnel Ridge Mine
Tunnel Ridge, LLC
Valley Grove, Ohio County, West Virginia
ID No. 46-08864

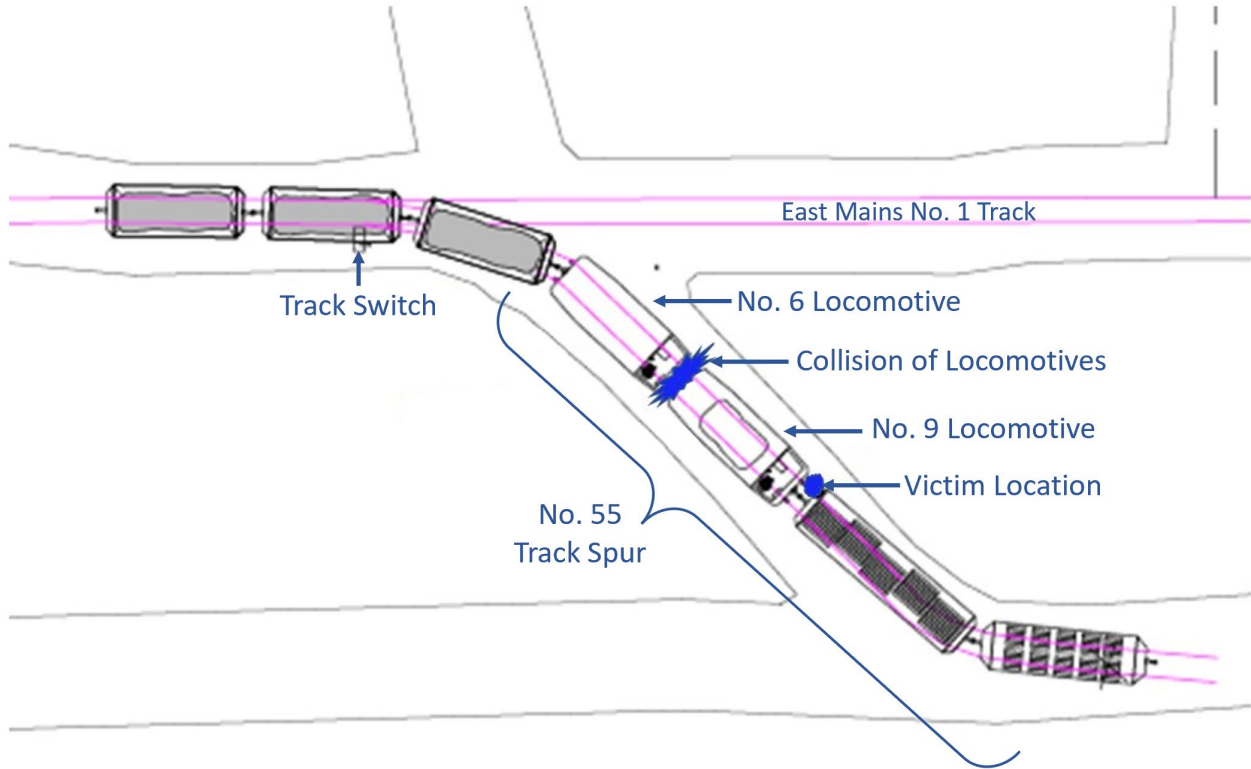
APPENDIX B – Collision Drawing

The accident occurred at the No. 55 track spur on the EM No. 1 track (see Appendix B). Investigators found the No. 6 locomotive parked in the middle of the switch with the three ballast cars still coupled to it. The No. 9 locomotive was parked by itself in the turn of the track spur. Two supply cars were in the spur, coupled together. The rear wheels of the wood crib supply car had been pushed beyond the rail stop at the end of the track spur. The rail stop was intact and in contact with the frame of the supply car. No other locomotives or cars were derailed in the accident.
