REPORT OF INVESTIGATION

Fatal Machinery Accident  
August 23, 2022

El Segundo  
El Segundo Coal Company, LLC  
Grants, McKinley County, New Mexico  
ID No. 29-02257

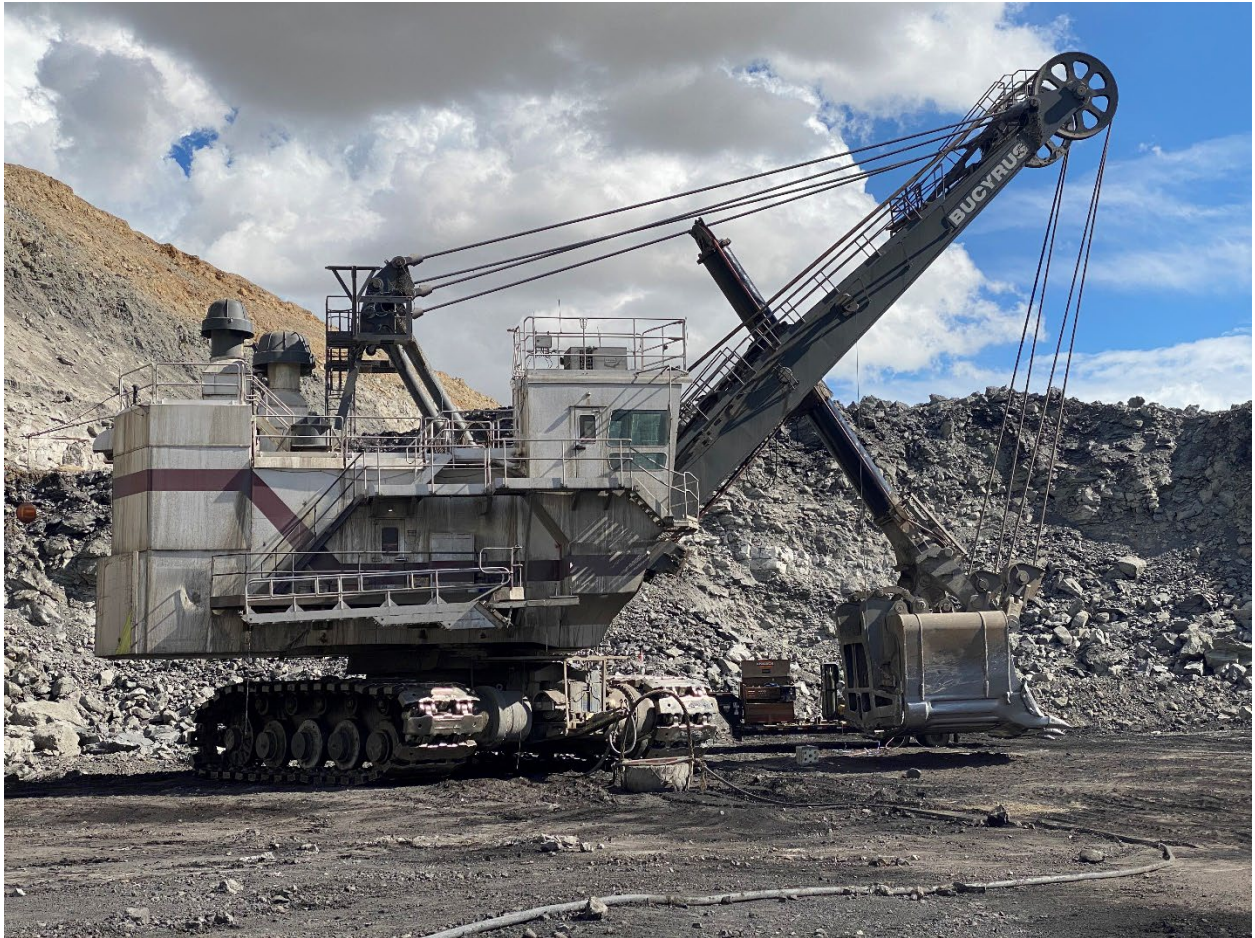
APPENDIX B – Bucyrus International 495B1 Electric Shovel

The electric shovel involved in the accident was a Bucyrus International 495B1 Electric Shovel with a 56 cubic yard dipper (see Appendix B). A shovel operator operates the shovel from an elevated control cab. The mine operator estimated that the weight of the dipper door involved in the accident was approximately 13 tons (26,000 lbs.). Investigators examined and tested the shovel and did not find any defects that contributed to the accident.

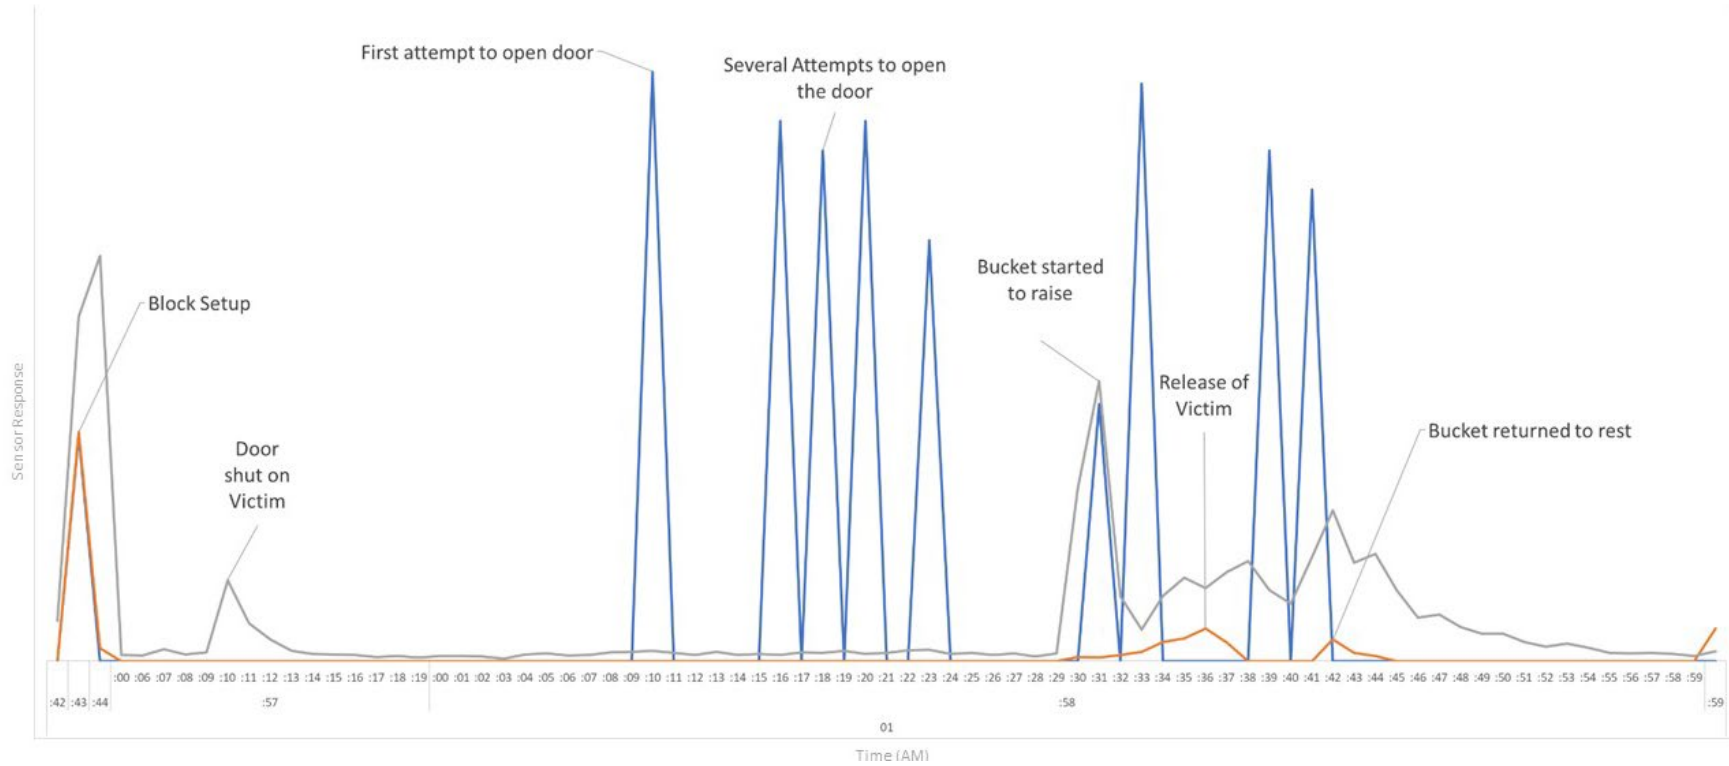
## APPENDIX C – Timeline Depicting the Accident

The mine operator submitted a video recording and the Argus computer data from the shovel. Mario Turner, Program Analyst, created a timeline of the accident using the video and computer data (see Appendix C). According to the timeline, the shovel was not in motion, and the controls were not in use when the door closed on Warren.

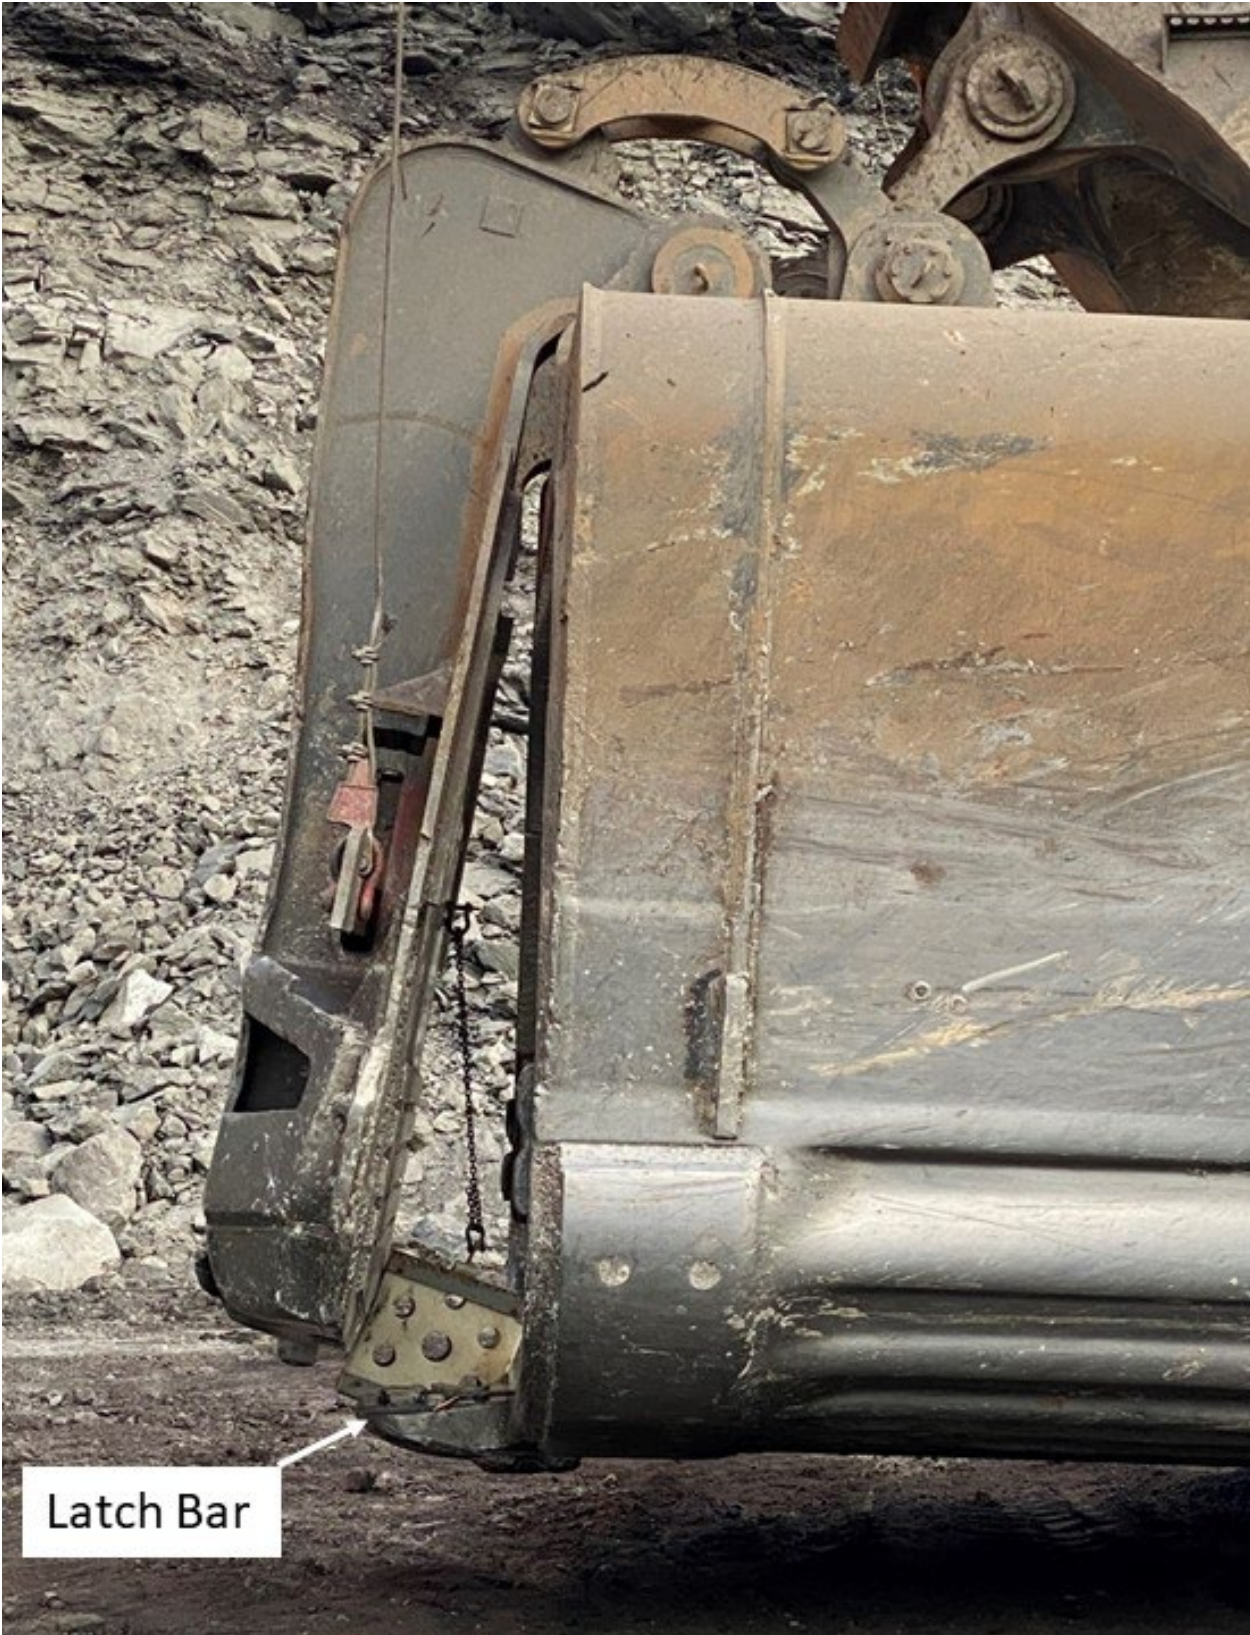
APPENDIX D – Block Placement

Investigators conducted tests to determine how the plastic block dislodged from the dipper. Investigators observed the mine operator perform the blocking procedure at a slow speed, and the plastic block fell correctly in place each time (see Appendix D). During one of the tests, the shovel operator moved the latch lever up and down several times (see Appendix E). The dipper door and the plastic block did not move. No action from the control cab could have dislodged the plastic block except by raising the dipper.

Investigators then observed the mine operator perform the blocking procedure at a typical speed, much faster than in the initial slow speed test. At a typical speed, the dipper door pinched the plastic block on its weakest side. The plastic block's orientation could vary with the speed of lifting and lowering the dipper, resulting in the plastic block not always being in the correct position.

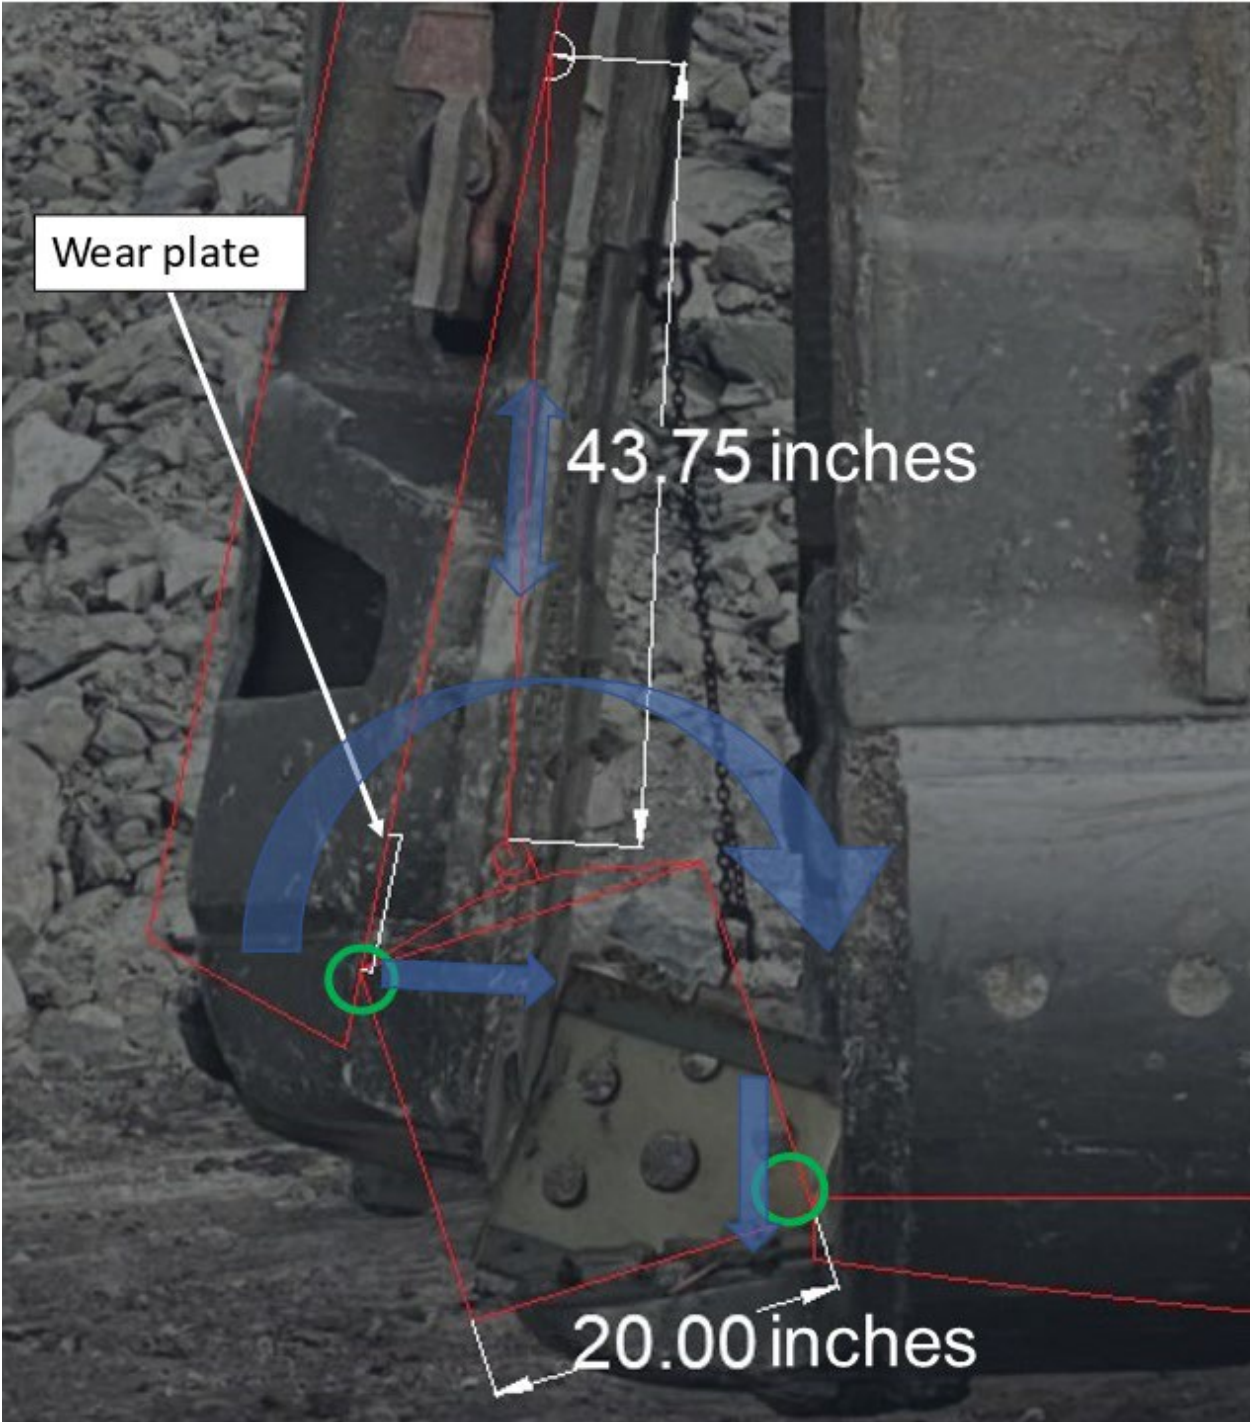
APPENDIX F – AutoCAD 2D Model Showing the Block's Corners Under the Wear Plate

Investigators measured the dipper and the plastic block and used AutoCAD graphic design software to create a two-dimensional (2D) cross-sectional model (see Appendix F). The 2D model indicated there was enough length to the blocking system for the block to be caught under the wear plate of the dipper door. Investigators simulated their findings on the dipper by placing the block under the wear plate of the dipper door (see Appendix G). The rust marks on the metal frame show that the plastic block had undergone high tensional stress prior to the accident, as observed during this test. The mine operator removed the clevis by hitting it with a sledgehammer, which caused the plastic block to dislodge and drop quickly to the ground, and the dipper door to shut.

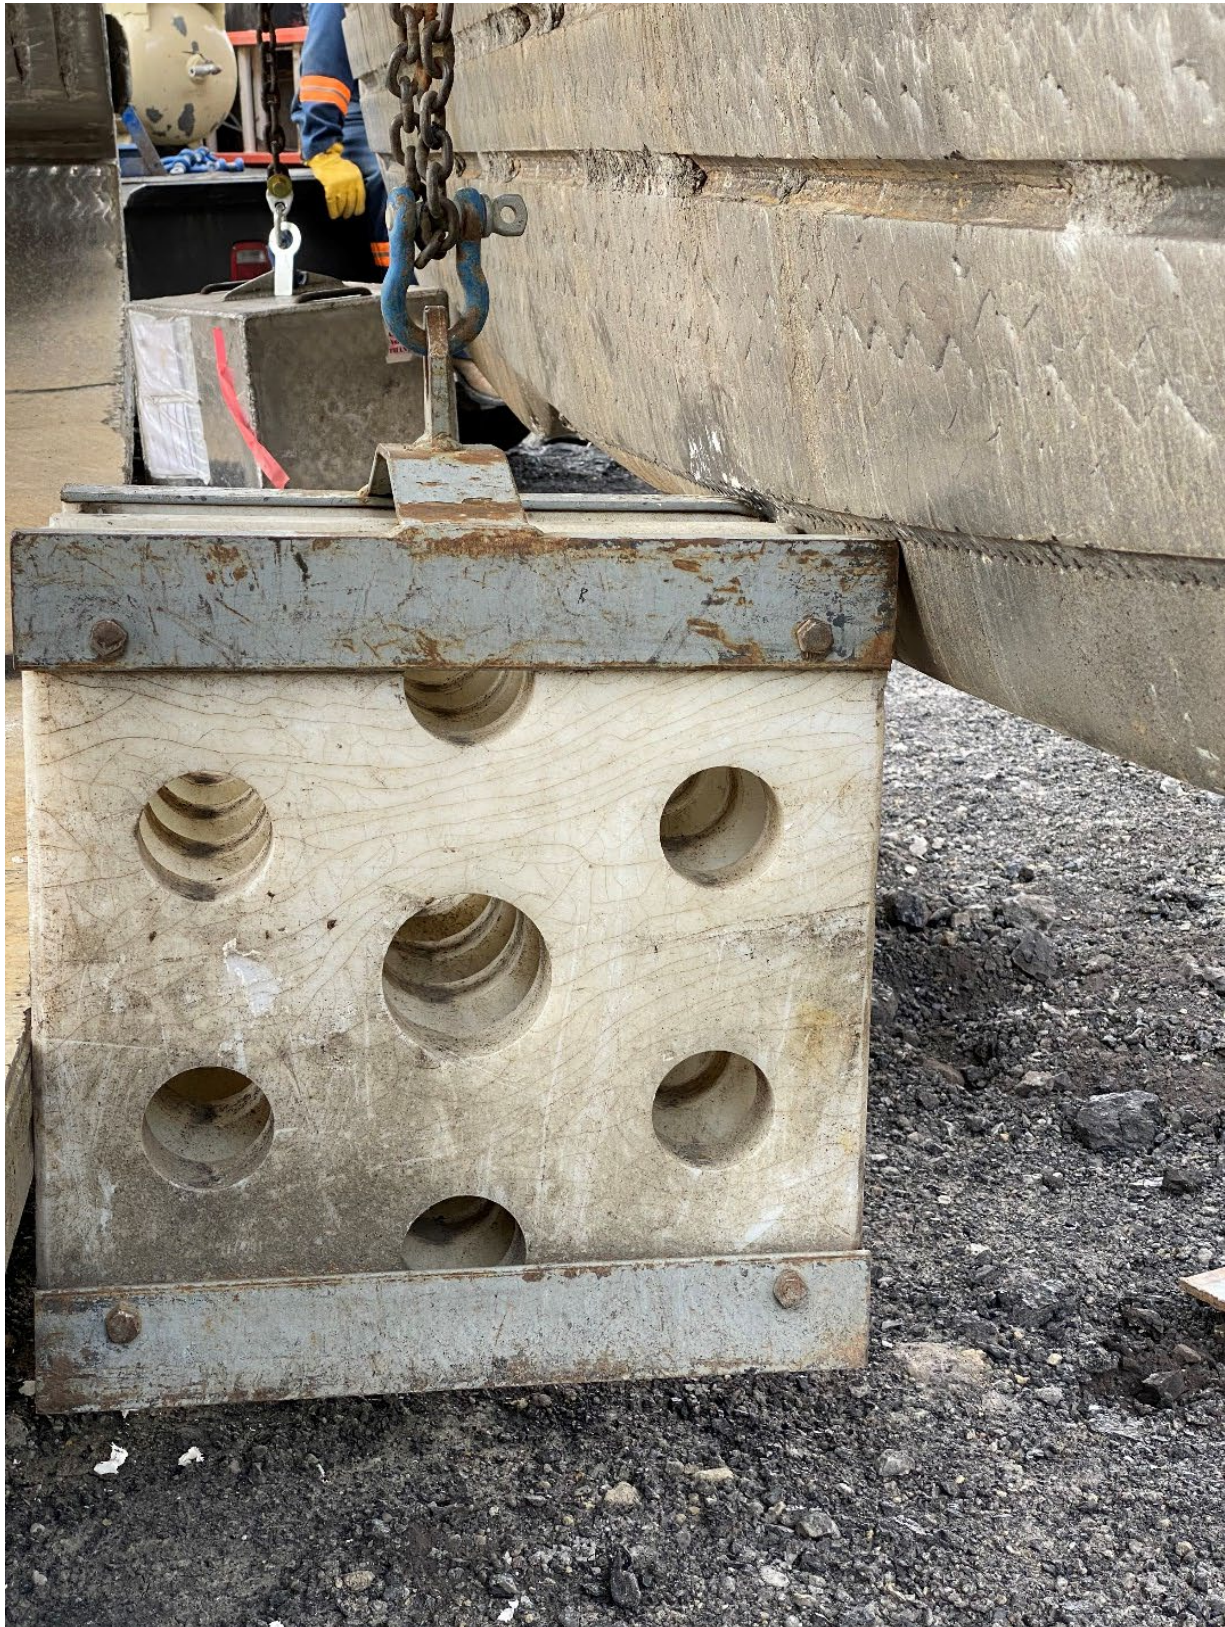
APPENDIX G – Block Placement Under the Wear Plate

Investigators determined that the mine operator did not adequately block the dipper door from motion before miners performed repairs, which contributed to the accident. Garcia observed the crew perform the blocking procedure before the accident. The mine operator did not ensure that the block was in the correct position and the door not effectively blocked from motion before Warren and Morlang positioned themselves between the dipper door and the dipper.

Corrective Action: The mine operator replaced the dipper involved in the accident with one that does not require opening the dipper door to access the latch bar. All other dippers at the mine also do not require opening the dipper door to access the latch bar. If a maintenance task requires opening and blocking the door, the mine operator developed a new written standard operating procedure with a double-blocking system. The system uses two engineer-certified blocks, a primary block and a redundant secondary block. The primary block is aluminum, and the secondary block is red oak with metal framing, which rests on the ground. The primary and secondary blocks will be attached to a chain welded to the dipper door on each side of the door. A come-a-long (a wire rope hand ratchet puller) will be used to make sure the secondary block rests on the ground. The mine operator trained all miners who will perform and supervise this task on the new standard operating procedure.
