REPORT OF INVESTIGATION

Fatal Carbon Monoxide Poisoning Accident
December 22, 2022

SNF Mining, Inc. (X948)
Pikeville, Kentucky

Wellmore #8 Prep Plant
The Black Diamond Company
Big Rock, Buchanan County, Virginia
ID No. 44-04982

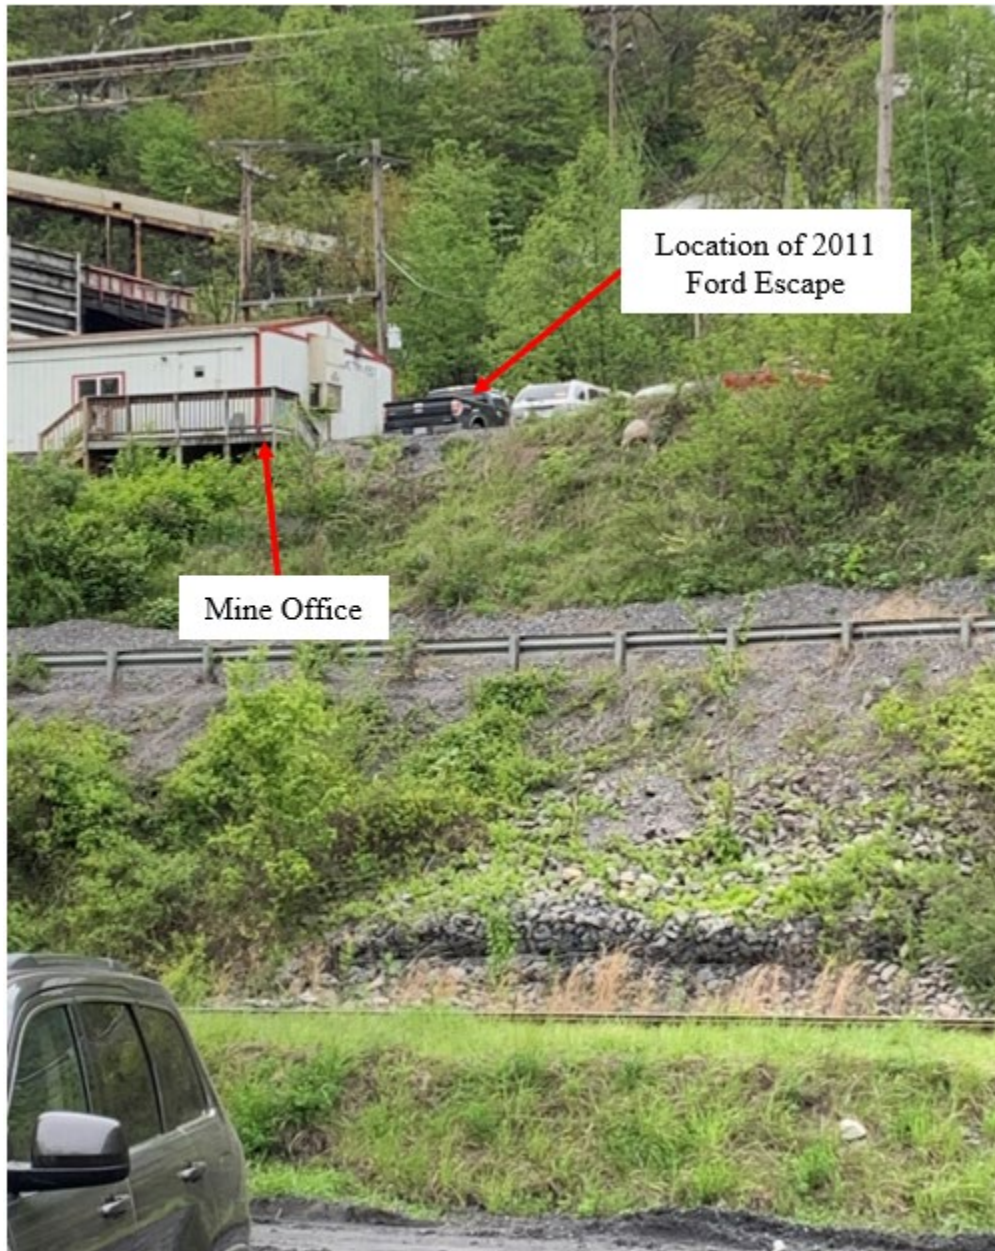
APPENDIX B – View from Railroad Track of the Mine Office

Coon was found in his personal vehicle, which he was using during the shift, adjacent to the mine office (see Appendix B).
