REPORT OF INVESTIGATION

Underground
(Bituminous Coal)

Fatal Machinery Accident
December 4, 2021

River View Mine
River View Coal LLC
Waverly, Union County, Kentucky
ID No. 15-19374

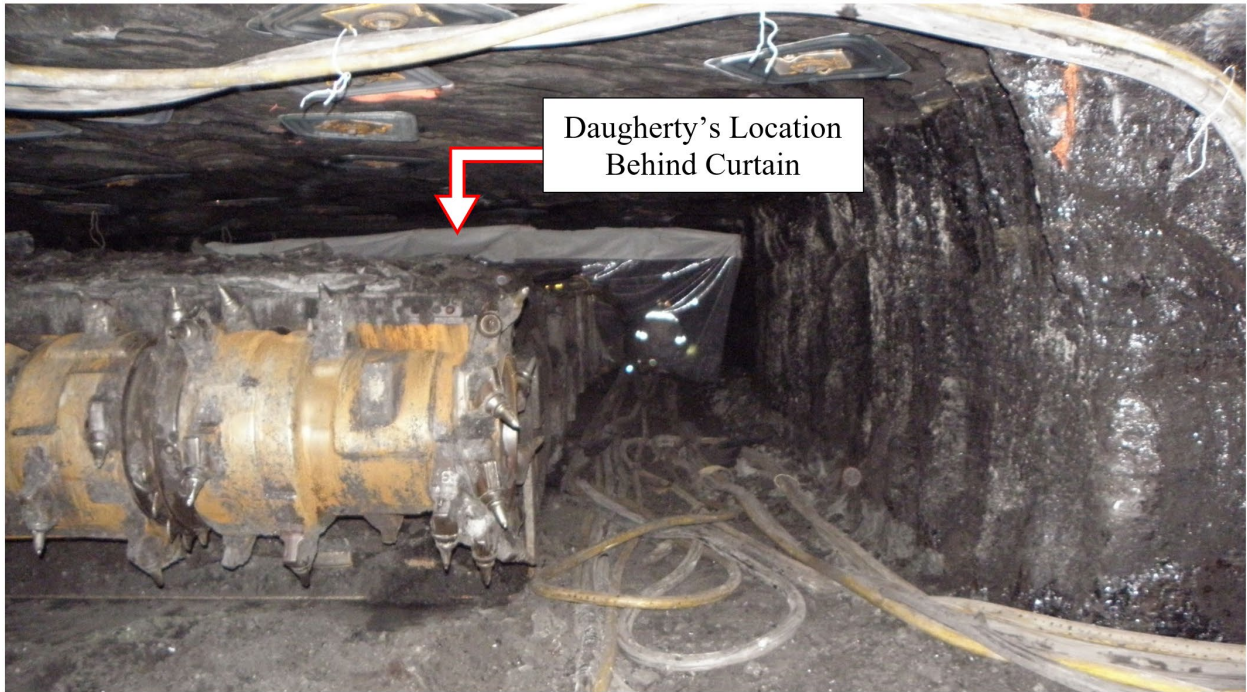
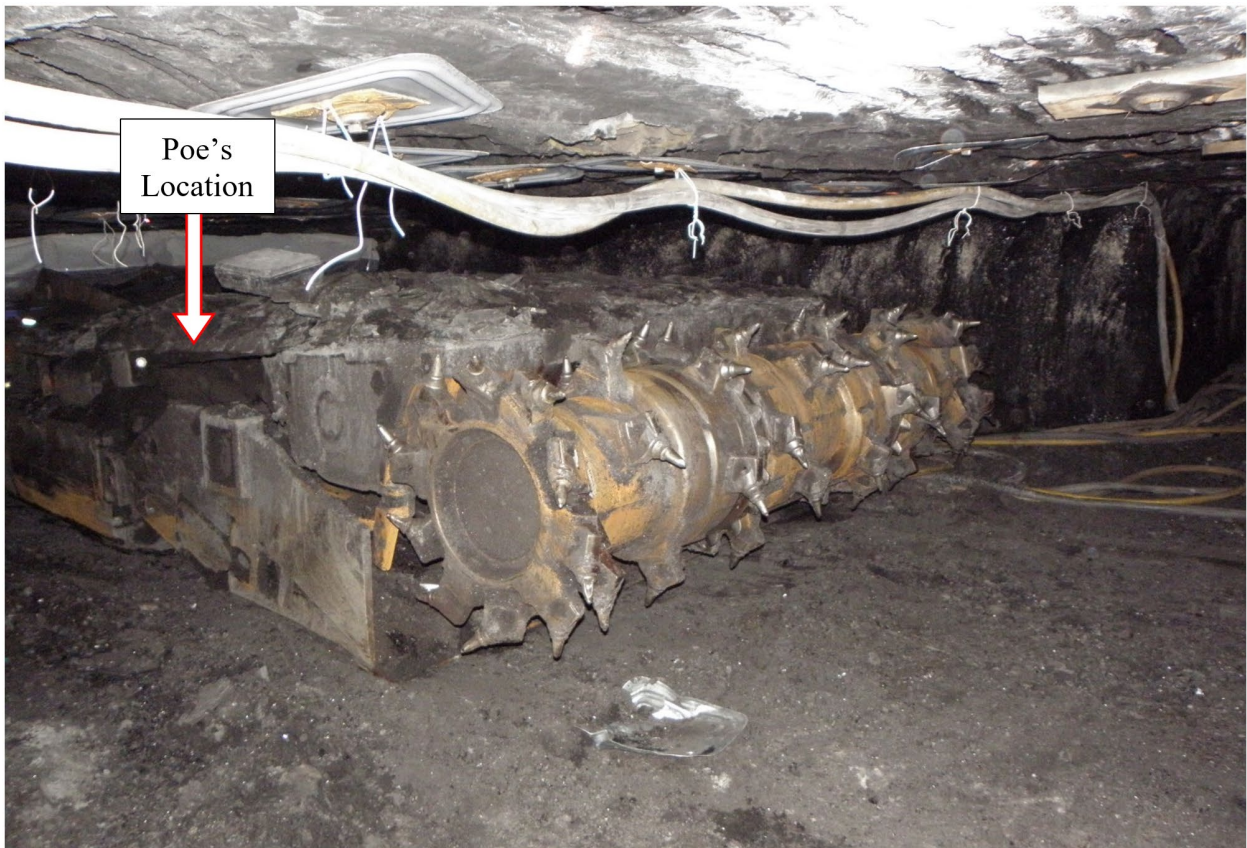
APPENDIX A – Daugherty’s and Poe’s Locations

At approximately 1:05 a.m., Daugherty was at the rear valve bank and Poe was positioned at the front of the continuous mining machine preparing to clean the sensor splash guard on the methane monitor. Daugherty informed Poe that he intended to start the continuous mining machine to raise the tail boom. From Poe's vantage point, he could not see Daugherty (see Appendix A). Poe moved away from the continuous mining machine and witnessed the machine energize. Poe heard the hydraulics engage for enough time to raise the conveyor tail boom and then the continuous mining machine de-energized. From interviews, investigators determined Daugherty raised the tail boom to have a better view of the hydraulic leak coming from the stabilizer jack. During interviews, Poe stated that Daugherty had taken the rear side cover off the continuous mining machine. Daugherty did this to access the valve bank to change out the stem and solenoid for the stabilizer jack prior to energizing the machine and raising the conveyor tail boom.

Based on interviews and evidence at the accident scene, investigators believe the following: Daugherty positioned himself between the conveyor tail boom and the rear bumper of the continuous mining machine to view a hydraulic leak on the stabilizer jack. Daugherty accidentally engaged the conveyor down switch instead of the stabilizer jack function on the remote-control transmitter. When the conveyor down switch was activated, the conveyor tail boom was lowered until the bottom made contact with the remote-control transmitter's emergency stop switch, thereby de-energizing the continuous mining machine.

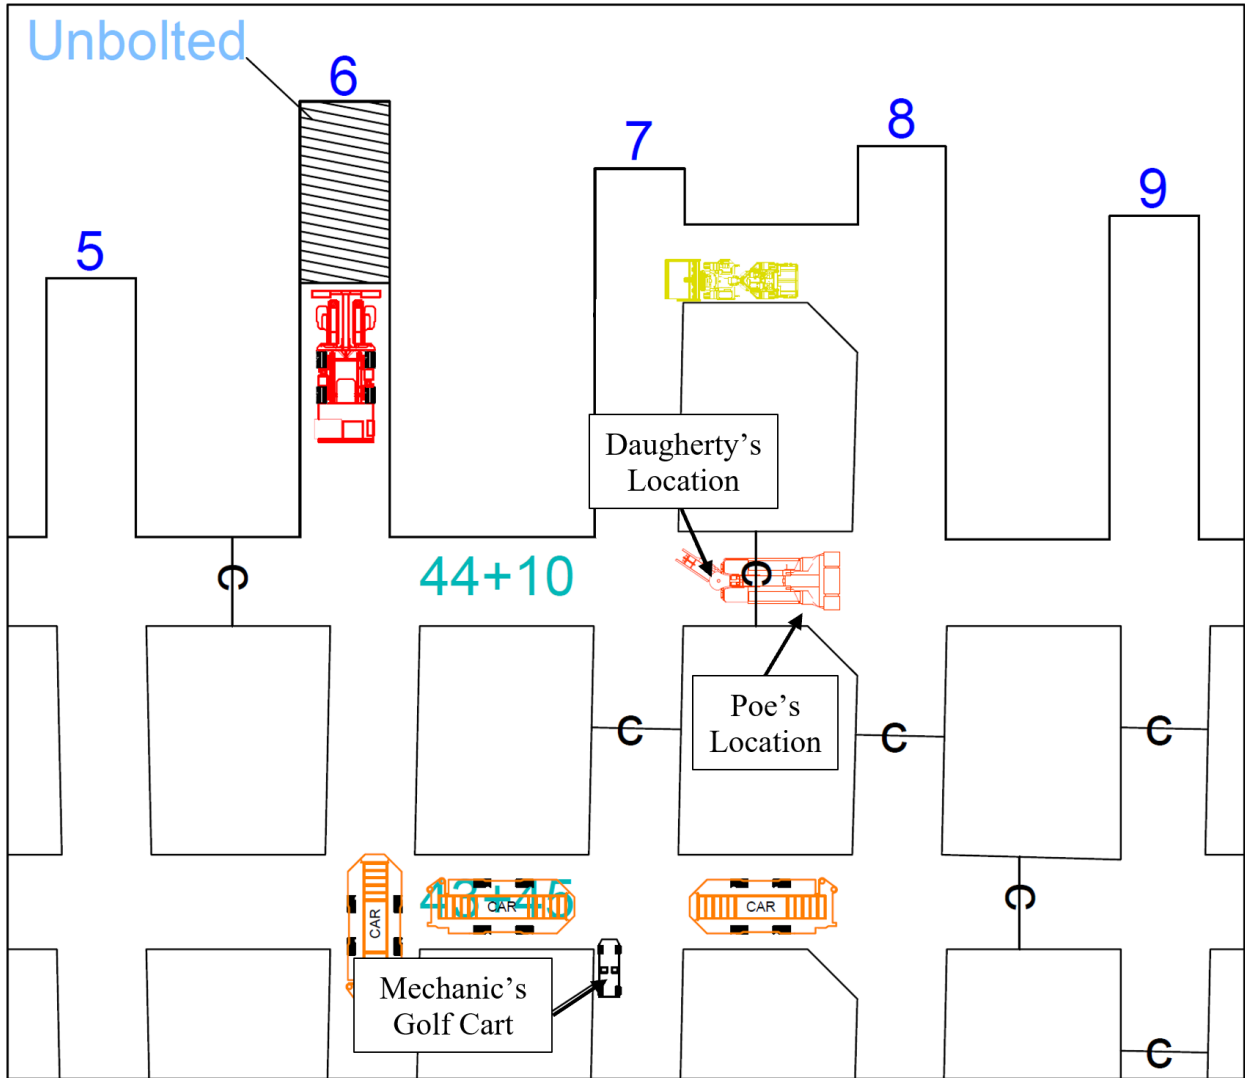
APPENDIX B – Drawing of the Accident Location

Poe traveled along the outby rib beside the continuous mining machine between the No. 7 and No. 8 entries and outby a crosscut and a half to the mechanic's golf cart to retrieve a gas kit for the methane monitor. He returned along the same route (see Appendix B). Poe was in position to start calibrating the methane monitor when Joey Mosely, No. 15 Unit Set-up Man, yelled for Poe to come to the rear of the continuous mining machine. At approximately 1:10 a.m., Mosely found Daugherty crushed between the conveyor tail boom and the rear bumper of the continuous mining machine.

The accident occurred on the right side of No. 15 Unit, MMU 016-0. Daugherty was performing maintenance work on the right-side continuous mining machine No. 5761. The No. 15 Unit is a split air ventilation unit comprised of two separate MMUs, 015-0 on the left side and 016-0 on the right side. Intake air feeds the unit from the middle entries and splits at the face to ventilate both sides of the unit simultaneously. The mining height at the continuous mining machine's conveyor tail boom was five feet seven inches. The entries are numbered from the left side of the unit to the right side. The continuous mining machine was in the last open crosscut on No. 15 Unit between the No. 7 and No. 8 entries at spad No. 44+10 (see Appendix B).

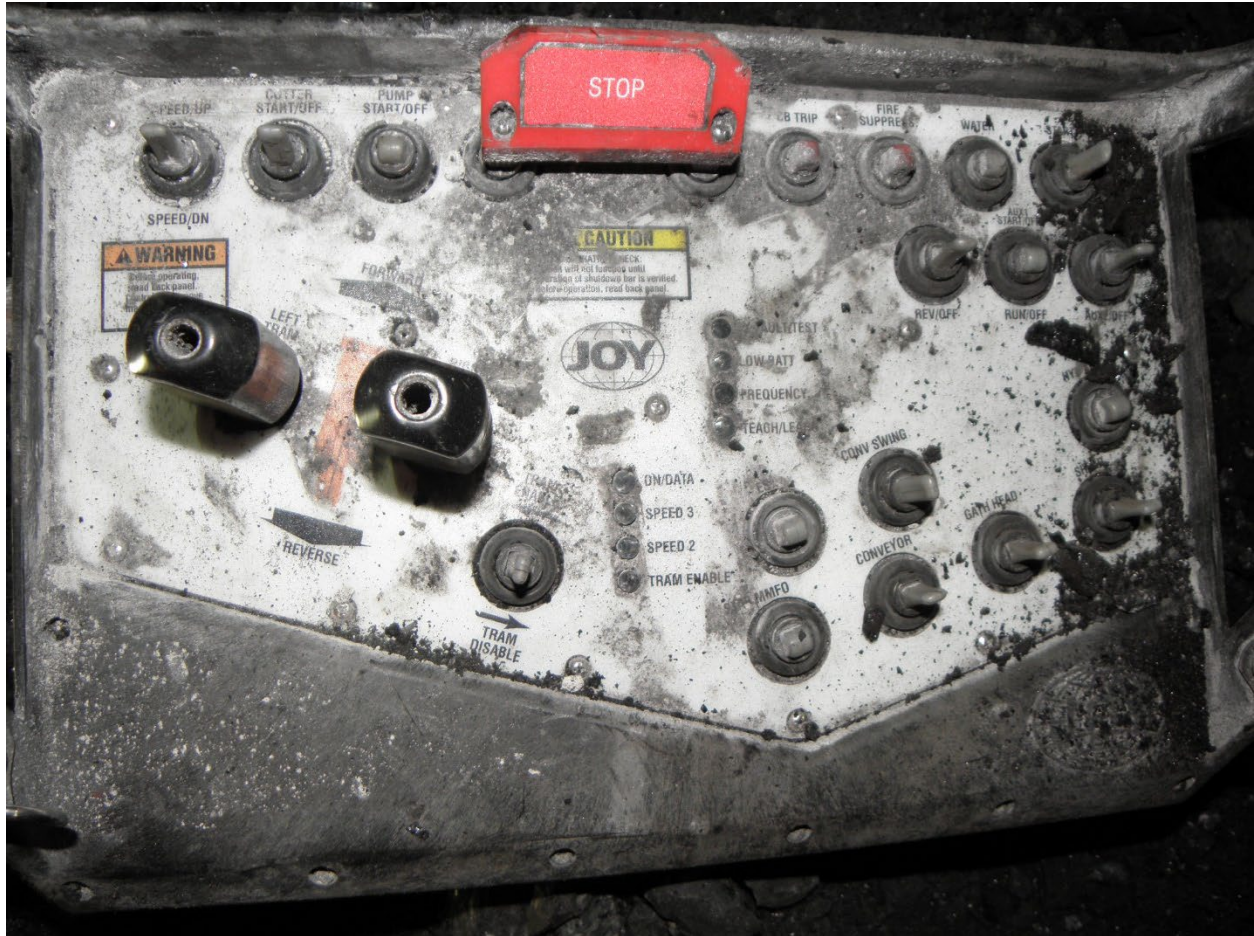
APPENDIX C – Photograph of Remote-Control Transmitter

Mosely examined the situation and determined that Daugherty was trapped with the continuous mining machine's remote-control transmitter in his hands (see Appendix C). Mosely got the remote-control transmitter from Daugherty, started the continuous mining machine, and raised the conveyor tail boom. Poe immediately went to the other side of the mechanized mining unit (MMU) to notify Matthew Whittaker, No. 15 Unit Lead Man. When Poe returned with Whittaker, Mosely had already retrieved Daugherty and was in the process of assessing his injuries. Mosely ran to get the automated external defibrillator (AED) and first aid kit while Poe and Whittaker continued to assess his injuries.
