REPORT OF INVESTIGATION

Fatal Machinery Accident  
February 28, 2022

GMS Mine Repair (Contractor ID MVK)  
Mt. Lake Park, Maryland

Berwind Deep Mine  
Ramaco Resources, LLC  
Berwind, McDowell County, West Virginia  
ID No. 46-09533

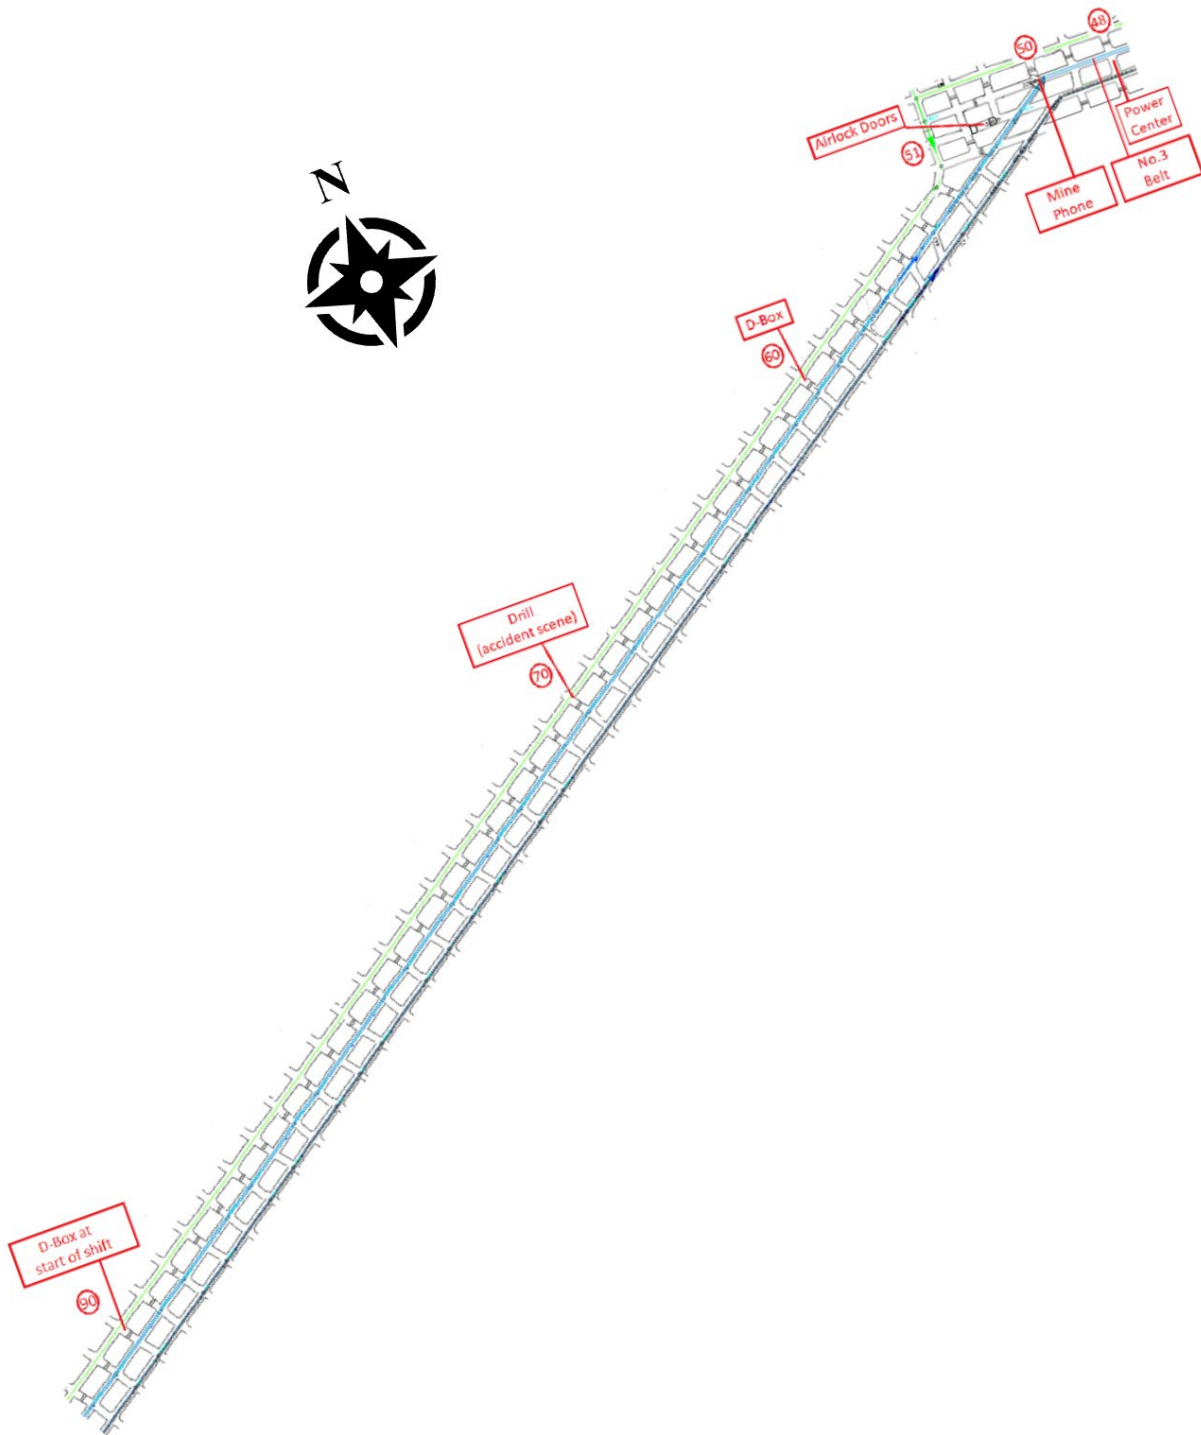
APPENDIX A – Mine Map

On February 27, 2022, Hively arrived at the mine at 10:30 p.m. Hively met Bradley Johnson, Belt Technician for GMS, and discussed their duties for this shift. Hively was responsible for moving the drill from underground to the surface. Johnson entered the mine at 11:14 p.m. through the track entry/alternate escapeway on a scoop, with Hively following him on a four-wheeled, rubber-tired personnel carrier (four-wheeler). At 11:54 p.m., Hively and Johnson traveled into the intake aircourse/primary escapeway through the airlock doors located at the No. 51 crosscut, which is located one crosscut inby No. 4 belt drive. Hively left the four-wheeler near the airlock doors and traveled with Johnson to the No. 90 crosscut (see Appendix A).

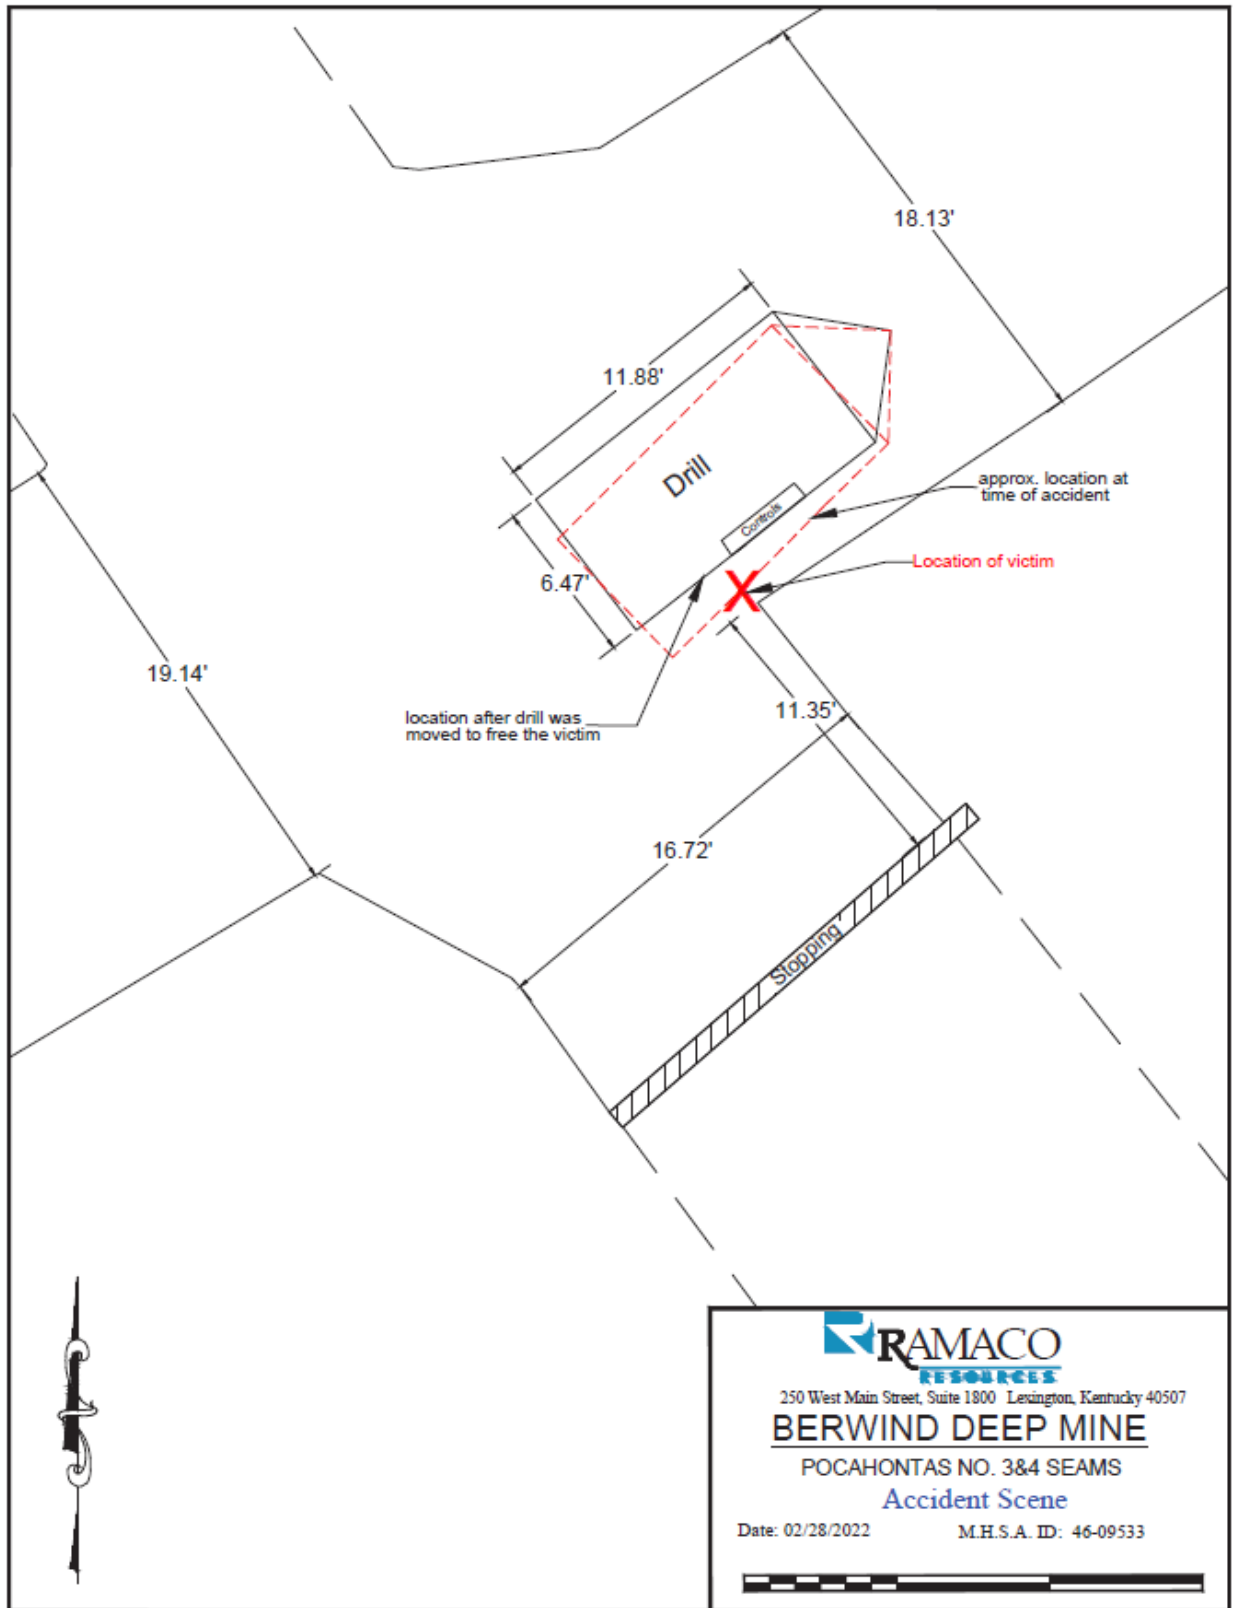
APPENDIX C – Drawing of the Accident Scene

The accident occurred at the No. 70 crosscut (Survey Station No. 519) of the intake air course/primary escapeway (see Appendix C).

Investigators determined that the lever being out of adjustment contributed to the accident. The right-side tram controls were out of adjustment which caused the drill to tram towards the coal rib, thereby crushing the victim between the coal rib and the drill.

Corrective Action: The mine operator employed a Fletcher Field Service Technician to replace and properly adjust the onboard tram control levers. The mine operator revised their training plan to include the use of the manufacturer's operator manual and retrained all electrical examiners to assure the drill is maintained in safe operating condition.
