REPORT OF INVESTIGATION

Fatal Falling, Rolling, or Sliding Rock or Material of Any Kind Accident
January 11, 2022

Colmar
Nally & Hamilton Enterprises Inc
Calvin, Bell County, Kentucky
ID No. 15-19884

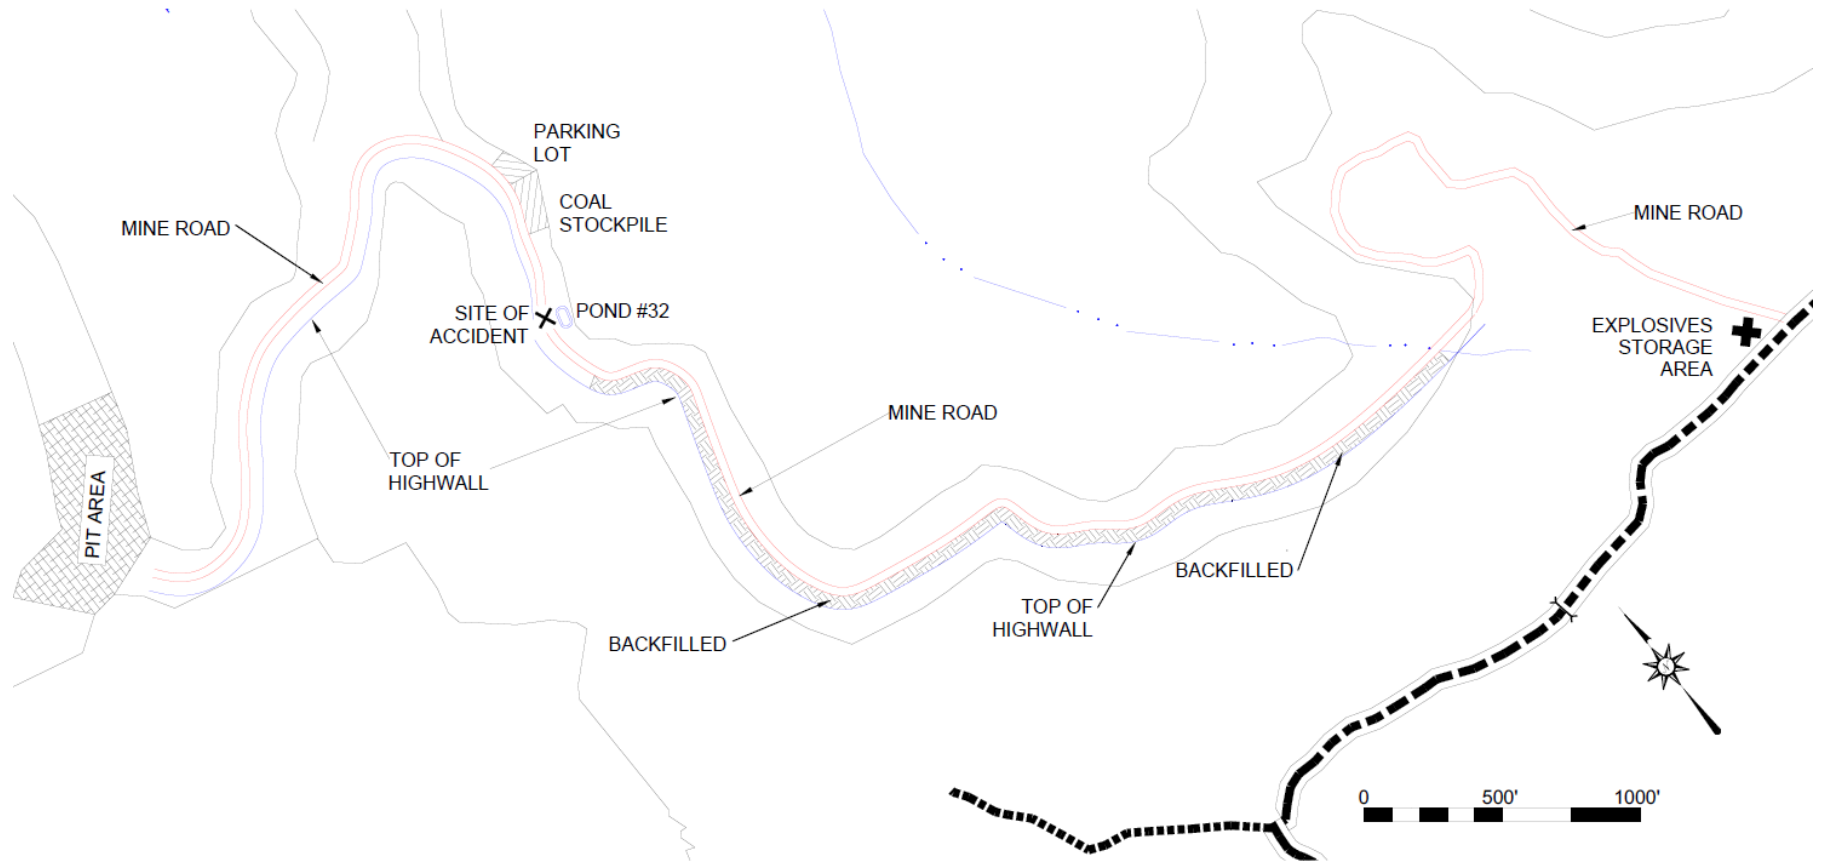
APPENDIX A – Sketch of Mine Site

The accident occurred along the mine road near Pond #32, which is located near the employee parking lot (see Appendix A).

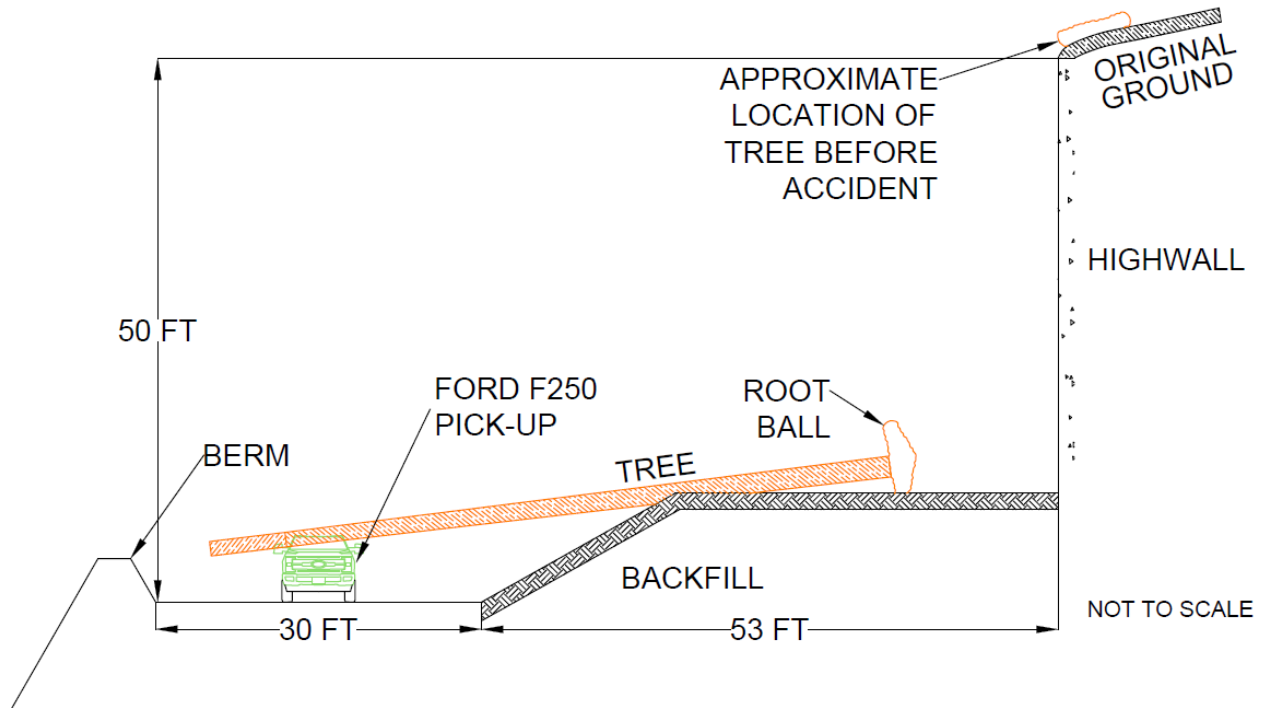
APPENDIX B – Profile Sketch of Accident Scene

Collett arrived and began working at the mine just after 1:00 p.m., having attended Surface Foreman Training at the Nally & Hamilton Enterprises Inc office in Balkan, KY earlier that day. Collett's regular duties included loading and detonating explosives. Joshua Pendleton, Heavy Equipment Operator, assisted Collett on the day of the accident. Collett was preparing to blast in the pit area, recognized that additional supplies were needed, drove a pickup truck, with Pendleton as a passenger, toward the explosives storage area (see Appendix A). Collett and Pendleton had traveled approximately one half of a mile from the pit when a tree approximately 80 feet tall fell from an adjacent highwall, striking the pickup truck. The tree broke upon impact. Investigators estimated the tree to weigh over 6,000 pounds (see Appendix B).

On June 30, 2020, MSHA acknowledged the mine operator's Ground Control Plan. On page three, General Precautions No. 6 states, "Unless a drop bench is provided, trees and other vegetation will need to be removed a safe distance from the top of the highwall." The mine operator did not provide a drop bench and four trees, in addition to the one involved in the accident, were not removed a safe distance from the top of the highwall at the accident location. Investigators determined that not following the Ground Control Plan contributed to the accident.

Corrective Action: The mine operator removed all trees near the highwall edge. On January 19, 2022, the mine operator revised their Ground Control Plan to address the removal of trees to a safe distance from the highwall edge by specifying a minimum distance of 20 feet.
