REPORT OF INVESTIGATION

Fatal Powered Haulage Accident
January 26, 2022

Ouachita Rock Portable
Ouachita Rock, Inc.
Mena, Polk County, Arkansas
ID No. 03-01867

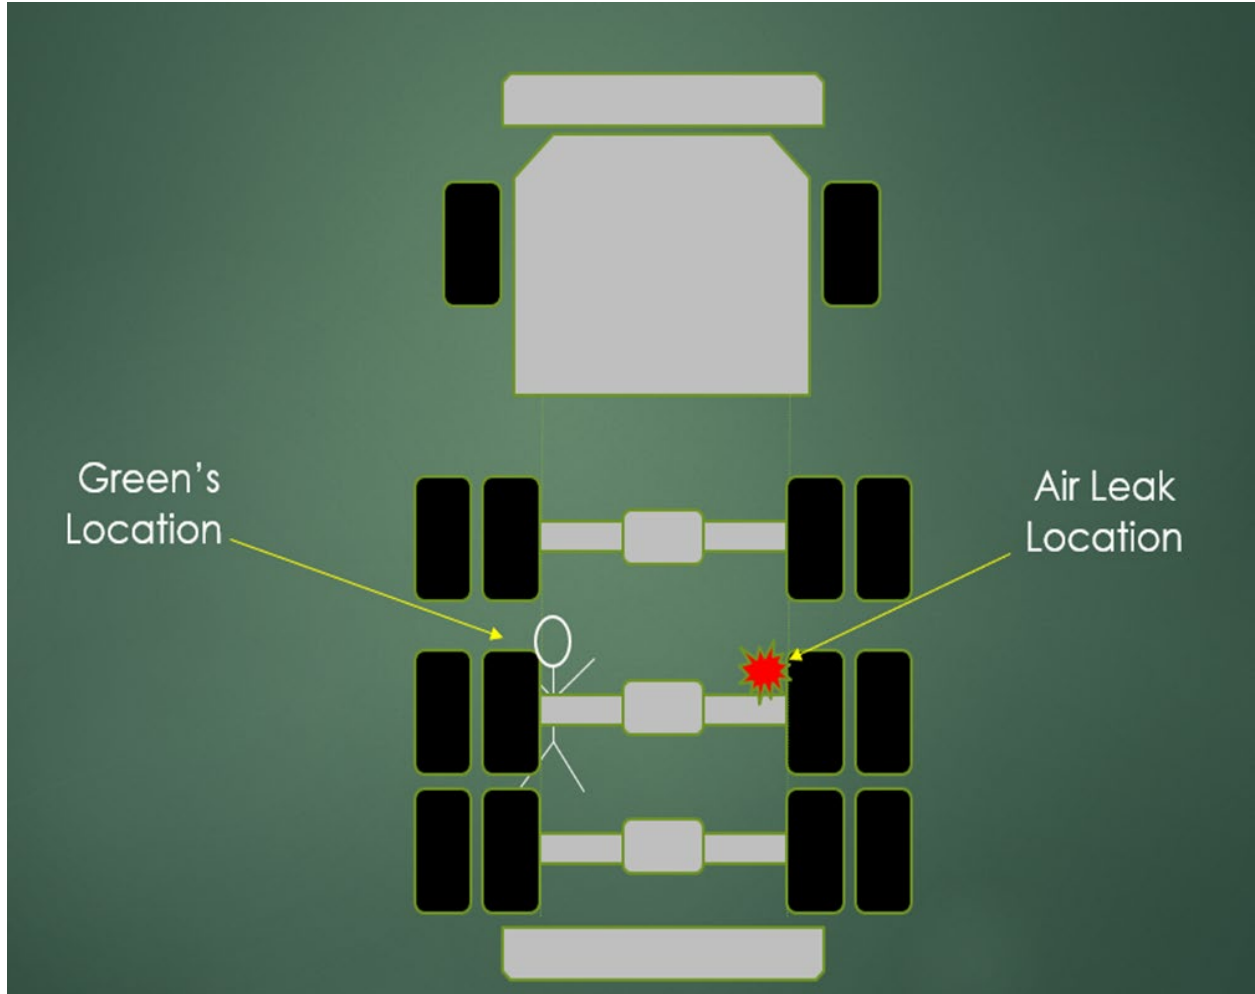
APPENDIX B – Location of Victim Under the Dump Truck

Miner said that he thought he heard someone yelling, so he turned off the dump truck and got out of the cab. He observed Green lying on his back under the inside portion of the driver's side front rear tandem tires. Miner returned to the cab, drove forward toward the stockpile, exited the cab, and pulled Green out from under the dump truck. Daniels arrived and called 911.

The accident occurred in the pit area in front of the overburden stockpile (see Appendix B). Green parked the front-end loader approximately 100 feet away and to the side of the dump truck (see Appendix C). Investigators determined that Miner likely would not have been able to see the front-end loader by looking in the dump truck's mirrors. This area was nearly flat, with a slope of less than 0.75 percent.

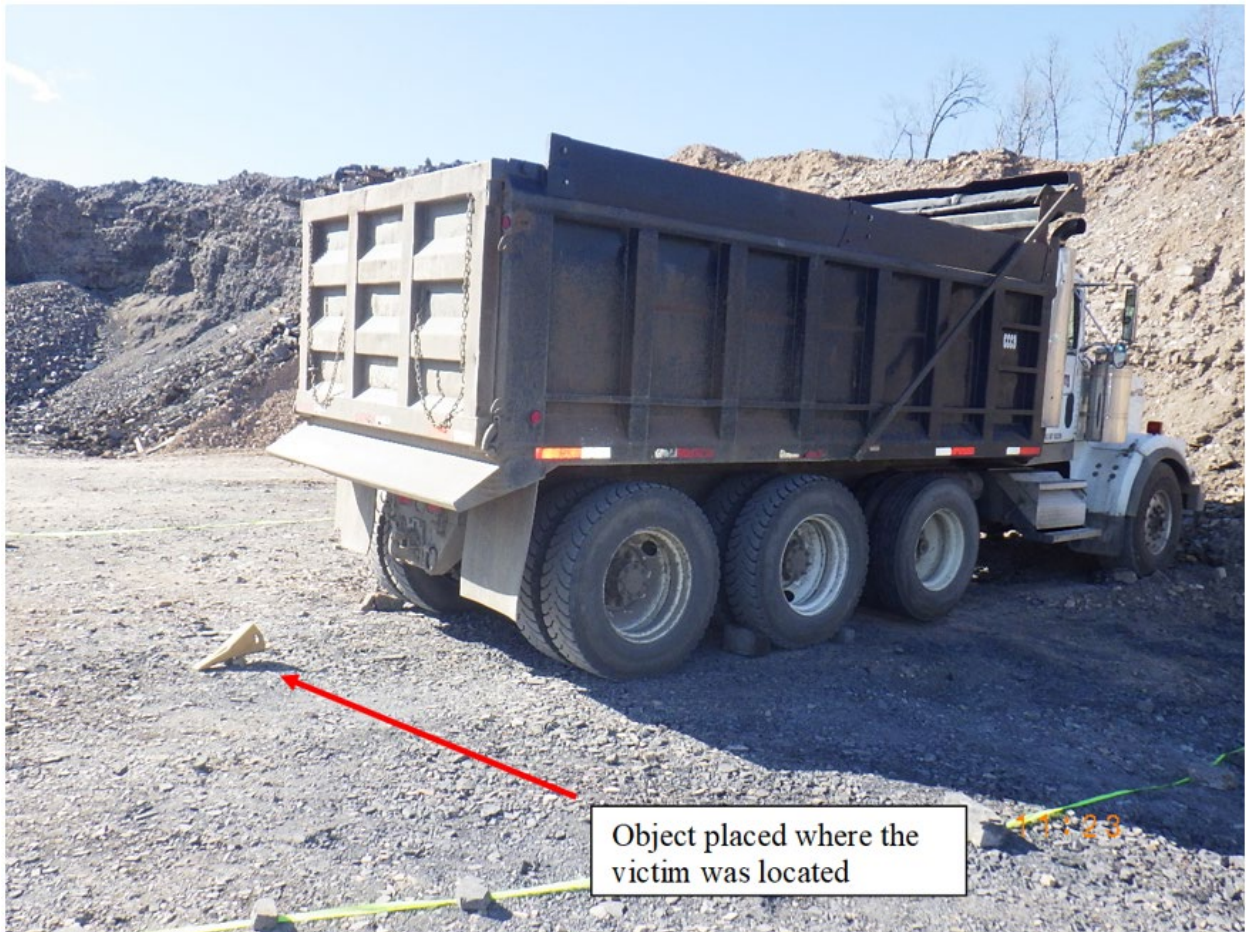
APPENDIX D – Photograph of the Equipment Involved

The dump truck involved in the accident was a 1998 Western Star tri-axle dump truck (see Appendix D). The mine operator allows Miner to park this dump truck away from the mine at his house. Miner, an employee of Ouachita Rock, Inc., only drives this dump truck onto mine property to receive loads of material, which Miner then delivers to customers. The mine operator also owns a second dump truck that is parked away from the mine site and is only used to deliver material to customers.

Ty Fisher, Mine Safety and Health Specialist, and Clark examined the braking system on the dump truck. Fisher and Clark identified an air leak on the passenger side front rear tandem

inside the dump truck's frame that was caused by a damaged valve fitting. They could not determine how the valve fitting became damaged or when it occurred.

The dump truck has a dual air system for braking. One system is for the service brake and the second is for the parking brake. The air leak was in the parking brake system. Investigators tested the braking system and determined that 85-90 PSI was necessary to manually release the parking brake. Also, the low air pressure alarm reset at 80-90 PSI. When Miner released the parking brake, he was attempting to see if it would release after the air pressure increased.

Corrective Action: The mine operator established a written procedure to turn off equipment and block against hazardous motion before performing repairs or maintenance. The mine operator trained all miners in this procedure and in the use of the blocking materials available at the mine.
