REPORT OF INVESTIGATION

Fatal Powered Haulage Accident
January 28, 2022

Tri County Materials Inc (V302)
Safford, Arizona

Freeport-McMoRan Morenci Inc.
Freeport-McMoRan Morenci Inc.
Morenci, Greenlee County, Arizona
ID No. 02-00024

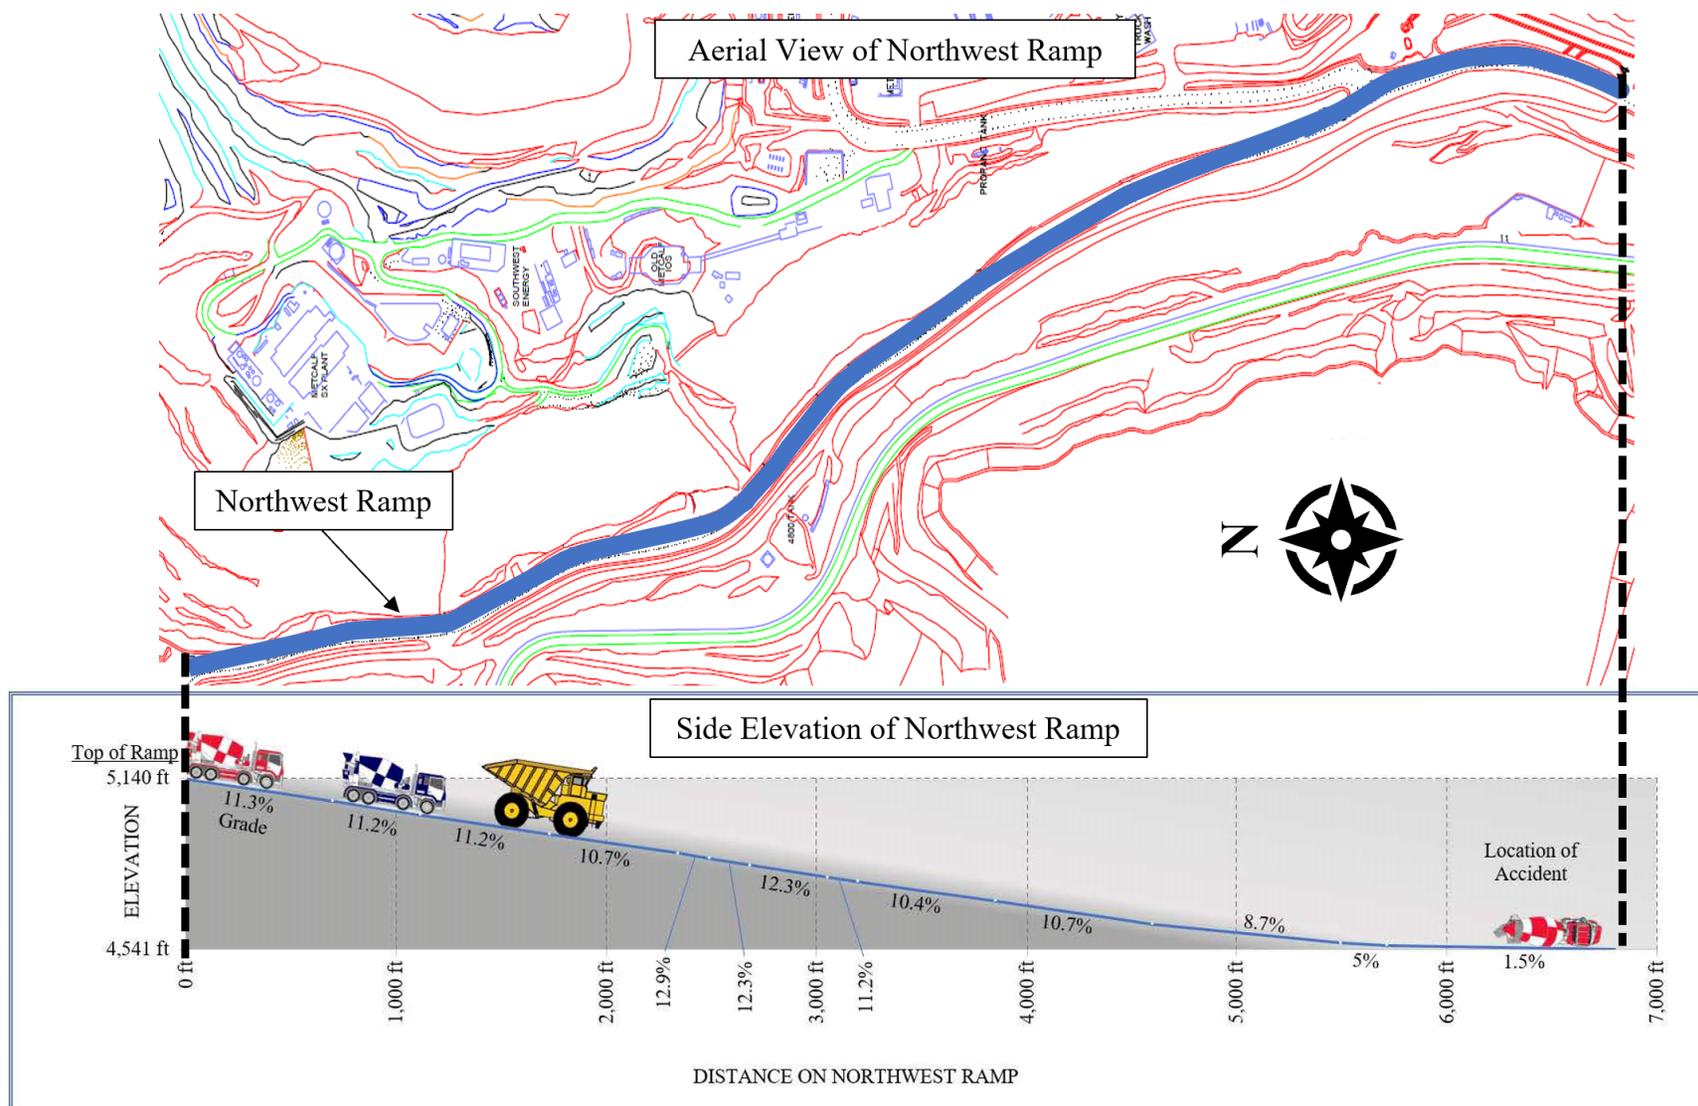
APPENDIX B – Survey Map of Northwest Ramp

The accident occurred at the bottom of the Northwest Ramp (see Appendix B) prior to the intersection with the Light Vehicle Access Ramp. The portion of the Northwest Ramp that the cement mixer truck travelled had an average grade exceeding 10 percent, with peaks greater than 12 percent. A survey map is included in Appendix B for reference with stated grades along the ramp. After overturning and sliding on its side, the cement truck left marks in the unpaved Northwest Ramp roadway that investigators measured to be 252 feet long.
