REPORT OF INVESTIGATION

Fatal Fall of Roof or Back Accident
January 7, 2022

1366 Laurel
Laurel Aggregates of Delaware, LLC
Lake Lynn, Fayette County, Pennsylvania
ID No. 36-08891

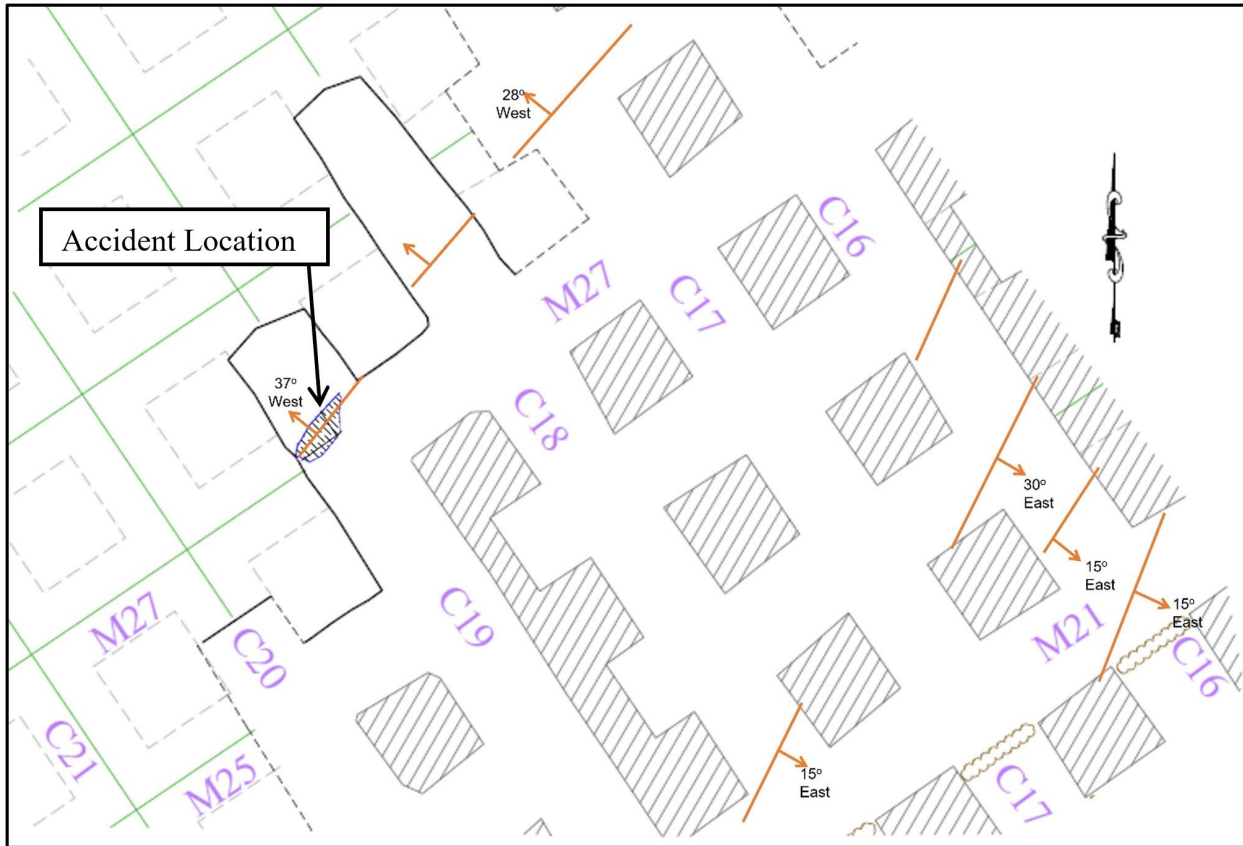
APPENDIX B – Accident Location

The accident occurred near the intersection of the C19 and M27 headings (see Appendix B). This area was mined for six months prior to the accident and the roof did not have any additional support installed. The mine's ground control plan requires the use of roof bolts as roof support on an as-needed, where-needed basis. The C19 heading had been advanced three times during the six-month period. The post-accident survey at the location of the fall indicated a mining height of 31 feet. Mining heights near the accident location measured 30 feet and 28 feet, which are consistent with the typical height at this mine.

The rock associated with the fatality fell from beneath a west-dipping fault. The wedge-shaped profile of the rock was defined by the steeply inclined fault plane intersecting the more gently inclined limestone bedding. Mining was following the inclined limestone down-slope. Prior mining encountered east-dipping faults that were easily identified because the faults caused wedge shaped material to fall during mining. After the material fell, the mine operator supported the area around the east-dipping faults with bolts.

No east-dipping faults had been identified within the few crosscuts outby the accident site, however, west-dipping faults had been identified in C17 and C18 headings from material falling because of vibrations from blasting. The mine used eight-foot-long, 7/8-inch-nominal diameter, fully grouted roof bolts to support these faults. No material fell as a result of blasting in the C19 heading, therefore no roof bolts were installed. The cavity from where the rock fell measured 6.3 feet high at its greatest extent. The lack of installation of eight-foot-long roof bolts in and around the fault area, as in the adjacent entries, contributed to the accident.

Local map showing accident location in the intersection of C19 and M27 Headings. Orange lines denote identified faults along with dip direction and angle. All identified faults on the map were supported by roof bolts with the exception of the accident location.

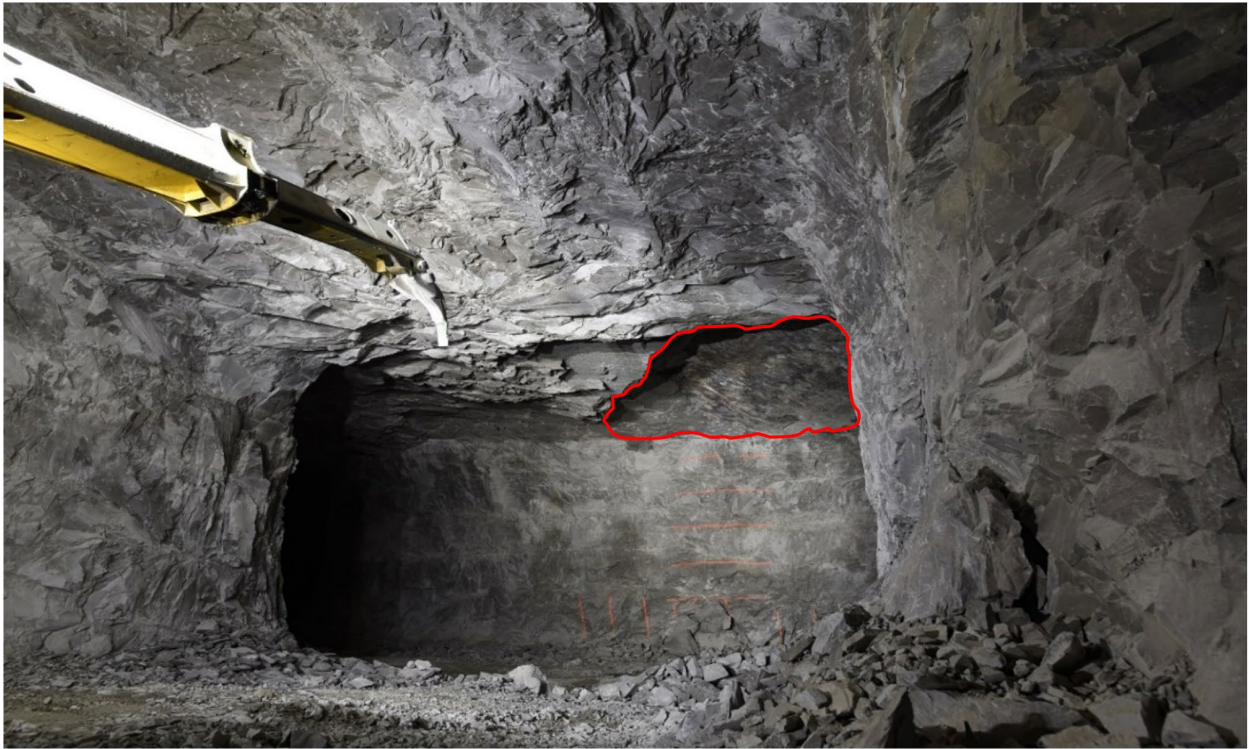
The mine operator's engineering consultant, Earthtech, Inc., used survey equipment to measure the wedge-shaped fall cavity. The cavity had dimensions of 37 feet long, 16.7 feet wide, and 6.3 feet high at the apex. Investigators calculated the weight of the wedge-shaped rock to be approximately 170-tons based on these dimensions and the rock density (see Appendix C). The rock fell approximately 17 feet onto the cab of the front-end loader.

View of rock fall from Crosscut M27 looking Southwest into Heading C19. The red outline indicates the wedge-shaped fall cavity.

Corrective Action: The mine operator revised the mine's ground control plan by including a written procedure for the installation of roof bolts. The plan requires eight-foot-long, 7/8-inch-nominal diameter, fully grouted roof bolts to be installed mine-wide on a five-foot by five-foot pattern to within ten feet of a mining face. The mine operator trained all miners on this procedure.

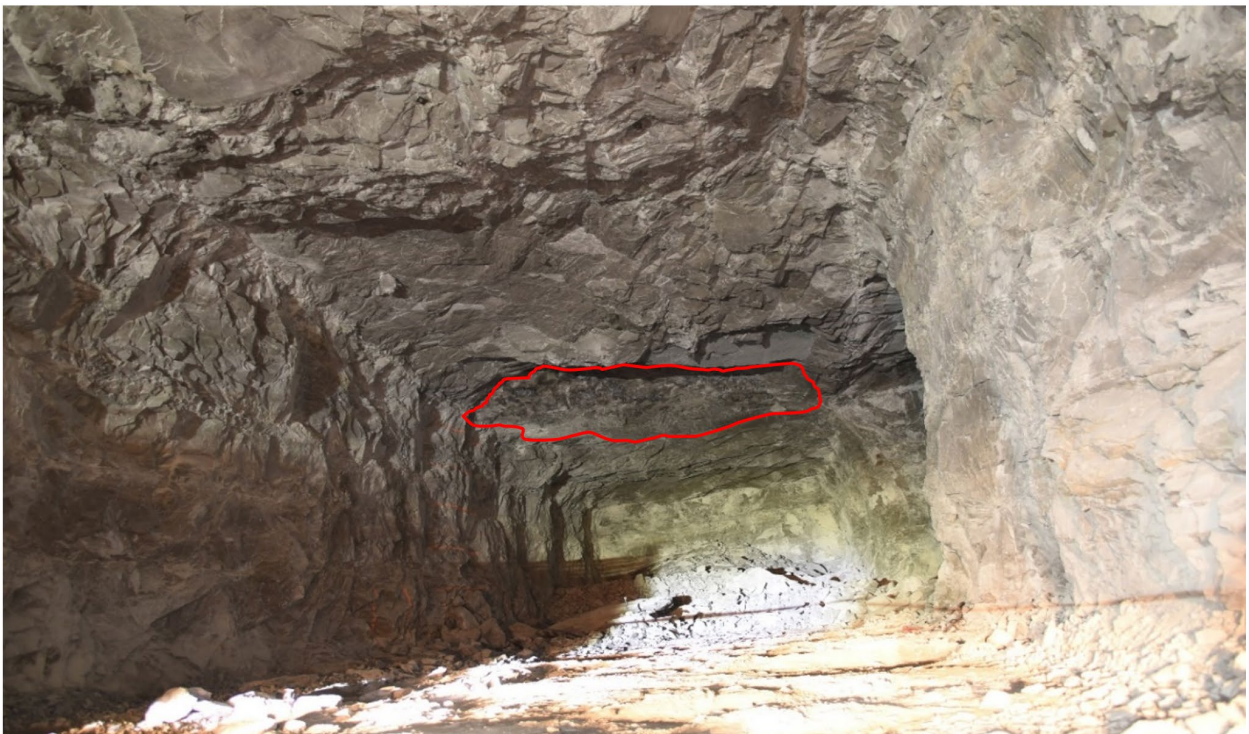
View of rock fall from Heading C19 looking Northwest into face. The red outline indicates the wedge-shaped fall cavity.
