REPORT OF INVESTIGATION

Fatal Machinery Accident
January 7, 2022

Oaktown Fuels Mine No. 1
Sunrise Coal, LLC
Oaktown, Knox County, Indiana
ID No. 12-02394

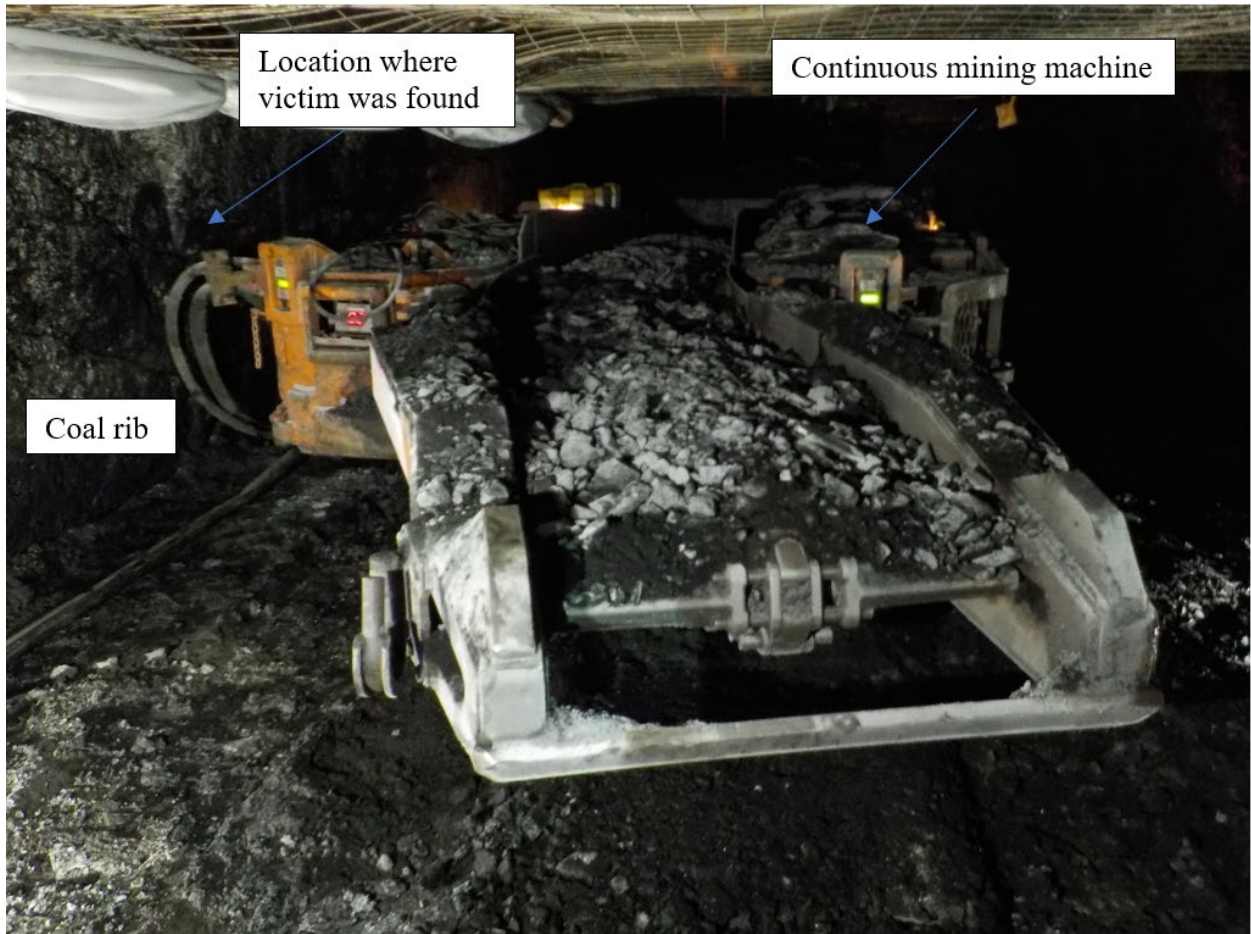
APPENDIX C – Photograph of the Accident Scene

The accident occurred at the face of the No. 11 entry on MMU 008-0 (see Appendix B). The mine height in the entry where the accident occurred was 71 inches. The mine floor was dry. The mine roof had metal screen wire installed in the entry. See Appendix C for photograph of the accident scene.

The Roof Control Plan Red Zone provisions were not followed. The accident occurred when the victim was in the Red Zone and became pinned between the CMM and the coal rib while repositioning the CMM in the working place. Investigators determined that this contributed to the accident.

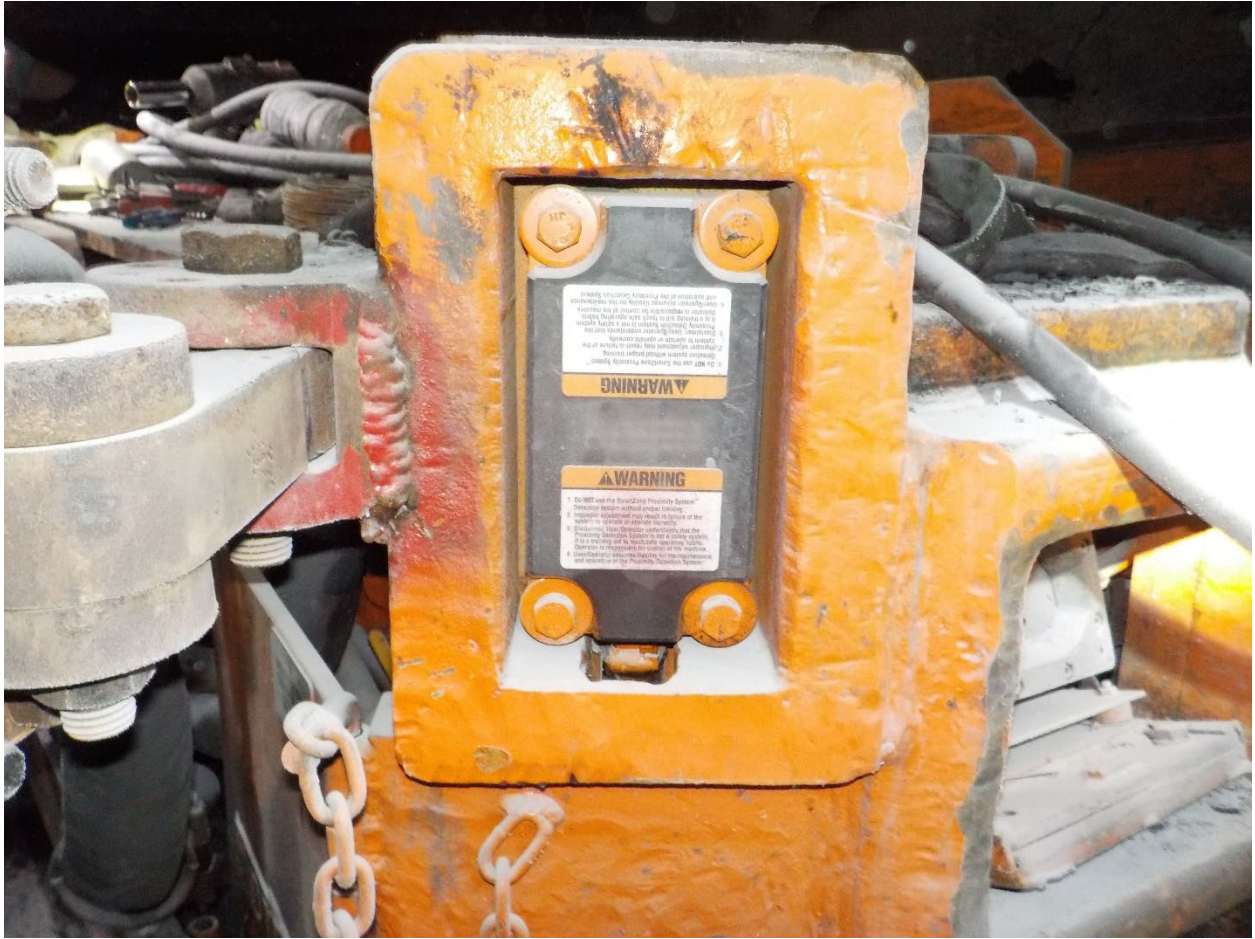
APPENDIX D – Photograph of a PDS Driver

The MMCs include four electromagnetic field generators, referred to as drivers. Two drivers are located near the front of the CMM, one on each side, and two drivers are located near the rear of the CMM (see Appendix D), one on each side. The PDS uses the drivers' electromagnetic fields and radio signals from the MWCs to determine the location of the MWCs relative to the CMM. When an MWC enters a certain area in the electromagnetic field, the MMCs and MWC recognize the intrusion and relay the appropriate signal to the system. See Appendix E for Rodriguez's MWC.

Investigators performed additional dynamic tests by placing Rodriguez's MWC in stationary positions around the CMM. The PDS stopped the CMM from contacting the MWC during some of the tests, but not in others. However, during all dynamic tests, the left front driver did not illuminate any warning lights and the PDS was unable to determine an accurate distance from the left front driver to the MWC. PDS data showed that the left front driver was malfunctioning during the shift of the accident and on the shift prior to the accident. The PDS should prevent movement of the CMM if any machine-mounted component, such as a driver, is not functioning properly. The PDS involved in the accident did not detect the malfunctioning driver and allowed movement of the CMM. During the dynamic tests with Rodriguez's non-shielded MWC at the location of the accident, the PDS stopped the CMM before contacting the MWC, even though the left front driver was malfunctioning. Therefore, investigators determined that the malfunctioning left front driver did not prevent the PDS from stopping the CMM at the time of the accident.

On March 8, 2022, the mine operator installed Matrix Design Group's optional machine-mounted locator (MML) on the No. 4 CMM. A MML is designed to prevent trammings or swinging the conveyor boom of a CMM if the electromagnetic signal from a driver changes by a certain percentage. After the MML was installed, investigators determined that the MML detected the malfunctioning driver and enabled the PDS to prevent trammings or swinging the boom of the CMM.

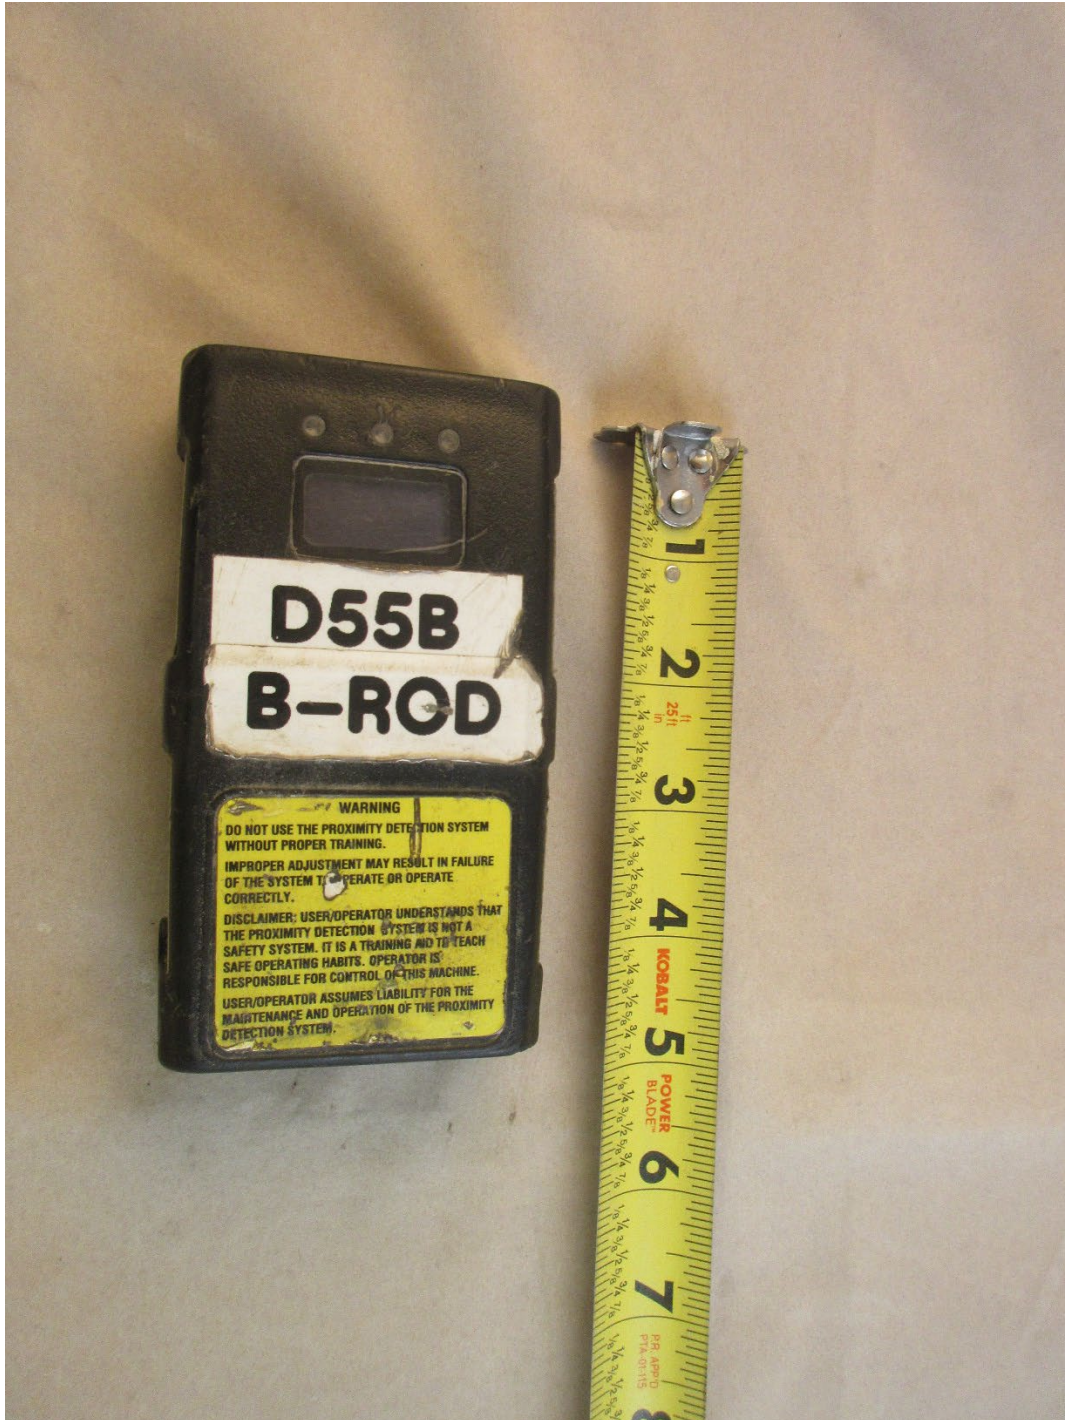
APPENDIX E – Photograph of Rodriguez’s MWC

On March 9, 2022, investigators conducted additional tests with MWCs shielded as described, and with non-shielded MWCs. Investigators placed metallic shielding around Rodriguez's MWC and put it in the shutdown zone where he was struck by the CMM. PDS real-time images from the PDS software showed Rodriguez's shielded MWC assigned to a location outside the shutdown zone and outside the warning zone. This location was consistent with the locations assigned by the PDS to Rodriguez's and Taylor's MWCs at the time of the accident and until 10:41:54 p.m. The location assigned to Rodriguez's MWC inside the shutdown zone after 10:41:54 p.m. was consistent with non-shielded MWCs. Investigators concluded that Rodriguez's MWC was defeated by metallic shielding at the time of the accident and contributed to the accident. Investigators also determined that the MWC worn by Taylor was also defeated by metallic shielding.

PDS data described in the previous paragraph shows that Rodriguez's MWC was shielded at the time of the accident and that the metallic material was removed from his (Rodriguez's) MWC at 10:41:54 p.m., prior to MSHA's arrival on-site to conduct the accident investigation. Therefore, the scene of the accident was altered before MSHA began its investigation.

Corrective Action: The mine operator retrained all miners on the proper use and location of their MWCs as recommended by the manufacturer. The mine operator revised their Roof Control Plan to require CMM operators to wear their MWC on their chest area, unobscured by a pouch or other material.

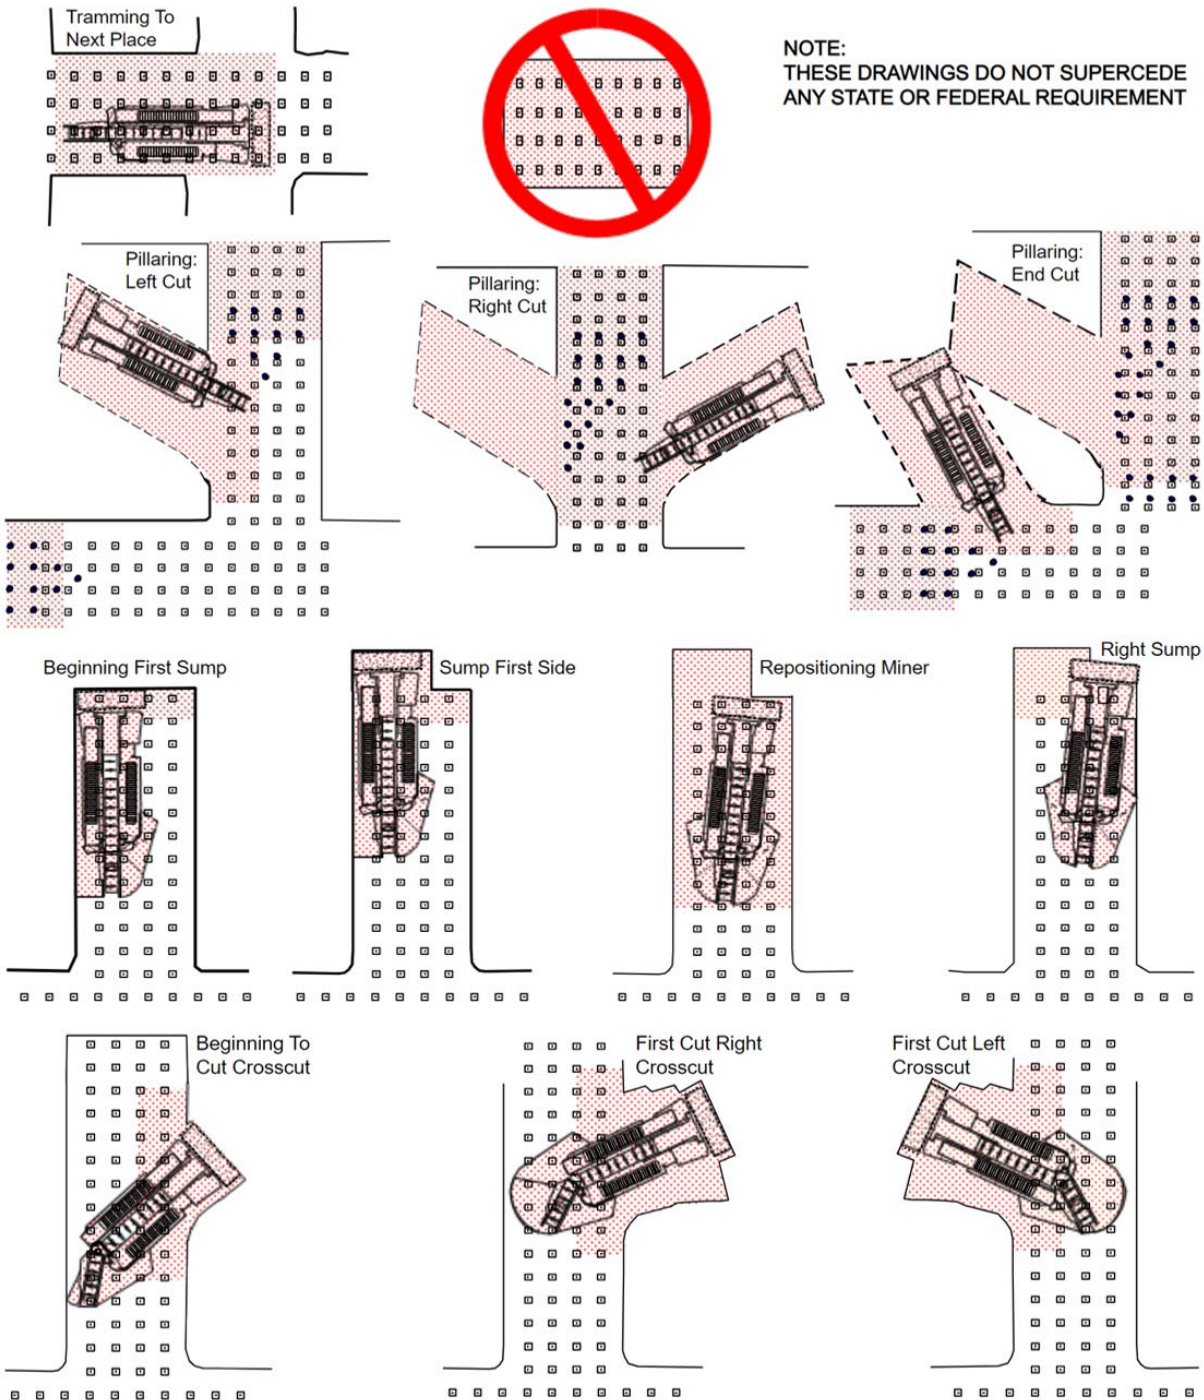
RED ZONES ARE NO ZONES FOR MINING WITH REMOTE CONTROL CONTINUOUS MINERS

The Roof Control Plan was approved on September 17, 2018. Appendix B Sketch 7 of the Roof Control Plan addresses the Red Zone provisions. It was submitted on May 6, 2019 and approved on May 22, 2019. The Plan states "Red Zones Stay Out of the 'Danger Zones!' No one shall be in the 'Danger Zone' when the miner is tramming from place to place or being repositioned in the working place." See Appendix F for illustrations of Red Zones around CMMs.

Corrective Action: The mine operator developed and implemented procedures for PDS examinations and Red Zone safety. The procedures include making static measurements and conducting dynamic tests of all PDS components, including MMCs and MWCs, on each CMM at the beginning of each shift, following Joy Global, Inc.'s Smart Zone Proximity Systems User Guide. The mine operator retrained miners on all eight working sections on: 1) the Red Zone area of the CMM, and 2) how to be safe on the working sections, including when repositioning, cable handling, and moving the CMMs. Additionally, a MML was installed on the No. 4 CMM and will be engaged when the CMM is in service.
