REPORT OF INVESTIGATION

Fatal Machinery Accident

July 21, 2022

Giant Cement Company
Giant Cement Company
Harleyville, Dorchester County, South Carolina
ID No. 38-00007

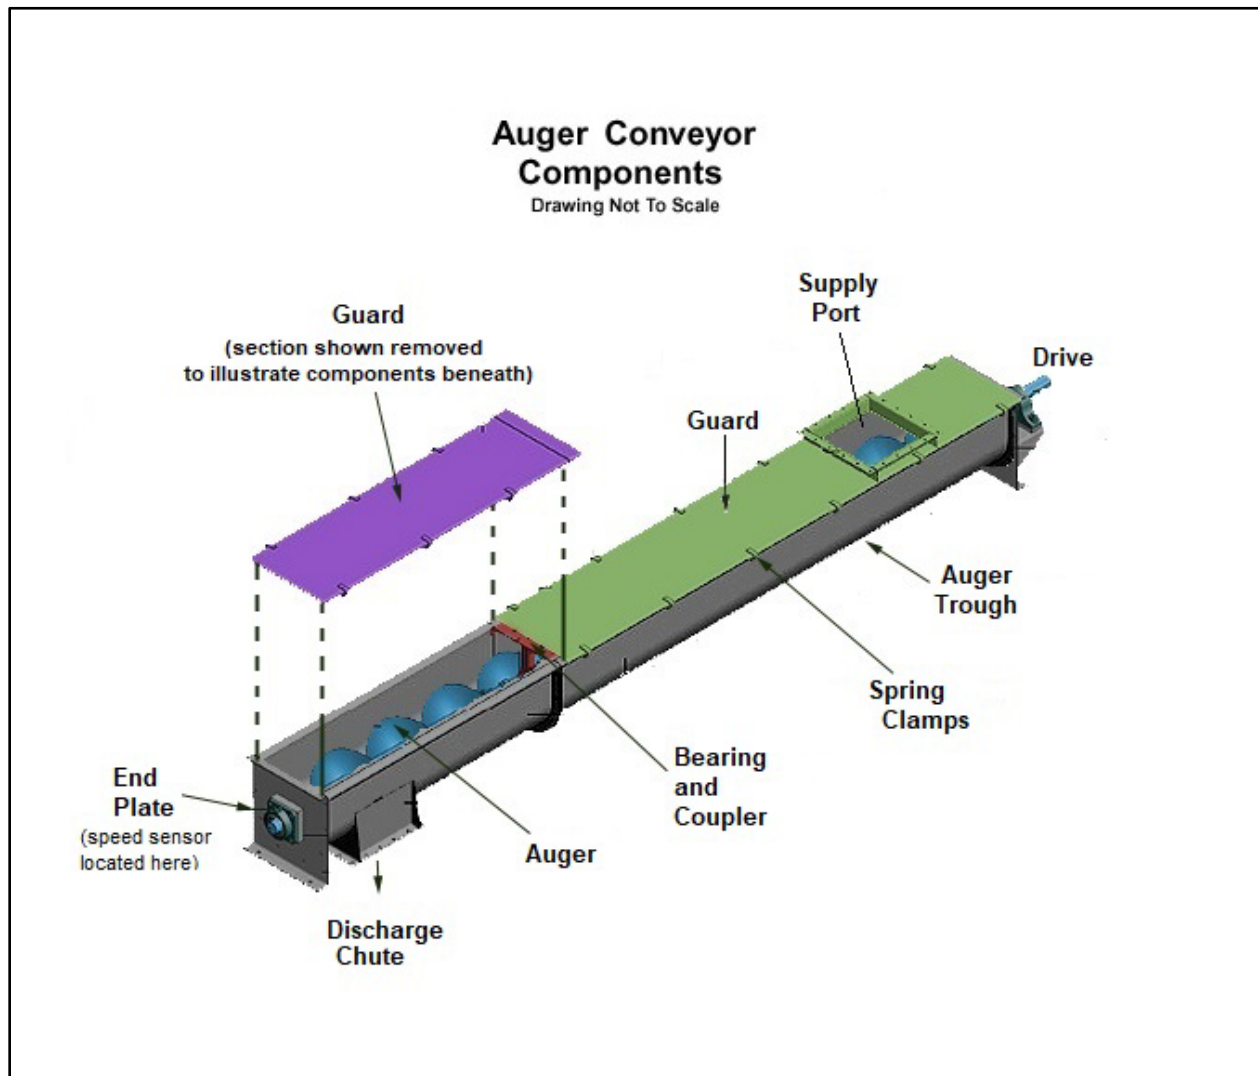
APPENDIX C – Auger Conveyor Illustration

The SC01 auger conveyor is over 28 feet long and consists of a ten-inch diameter auger, which rotates inside a trough, and conveys material as the auger turns. The auger conveyor was installed horizontally, 48 inches above the floor. The entire length of the conveyor is designed to be covered by guards held in place by spring clamps. The auger is made up of sections joined by gudgeons and supported by bearings and metal fixtures inside the conveyor trough (see Appendix C).

According to interviews, this SC01 auger conveyor had a history of breaking at the gudgeons. Additionally, material would clog at or in the discharge pipe, so an air lance was installed for shift utility workers to use to clear blockages. Investigators learned through interviews that the mine operator had planned to replace the entire SC01 auger conveyor in August 2021, but afterwards decided not to replace it. Instead, the mine operator decided to repair the gudgeons each time they broke. In June of 2022, Marion Gaskins, Maintenance Manager, put a work order in to fully replace the SC01 auger conveyor but this work had not commenced.

The SC01 auger conveyor had metal guards which enclosed the auger in the trough. The guards were normally held in place by spring clamps placed over the lip of the conveyor trough and the top of the guard to hold it in place. Investigators observed several of these spring clamps lying loose on top of a guard and generally inconsistent spring clamps spacing. During interviews, investigators determined that over time, the spring clamps loosened from use and as a result, removing the clamps from the guard required less effort. When MSHA's accident investigation team arrived, two of the guards were off. With the guards off, the rotating auger of the conveyor created an entanglement hazard to miners working in the area. According to interviews, miners placed warning tape up in various areas around the mine as a warning to prevent miners from entering areas where guards were not secured, damaged or missing. However, miners continued to access those areas and be exposed to the hazard from unguarded machinery. Investigators did not find warning tape in the area around the SC01 auger conveyor when they arrived to conduct the investigation.

Supervisors stated that shift utility workers were told to look at the ends of the auger shafts to ensure that the shaft was rotating. The SC01 auger conveyor had a two-piece solid metal drive guard located on the drive end which prevented visual observation when closed. Investigators observed that during the investigation, the guard was separated, exposing the keyed shaft, pulleys, and belts.

Corrective Action: The mine operator permanently removed the auger conveyor from service. The auger conveyor and associated equipment will not be replaced. Additionally, the mine operator trained all miners to secure all guards in place while equipment is in operation.

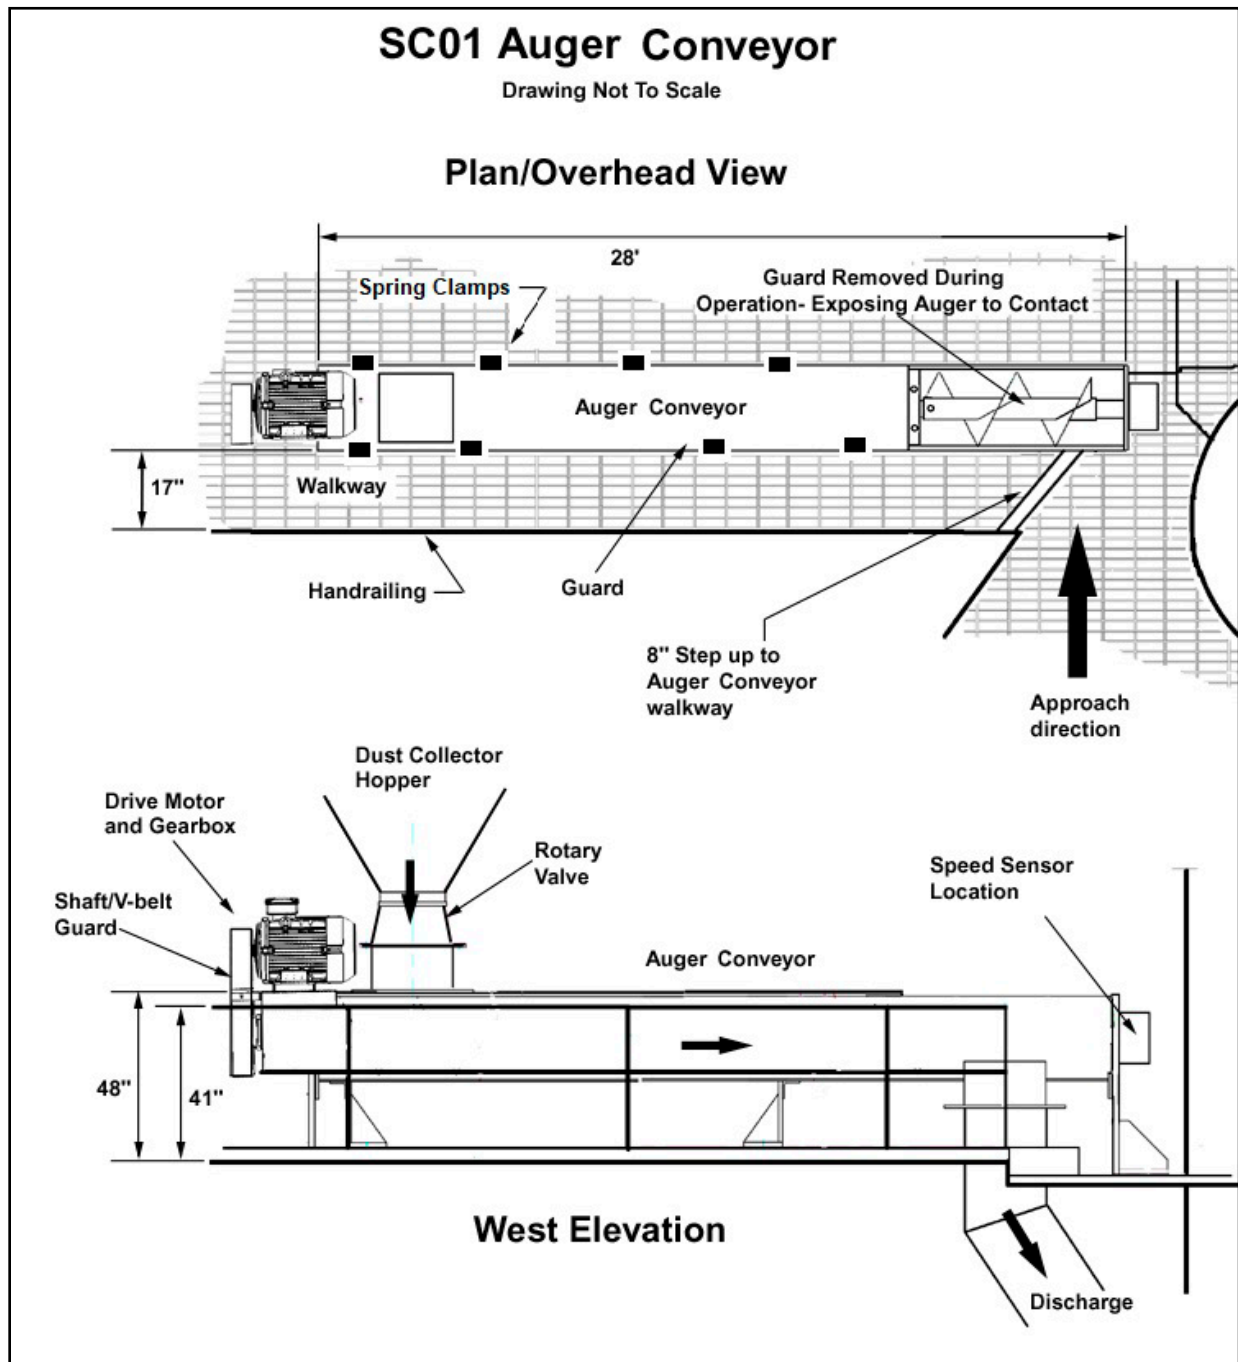
APPENDIX D – Plan and Elevation Illustrations

The accident occurred along the west side of the SC01 auger conveyor located on the third floor of the #2 Finish Mill. An outside aerial view of the Giant Cement Company facility can be seen in Appendix B.
