REPORT OF INVESTIGATION

Fatal Machinery Accident
June 17, 2022

Terra Excavating, LLC (C3757)
Augusta, Georgia

Jackson Quarry
Vulcan Construction Materials LLC
Jefferson, Jackson County, Georgia
ID No. 09-01264

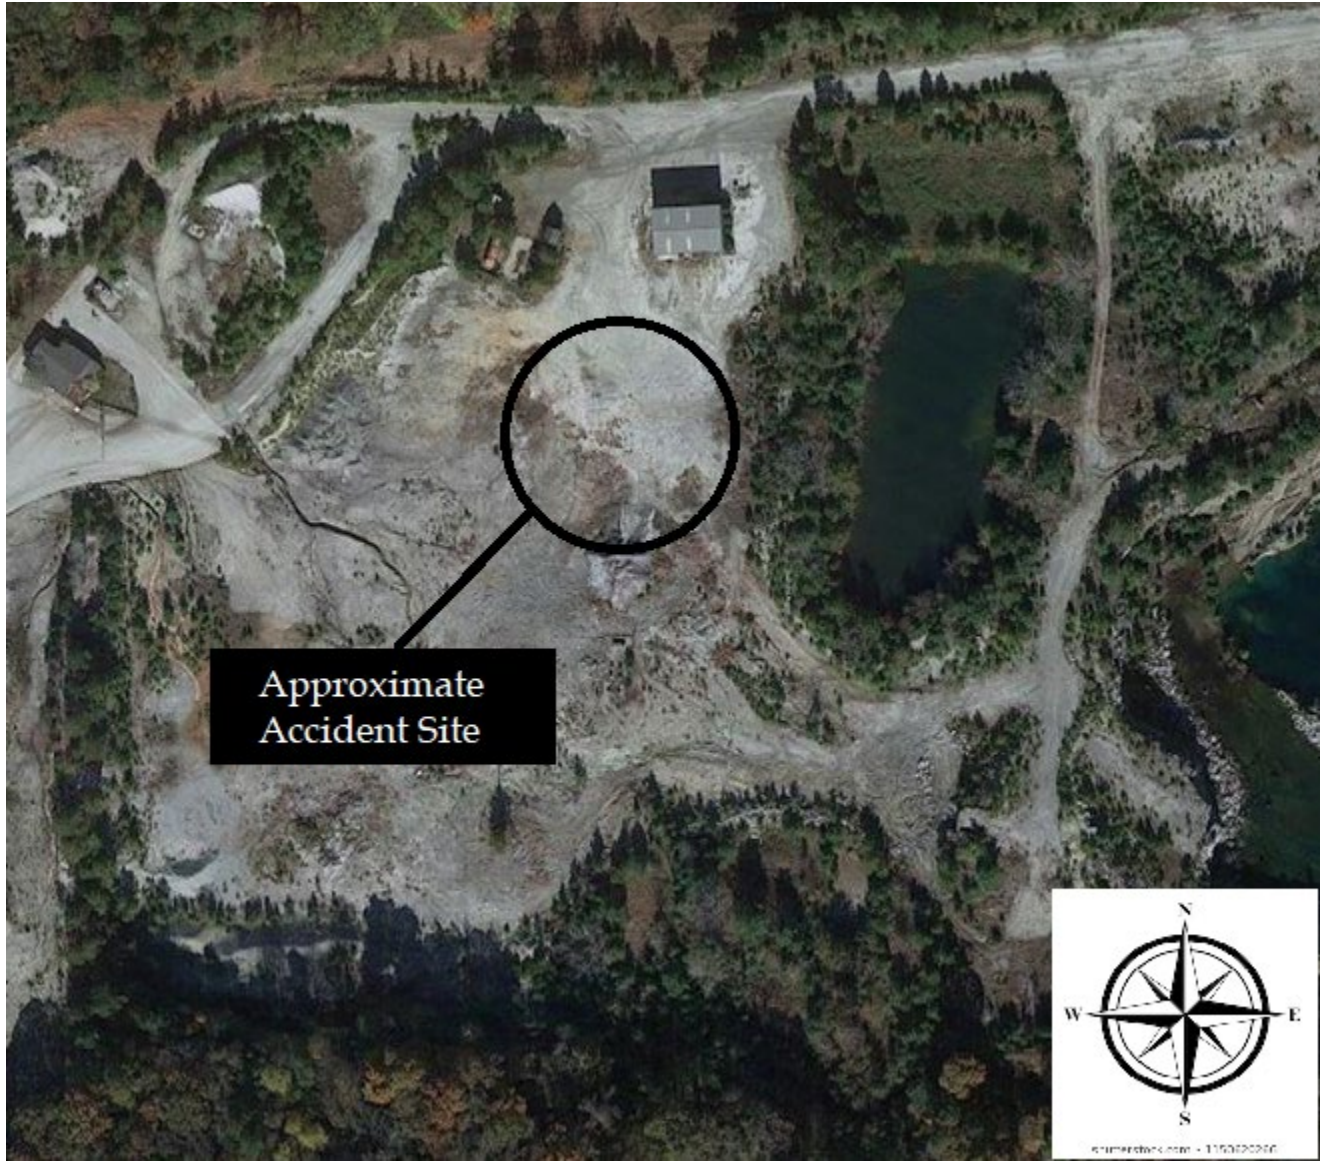
APPENDIX B – Aerial View of Accident Scene

was overturned and lying on its side. Based on interviews and evaluation of the ground conditions and tire tracks, investigators determined that Thigpen trammed the compactor in reverse and the left tire dropped off the edge of the elevated building pad, causing the compactor to overturn.

The accident occurred at the elevated building pad that the subcontractors were constructing for the future installation of crushing and screening equipment (see Appendix B). The material being compacted was approximately four feet higher than the surrounding ground level. The building pad was approximately 343 feet long by 50 feet wide.

Terra was not conducting workplace examinations at this mine and there were no records of any examinations having been conducted. The four-foot drop-off adjacent to the elevated building pad being compacted would have been identified by a workplace examination, and the equipment operator would have been aware of the hazard presented by operating near the drop-

off. Investigators determined that not conducting workplace examinations contributed to the accident.

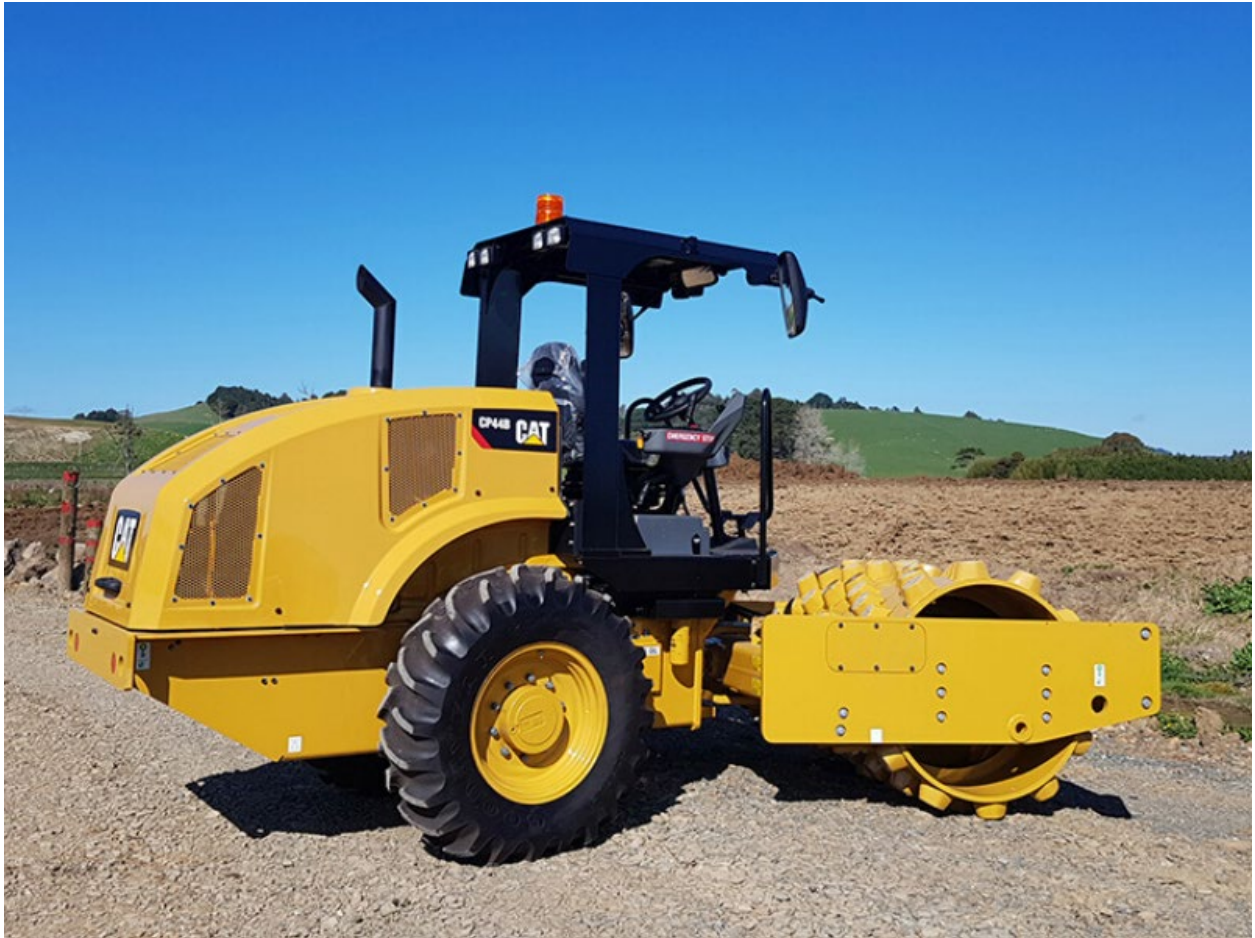
APPENDIX C – Padfoot Compactor

The equipment involved in the accident was a Caterpillar CP44B Padfoot Compactor (see Appendix C). This compactor was relatively new with only 48 operating hours on the hour meter. The rear of the machine had rubber tires and was equipped with an open cab, roll bar, and canopy. Caterpillar dealer, Yancy Bros. Co., provided regular maintenance with the lease of the compactor at this mine. MSHA investigators, with the assistance of Yancy Bros. Co., conducted a diagnostic test on the compactor and found no defects on the compactor that contributed to the accident.

Investigators examined and tested the seat belt and determined that it functioned as designed. Upon close inspection, the seat belt buckle, the webbing, and buckle insert did not exhibit signs of wear. Terra did not have any procedures requiring the use of seat belts. Investigators determined Thigpen was not wearing a seat belt at the time of the accident, which contributed to the severity of the accident.
