REPORT OF INVESTIGATION

Fatal Slip or Fall of Person Accident
June 20, 2022

Explosive Contractors Inc. (6EJ)
Hollister, Missouri

3M Little Rock Industrial Mineral Products
3M Company
Little Rock, Pulaski County, Arkansas
ID No. 03-00426

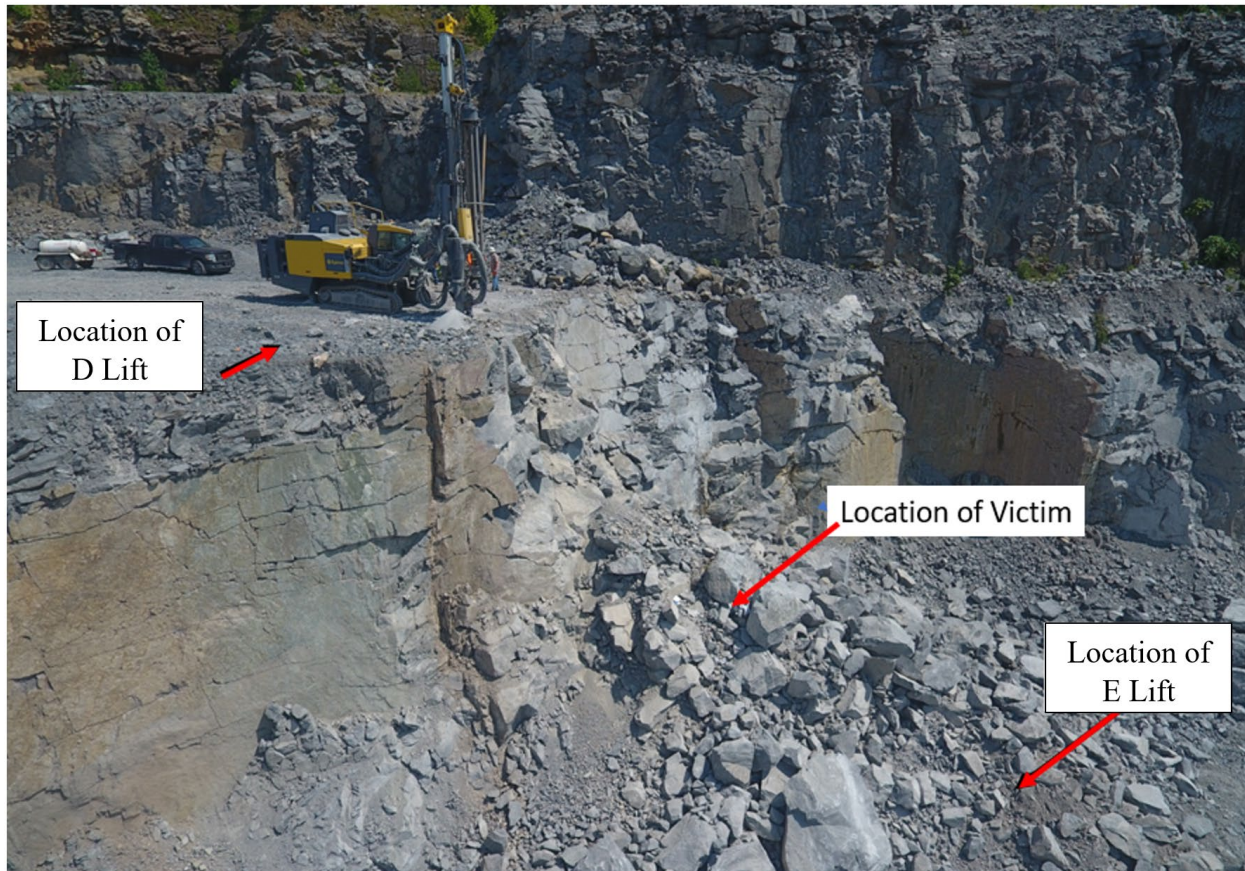
APPENDIX B – Location of Accident

The accident occurred on the D Lift of the southeast quarry (see Appendix B). Saul's pickup truck and a water trailer were parked on the D Lift away from the drill. Based on the examination of the accident scene, investigators determined that Saul fell from the D Lift down to the "E Lift" when he was positioned between the drill steel carousel and the edge of the highwall.

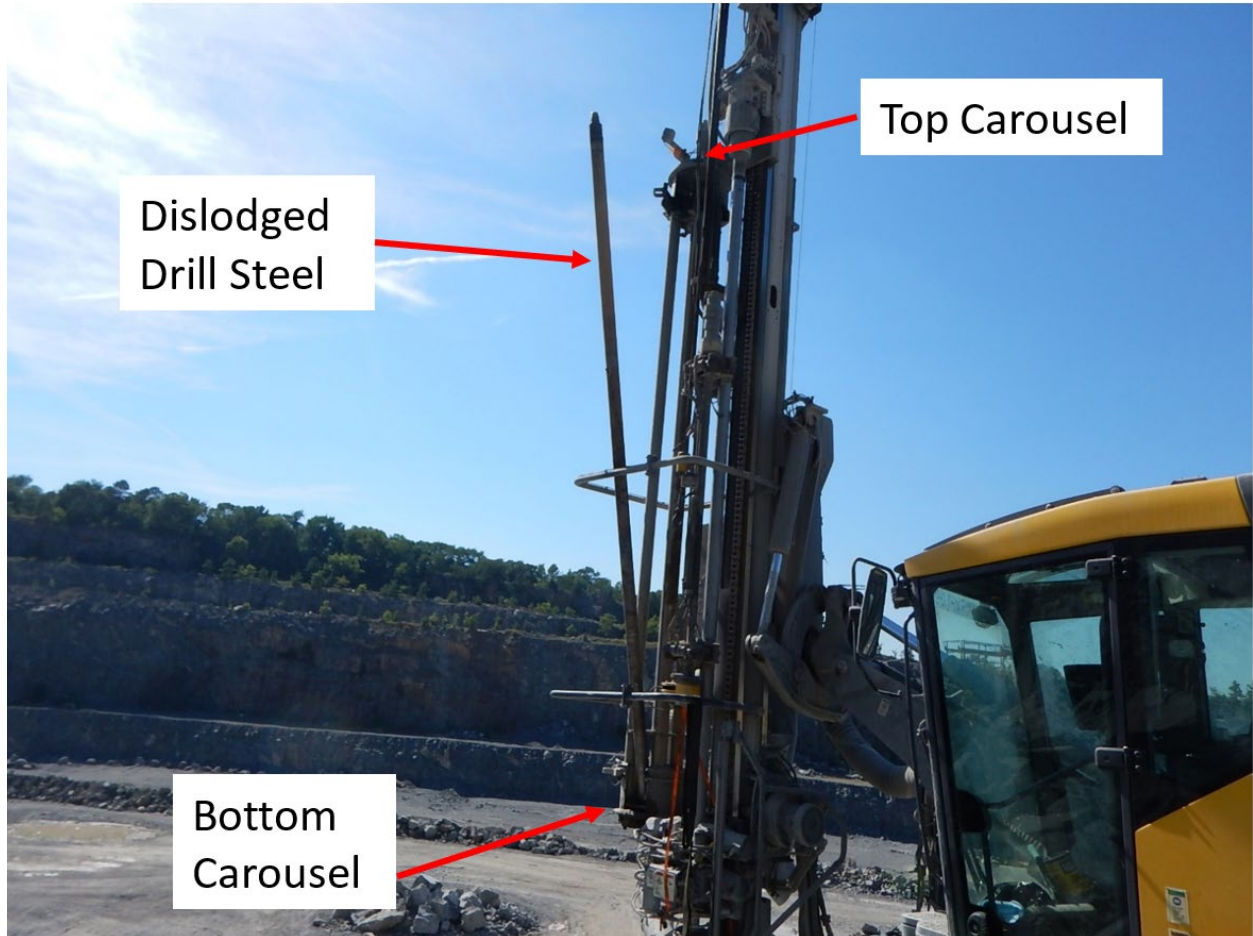
APPENDIX C – Drill Mast with Dislodged Drill Steel

Investigators found the carousel drill steel securing gates open, and a drill steel leaned out of the carousel from the top against the lower railing on the mast. Investigators believe Saul intentionally open the gates by way of the emergency rod handling device, in an effort to relocate the drill steel. The drill steel was in place in the bottom of the carousel, even with both securing gates open (see Appendix C). The winch cable on the drill mast was approximately $\frac{3}{4}$ of the way down the mast and there was a small ratchet style webbed strap tied to the winch manual control located at the drill mast. Based on the location of the winch and associated rigging, investigators concluded that Saul was attempting to move the dislodged drill steel with the winch cable. There was a webbed lifting strap hanging over the upper rail on the drill mast that appeared to be ready to be used in the process as well (see Appendix D). Based on interviews, it was not a common occurrence for the drill steel to come out of the carousel. Investigators believe that Saul was in the process of attempting to relocate a drill steel back into the drill carousel by hand when he fell from the drill mast and over the highwall.
