REPORT OF INVESTIGATION

Underground
(Limestone)

Fatal Machinery Accident
June 20, 2022

Kimballton Plant #1
Lhoist North America of Virginia, Inc.
Ripplemead, Giles County, Virginia
ID No. 44-00082

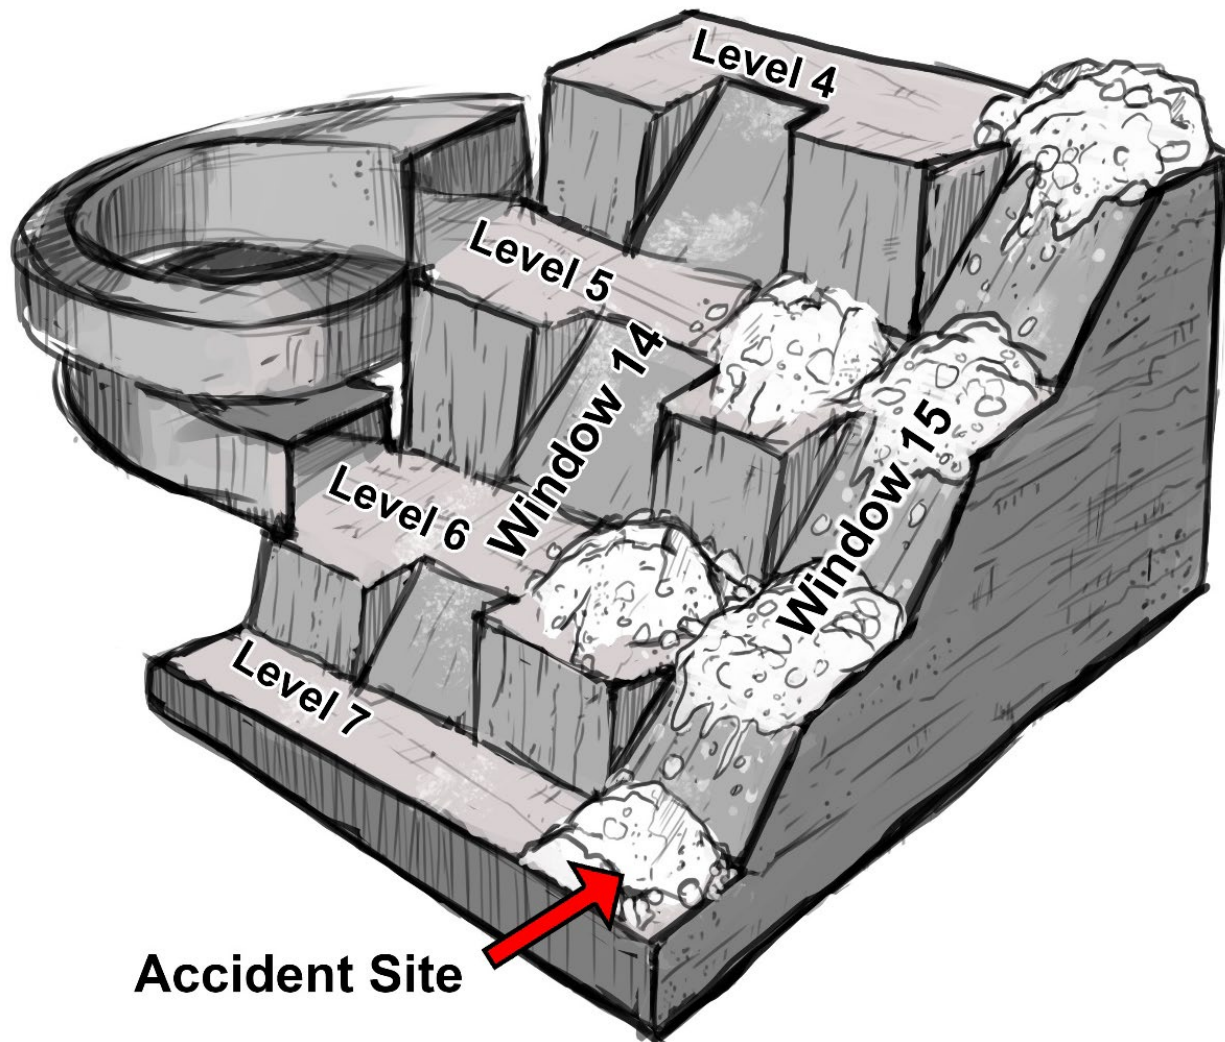
APPENDIX A – Artist Depiction of Windows at the Kimballton Plant #1

The accident occurred at Window 15 on Level 7 of the mine. Windows are openings at irregular intervals that connect the levels together (see Appendix C). Due to the elevation differences between the levels, the windows are sloped. The elevation changes approximately 234 feet from Level 4, the level that material was being cast from, to Level 7. The haul road on Level 7 is 46 feet in width. The width of the windows varies depending on the shape of the pillars.

*Note: This drawing is only meant to illustrate what the term “Windows” are used at the Kimballton Plant #1’s Mine and do not reflect the mine’s actual layout.
