REPORT OF INVESTIGATION

Fatal Fall of Face, Rib, Pillar or Highwall Accident  
March 2, 2022

Maple Springs Mine  
LCT Energy, LP  
Hollisopple, Somerset County, Pennsylvania  
ID No. 36-09973

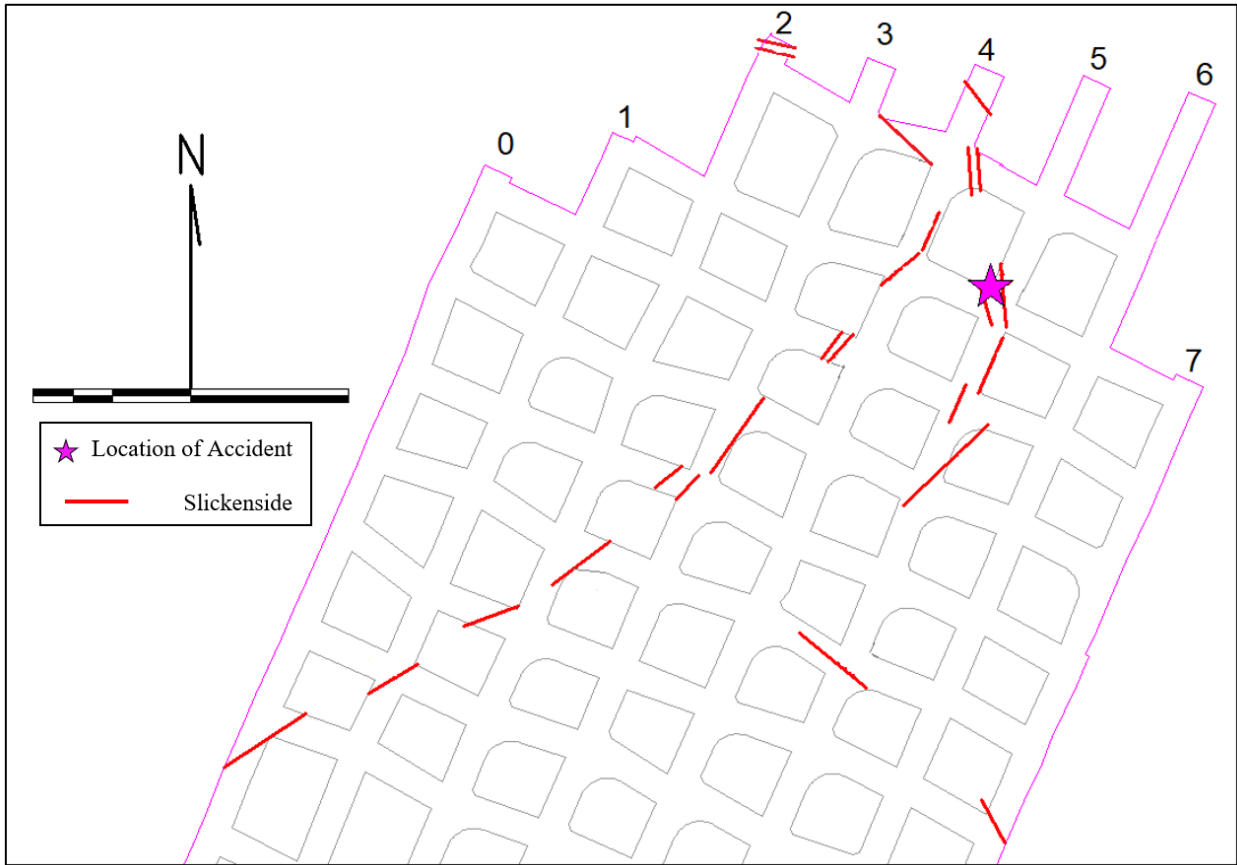
APPENDIX B – Drawing of the Main A Section

The accident occurred in the Main A Section, in the No. 5 entry approximately 210 feet from the working face on the corner of the coal pillar between the No. 4 and No. 5 entries (see Appendix B). The No. 5 entry was mined approximately 18 feet wide, and the depth of cover was about 400 feet at the accident site.

The compaction zone has two sides (see Appendix B). The left side was first encountered in the No. 1 entry about seven crosscuts outby the accident site and the right side was first encountered in the No. 7 entry about five crosscuts outby the accident site. The left and right sides come together within 60 feet of each other at the accident site, increasing the deformation of the roof and ribs. Slickensides weakened the coal seam, although very little sloughing was apparent immediately after the accident. The slickensides were the source of the adverse roof that was removed before the accident.

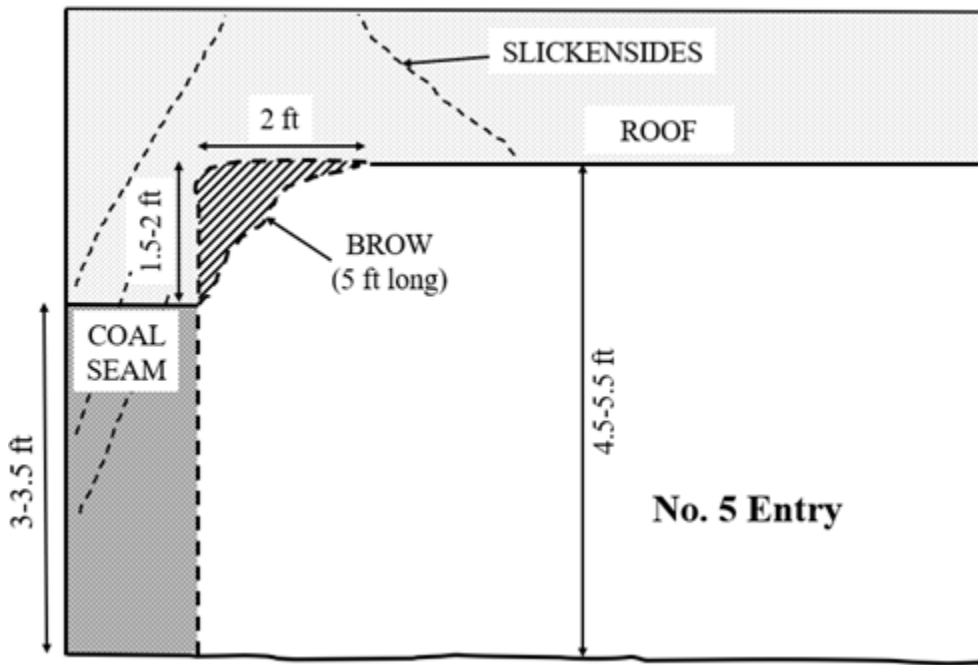
APPENDIX C – Drawing of Rock Brow

The removal of the adverse roof resulted in a slightly arched entry profile, which in turn created a rock brow that was not rectangular or stair-stepped like a typical rock brow, but instead was angled at about 45 degrees from the top of the coal rib to the flat roof (see Appendix C). The rock brow fell when an unseen vertical tension fracture developed at the back of this rock brow above the coal rib line. Investigators estimated that the rock brow measured 52 inches long, 24 inches wide, and 18 to 24 inches thick.

The on-shift and preshift examinations were made on the Section as required. No hazardous conditions were recorded in relation to the ribs and roof for the day of the accident or the two preceding shifts. Based on interviews and observations at the accident site, the rock brow that fell was wedge-shaped rather than the rectangular shape that is typical of rock brows. The rock brow did not appear to have any visible cracks or separations that would have indicated that it was susceptible to falling out at the time of the accident (see Appendix C).

Corrective Action: The mine operator trained all miners to identify this specific type of rock brow. The mine operator proposed, and MSHA approved, an amendment to their roof control plan that addresses adequately supporting ribs and rock brows in areas that have loose material in the roof due to adverse roof and rib conditions. When rock brows are encountered during mining they will be removed, if possible. If a rock brow cannot be removed, it will be secured during the roof bolting cycle. The roof bolters will be informed of the rock brow before they enter the cut. If it cannot be supported, the rock brow will be dangered off immediately and recorded by the end of the shift. The mine operator trained all miners on this amendment to their roof control plan.

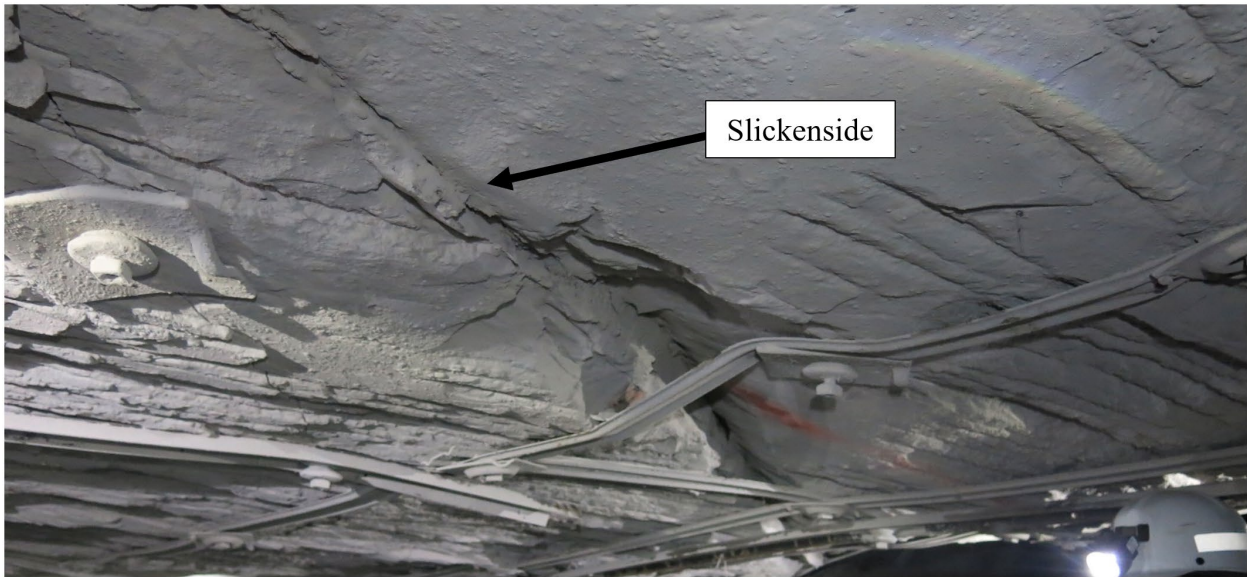
APPENDIX D – Slickenside Visible in Roof

The Section had advanced by eight crosscuts during two months of mining into a geological feature known as a compaction zone. A compaction zone is an area where shale and coal deform over time beneath a body of sandstone. The compaction zone in Main A hosts a series of slickensides (polished fault surfaces) that deformed the roof and ribs (see Appendix D).
