REPORT OF INVESTIGATION

Fatal Drowning Accident
March 22, 2022

AMI Silica LLC
AMI Silica LLC
Hixton, Jackson County, Wisconsin
ID No. 47-03742

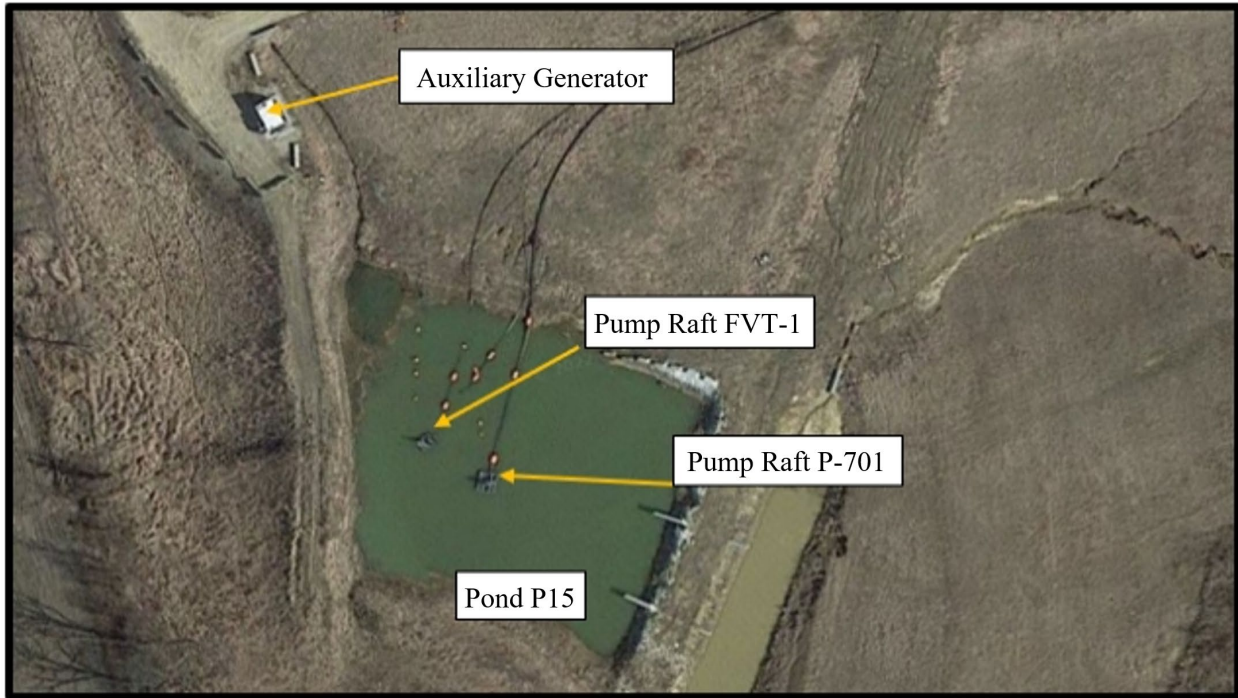
APPENDIX B – Aerial View of Pond P15 Stormwater Retention Pond

The accident occurred at pump raft FVT-1, located on Pond P15 (see Appendix B). Pond P15 is a retention pond. The pond depth ranges from 8 to 11 feet and is approximately 145 feet wide, and 180 feet long. Water from Pond P15 is used to replenish process water when needed.

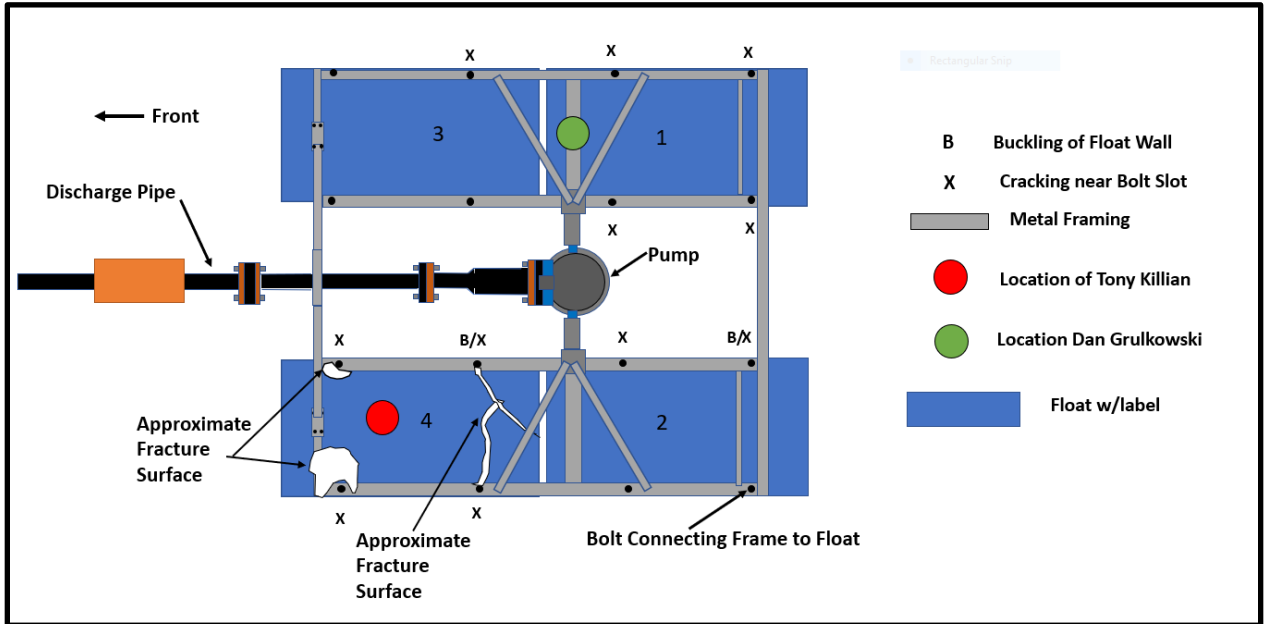
APPENDIX C – Plan View Diagram of Pump Raft FVT-1

The pump raft involved in the accident was a Turbi-Float Floating Pump System that was manufactured by Canfield Custom Pumps (Canfield). The floating pump system consisted of an Emerson 60-horsepower motor, a Canfield pump with a 500 gallons per minute capacity, a steel frame, and four floats manufactured by Carolina Waterworks, Inc. The pump raft was placed into service during the summer of 2017 and was in Pond P15 for five winters. Each plastic float was connected to the steel frame of the pump raft by four, 3/8-inch diameter by 4.7-inch-long bolts that passed through the frame and the slot in the top flange. A 1.75-inch diameter flat washer and nut on the underside of the flange secured the floats to the frame. The plastic floats were model E900, and each were two feet wide, two feet tall, and four feet long (see Appendix C).

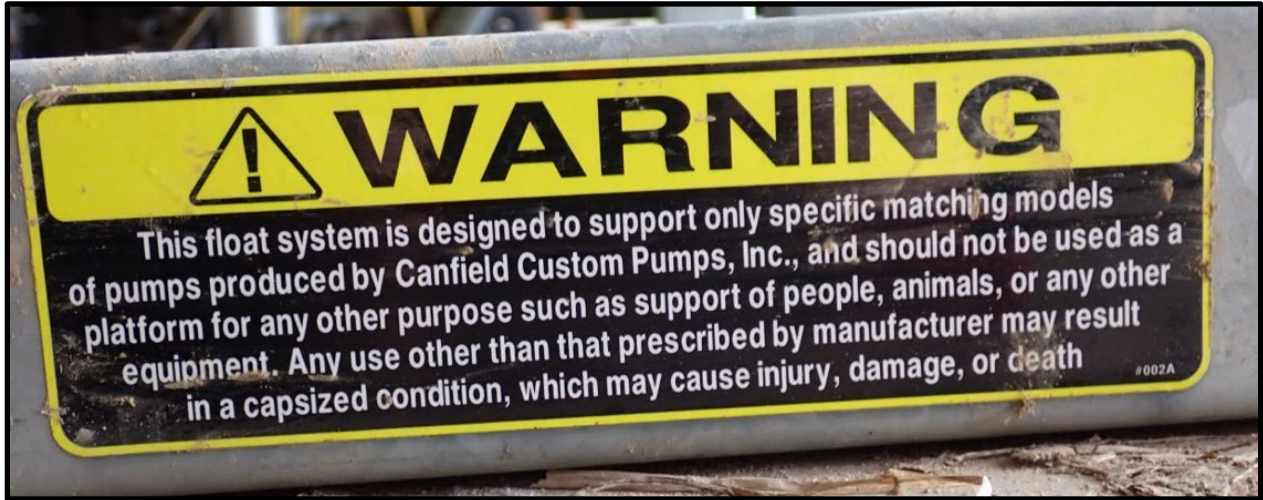
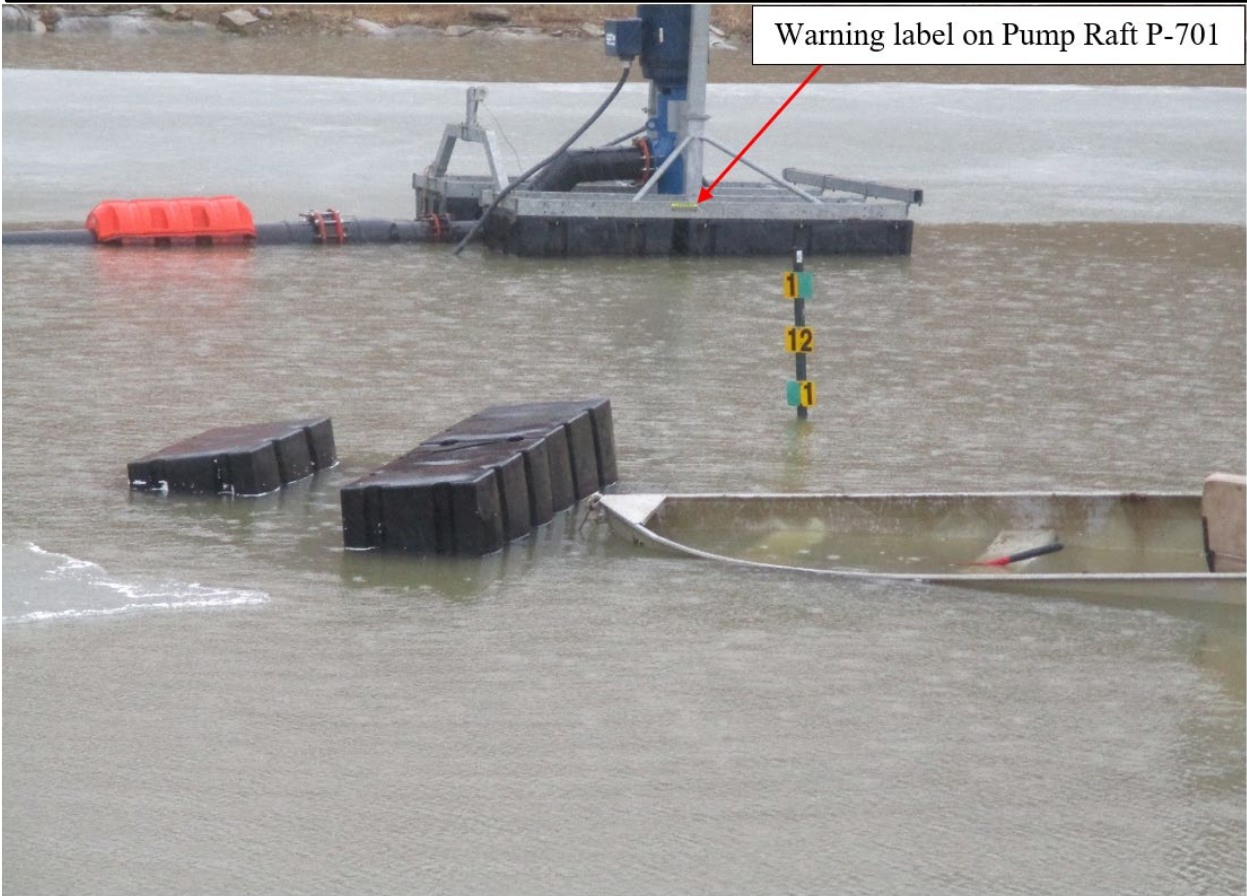
APPENDIX D – Pump Raft FVT-1 Warning Label

A warning label on each side of the pump raft states, “WARNING This float system is designed to support only specific matching models of pumps produced by Canfield Custom Pumps. Inc., and should not be used as a platform for any other purpose such as support of people, animals, or any other equipment (see Appendix D). Any use other than that prescribed by the manufacturer may result in a capsized condition, which may cause injury, damage, or death.” The warning labels are available to be viewed by anybody accessing the raft. According to statements by mine management, the mine operator previously brought the pump raft to shore to perform maintenance or repairs. The pump raft was used beyond the design capacity intended by the manufacturer when the miners used it as a working platform. Investigators determined that this contributed to the accident.

Corrective Action: The mine operator developed a new written procedure requiring miners to remove pump rafts from the water before performing maintenance or repairs. The mine operator trained all miners on the procedure. Additionally, the mine operator will comply with all warning labels and follow the known safe procedure.

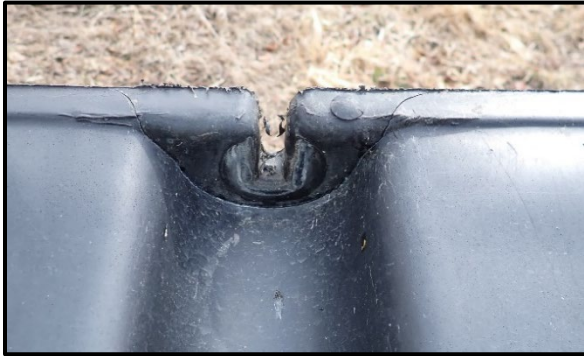
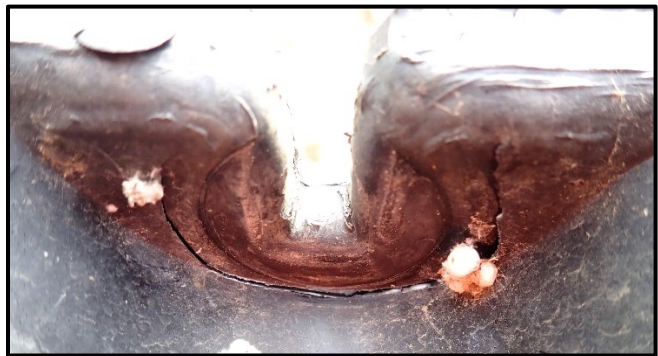
After the raft was removed from the water, investigators took custody of sections of the pump raft’s plastic floats and turned them over to MSHA Technical Support (TS). MSHA TS examined the materials and determined that pre-existing cracks at the bolt connection locations on the four floats (see Appendix E) were either:

1. Caused by high stress in the plastic due to ice pressure when it had been frozen in place each winter since it was purchased in 2017, or
2. Caused by a combination of the ice pressure and overtightening of the anchor bolts during installation or maintenance.

Float 1 – Plastic shell cracked at the rear inner and front inner bolt locations.

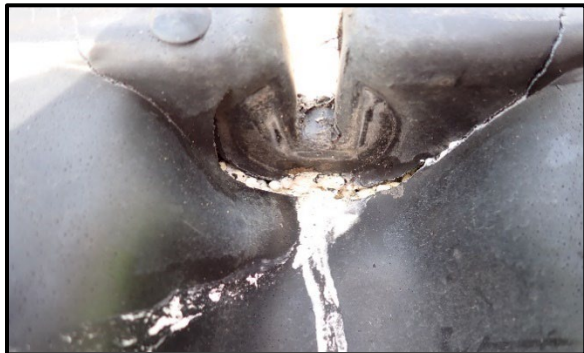
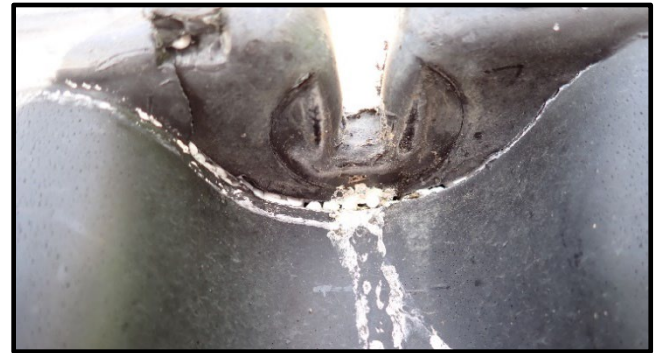
Float 1 – Plastic shell cracked at the front outer and rear outer bolt locations.

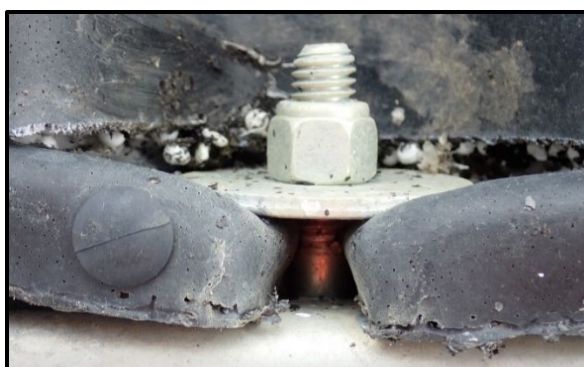
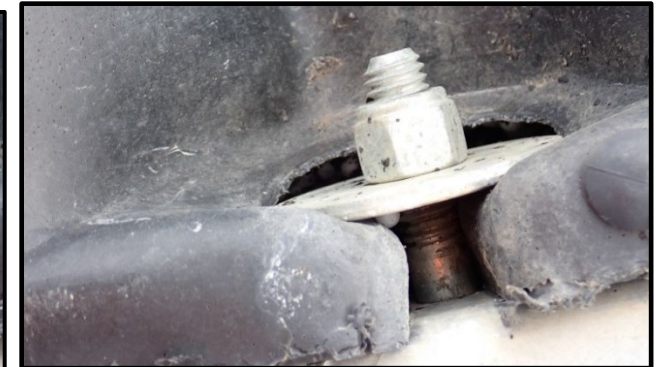
Float 2 – Plastic shell cracked at the front inner and rear inner bolt locations.

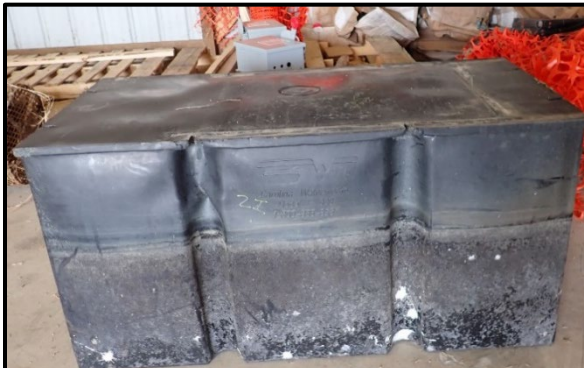
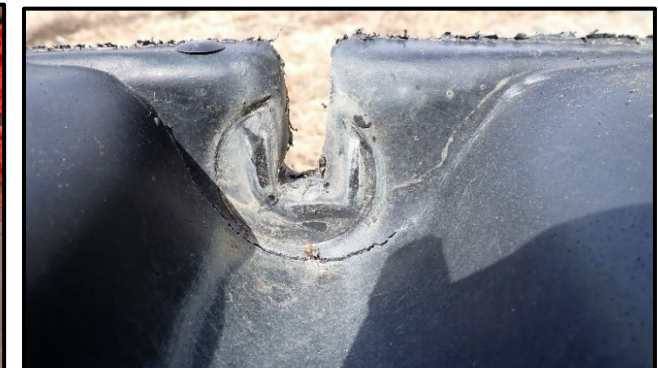
Float 2 – Plastic shell sidewall buckled at rear inner and Float 3 – Plastic shell cracked at rear outer bolt locations.

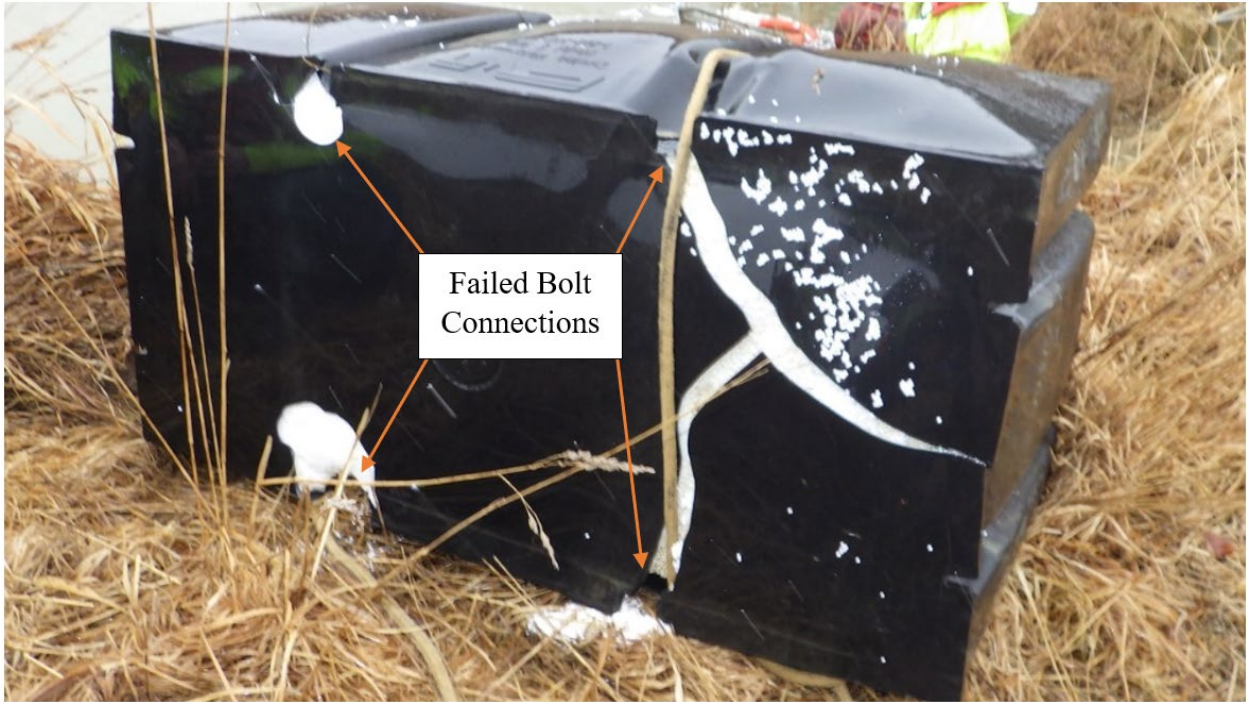
APPENDIX F – Float 4

When Killian stood on Float 4 of pump raft FVT-1 to connect the discharge line to the floating pump system, his weight and the weight of the discharge line that he was supporting caused the pre-existing cracks on Float 4 to propagate and the four bolt connections to fail (see Appendix

F). Float 4 dislodged from beneath the frame and the pump raft FVT-1 capsized, trapping Killian underneath.
