REPORT OF INVESTIGATION

Fatal Machinery Accident
March 4, 2022

Brunswick Canyon Materials LLC
Brunswick Canyon Materials LLC
Carson City, Carson City County, Nevada
ID No. 26-02007

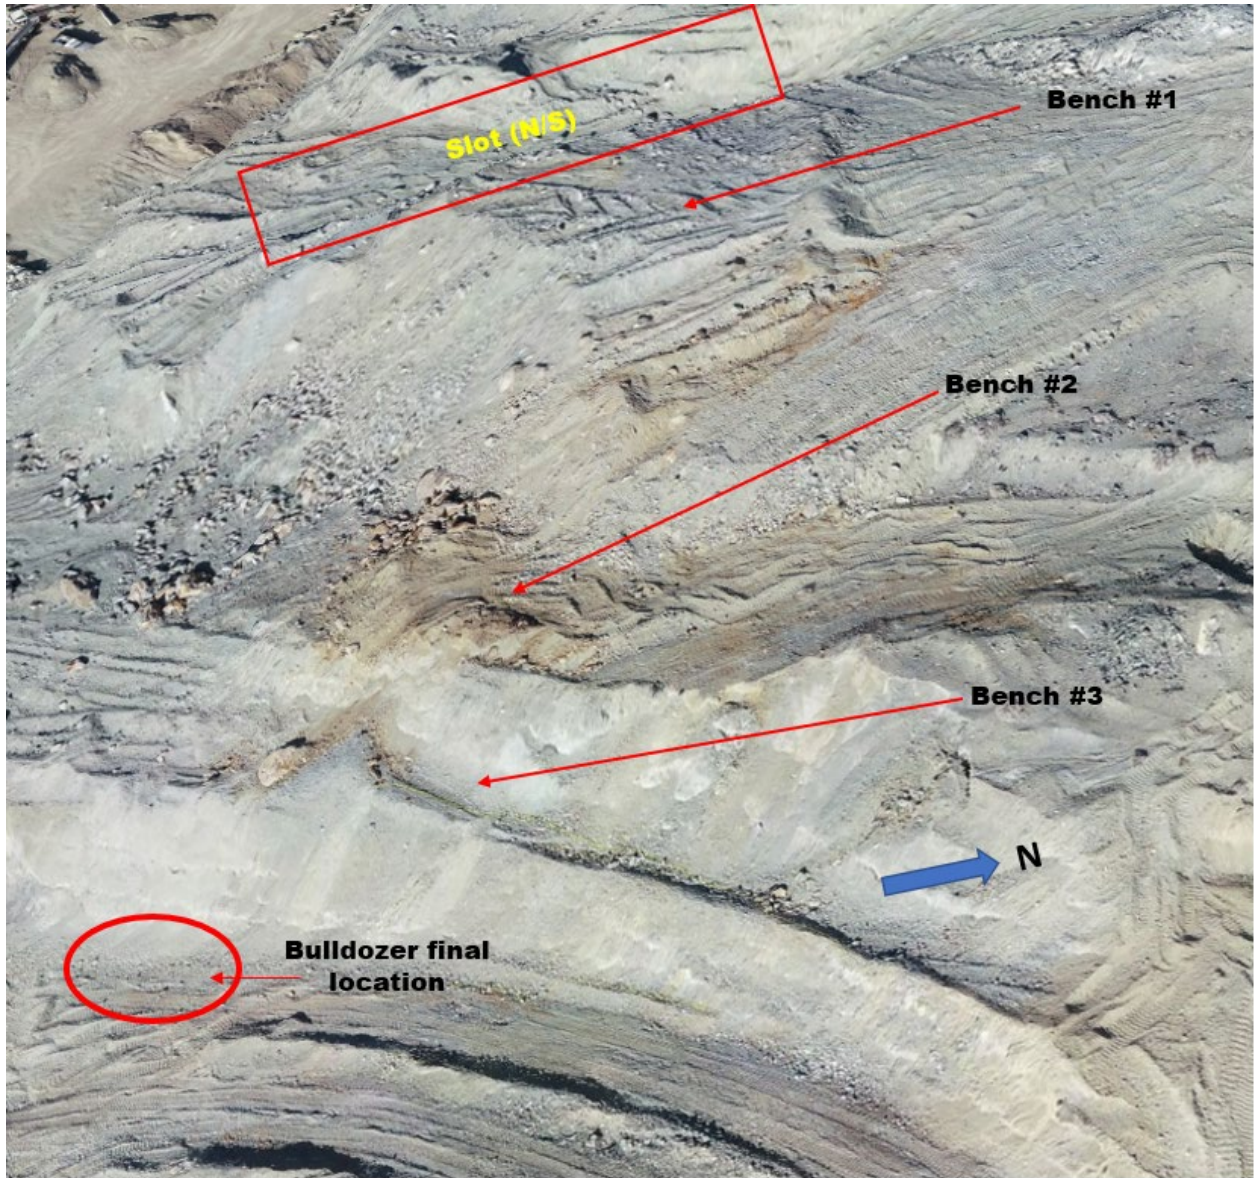
APPENDIX B – Aerial View of the Highwall

The accident occurred at the base of the highwall, north of the quarry floor (see Appendices B and C).

Bench #1, approximately 200 feet above the quarry floor, was a wide sloping area and with berms. Covington pushed the berms over the edge of Bench #1 prior to the accident. Investigators could not determine the reason. Bench #2, 156 feet above the quarry floor, measured 26 to 29 feet wide, and did not have berms. Bench #3, 117 feet above the quarry floor, measured 17 feet wide, and did not have berms. Benches #2 and #3 were covered in loose sand and gravel. The bulldozer was 9.2 feet wide, 26.8 feet long, and the blade was 13 feet wide. Covington did not have sufficient room to safely operate the bulldozer on Benches #2 and #3. The mine operator did not barricade to prevent the bulldozer operator from going to Bench #2 or post warning signs to indicate that the bulldozer could not be safely operated on Bench #2. Investigators determined that this contributed to the accident.

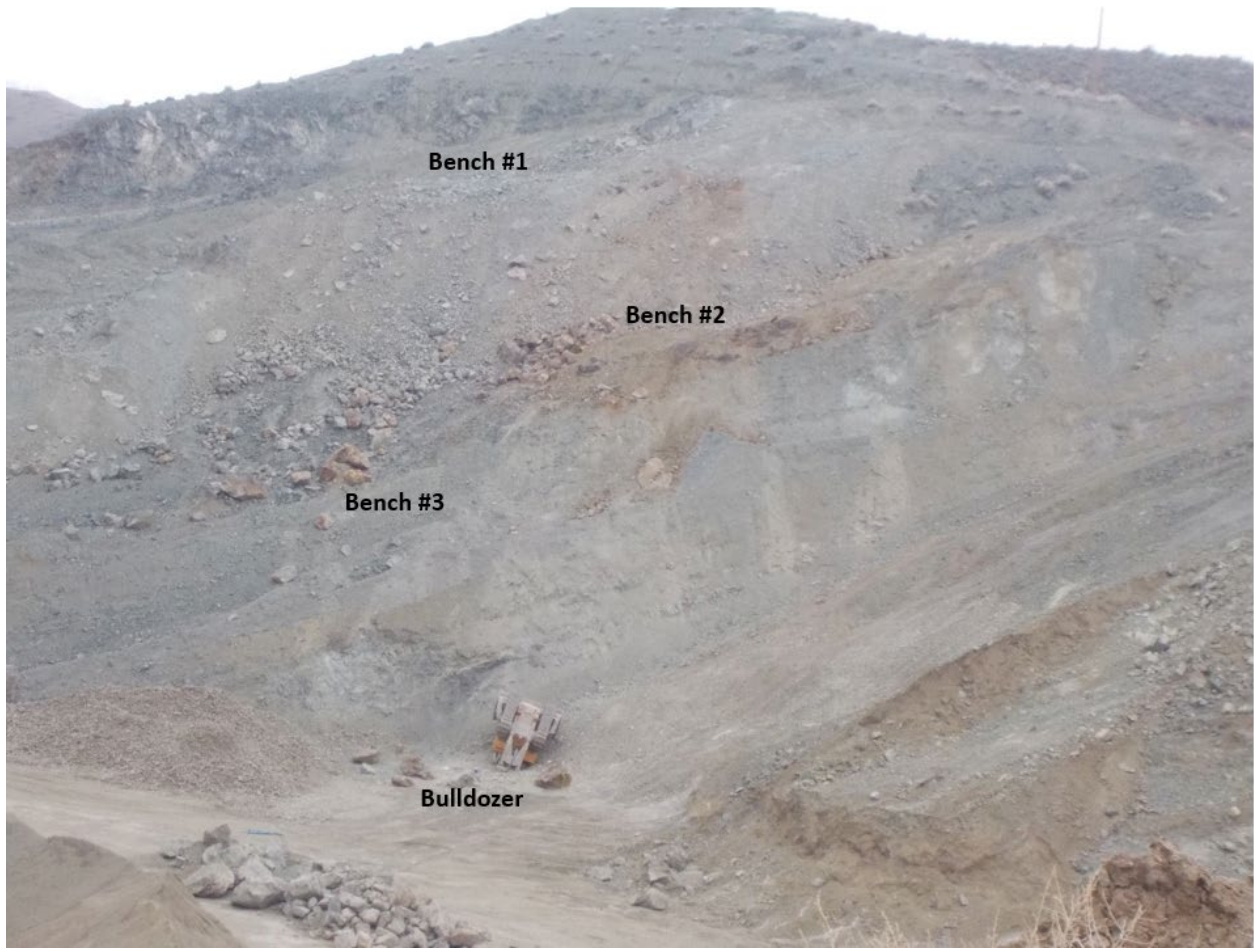
APPENDIX C – Side View of the Highwall and Bulldozer

On March 4, 2022, a fatal accident occurred at this mine when the Liebherr PR 756XL bulldozer, Company #BE6J56, SN 16140, traveled over the highwall. The bulldozer was pushing a large rock off of the edge of Bench #2 to Bench #3 below. The bulldozer followed it, landing on the rock with the blade. The bulldozer traveled over the highwall and tumbled approximately 65 feet to the quarry floor, resulting in the death of the bulldozer operator. The mine operator did not assure that the bulldozer operator maintained control of the bulldozer.
