REPORT OF INVESTIGATION

Fatal Engulfment Accident
November 5, 2022

Knoxville Cement Plant
CEMEX Construction Materials Atlantic, LLC
Knoxville, Knox County, Tennessee
ID No. 40-00840

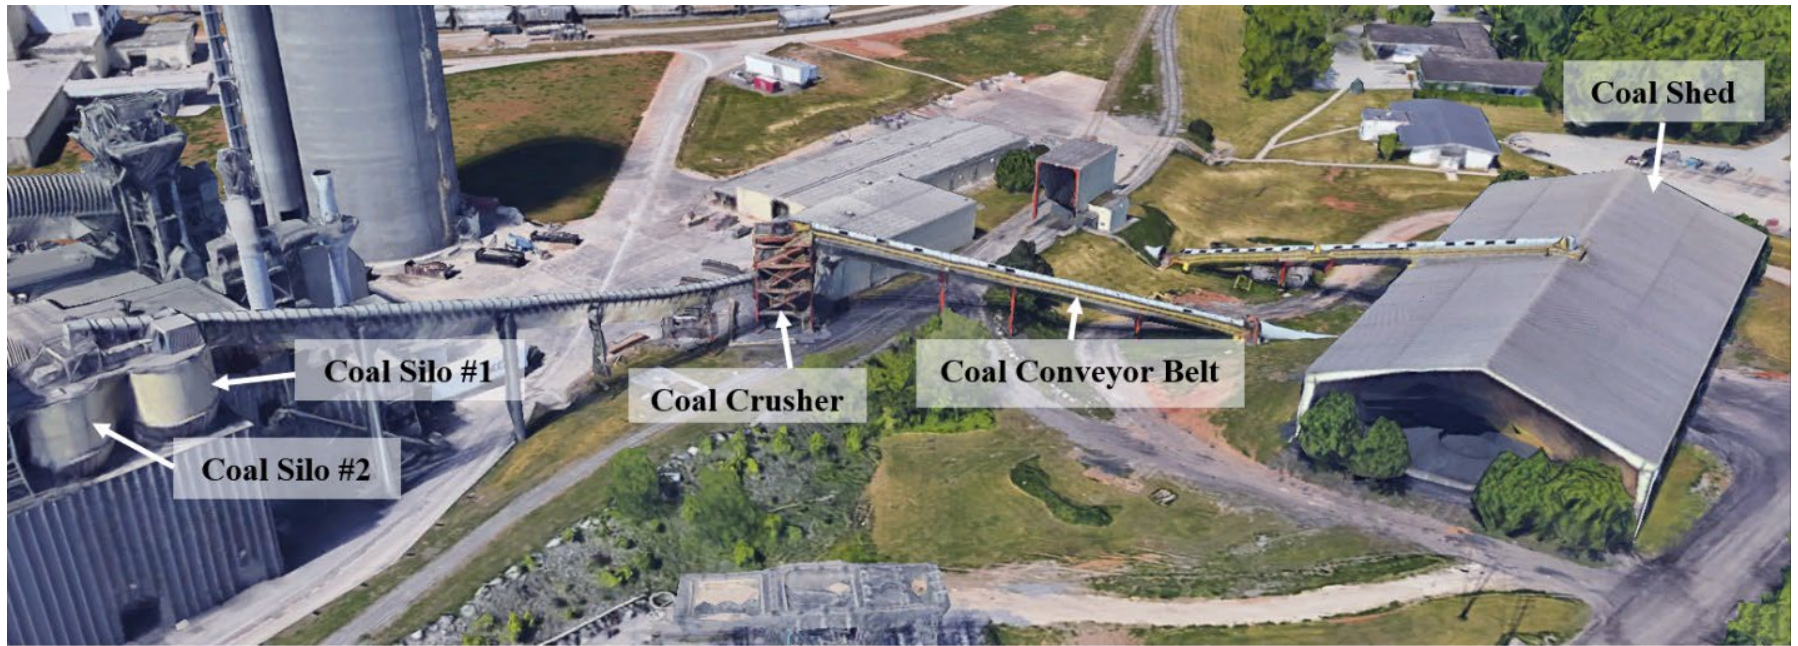
APPENDIX B – Aerial View of the Accident Location

The accident occurred at the coal shed (see Appendix B). The grizzly is in the center of the south side of the coal shed (see Appendix C).

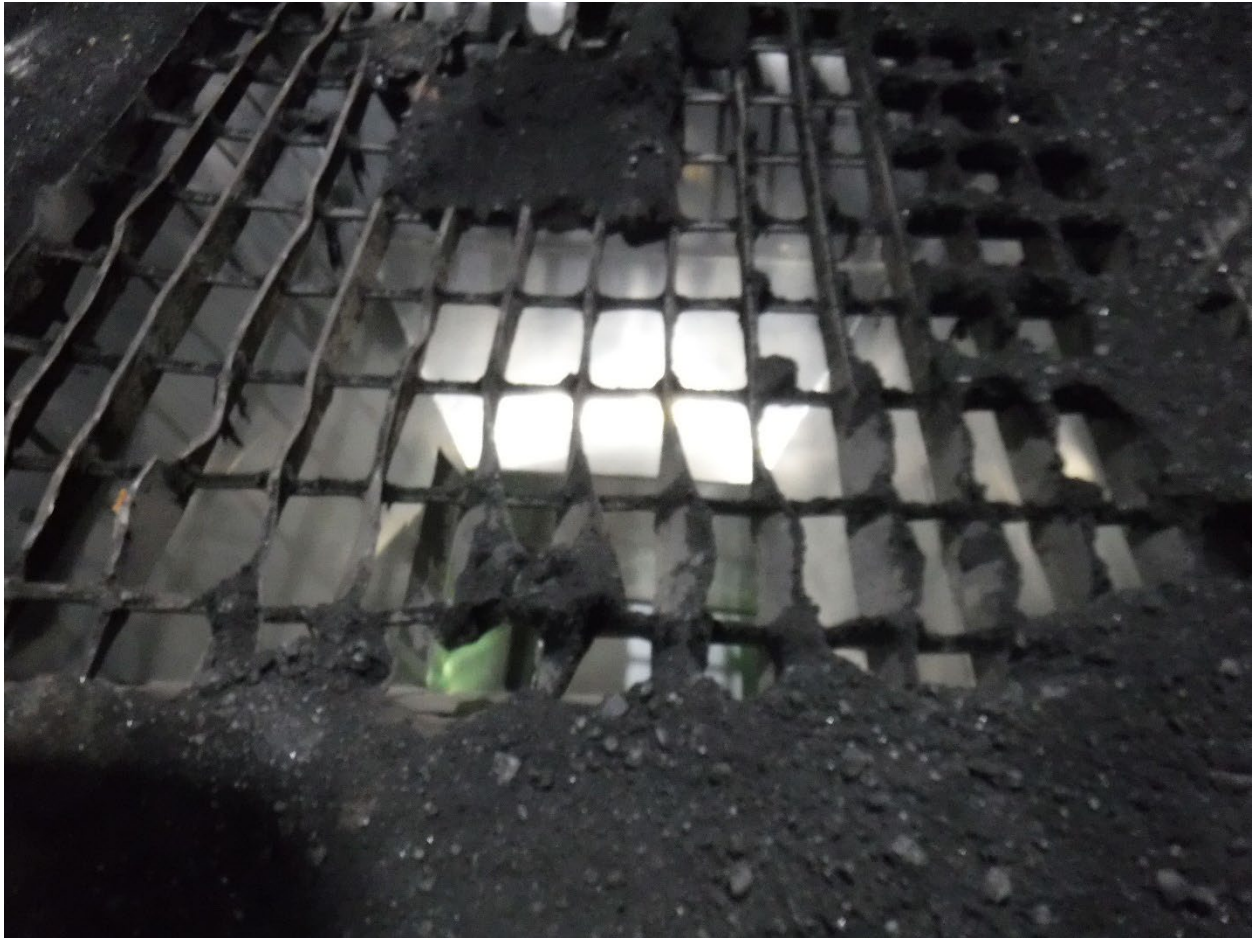
APPENDIX C – Grizzly in the Floor of the Coal Shed

The light on the ceiling of the coal shed that marks the grizzly's location was not working at the time of the accident. There were no other signs indicating the location of the grizzly. The coal did not feed uniformly through the grizzly and into the hopper because it was fine and damp, making it susceptible to binding and bridging. Bridging occurs when a surface layer of coal remains intact as coal below the surface layer falls through the grizzly, thereby creating a hidden cavity below the surface layer of coal (see Appendix E). During the investigation, the investigator conducted four simulations of loading coal over the grizzly with the front-end loader. As coal entered the hopper, the coal bridged over the grizzly each time, creating a void. The investigator determined that a void was created after the belt conveyor was restarted at 3:05 p.m.

Corrective Action: The mine operator developed and implemented a new written procedure requiring a supervisor to conduct a minimum of two workplace examinations of the coal shed each shift. The mine operator trained all supervisors on this procedure. The mine operator installed a light that illuminates when the underground belt and feeder are running. The mine operator repaired the light over the grizzly and installed a reflective ball that is used to mark the location of the grizzly. As an additional precaution, the mine operator installed cameras to monitor the coal shed.

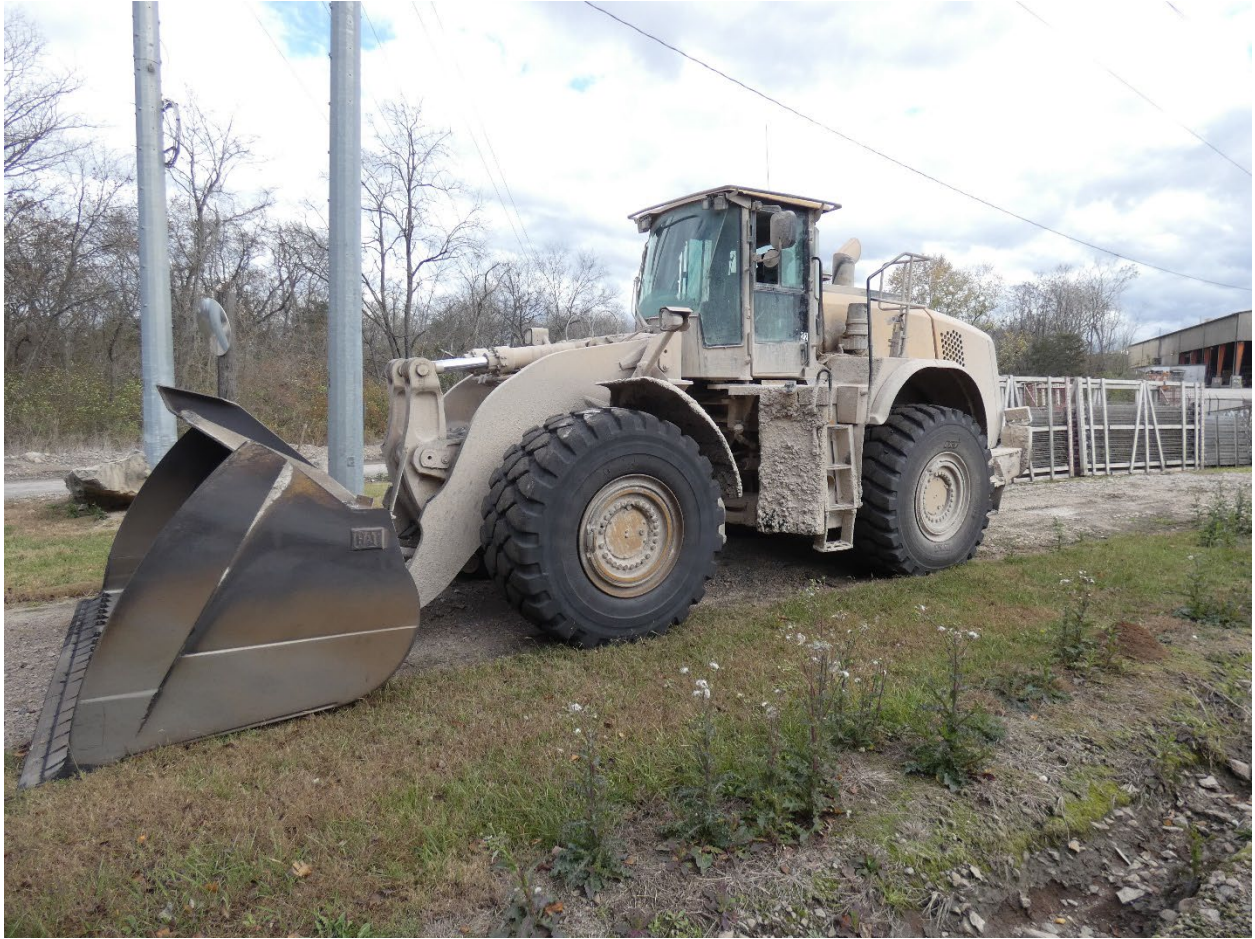
APPENDIX D – Caterpillar 980K Front-End Loader

Mitchell was operating a Caterpillar 980K front-end loader, company No. 22. The investigator found no defects on the front-end loader that contributed to this accident.

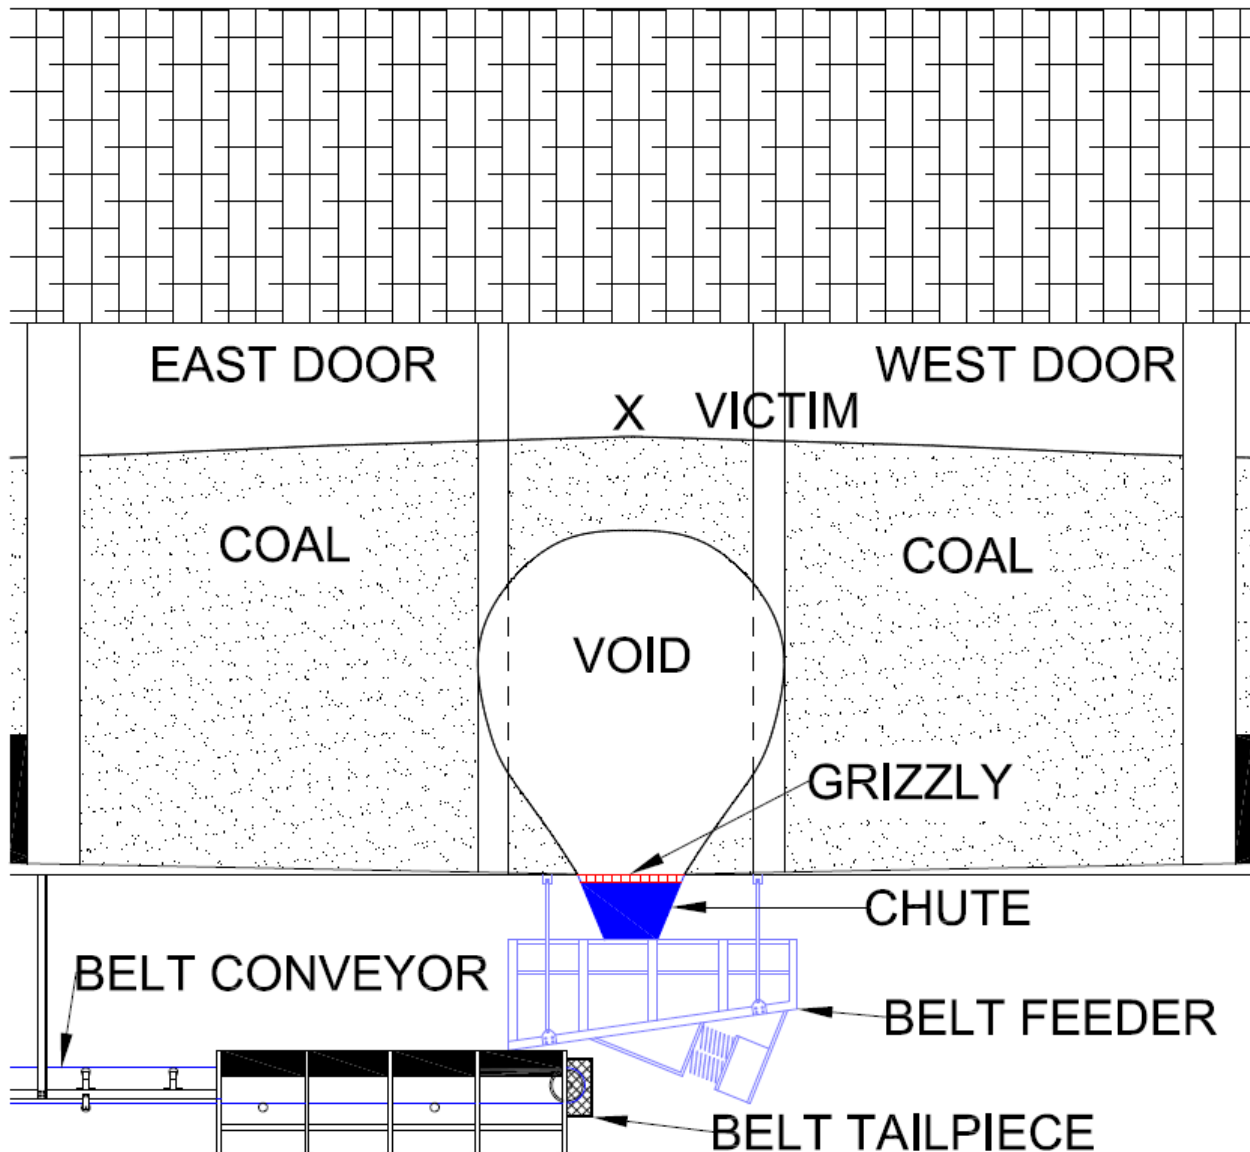
APPENDIX E – Profile View of Bridging

While assigned to load coal onto the grizzly using a front-end loader, the production utility miner exited the front-end loader and positioned himself on the coal stockpile over the grizzly. At the time of the accident, the coal over the grizzly was approximately 14 feet high and connected to the coal stockpiles on each side of the coal shed. The coal did not feed uniformly through the grizzly and into the hopper because it was fine and damp, making it susceptible to binding. As coal gravity-fed through the grizzly and into the underground hopper, the coal stockpile became bridged over the grizzly. Bridging occurs when a surface layer of coal remains intact as coal below the surface layer falls through the grizzly, thereby creating a hidden cavity below the surface layer of coal.

Corrective Action: The mine operator developed and implemented new written coal shed procedures for working in the coal shed. These procedures address loading coal on the grizzly and what to do if a miner must exit the front-end loader, which includes communication procedures. The procedures prohibit accessing the grizzly on foot, require piles to be maintained less than six feet high, and require a center travelway that will be kept clear of coal at a specified distance. Pedestrians are not allowed in the coal shed unless additional precautions are taken, as listed in the safety rules. Miners in the coal shed must always have two-way communication on their person.

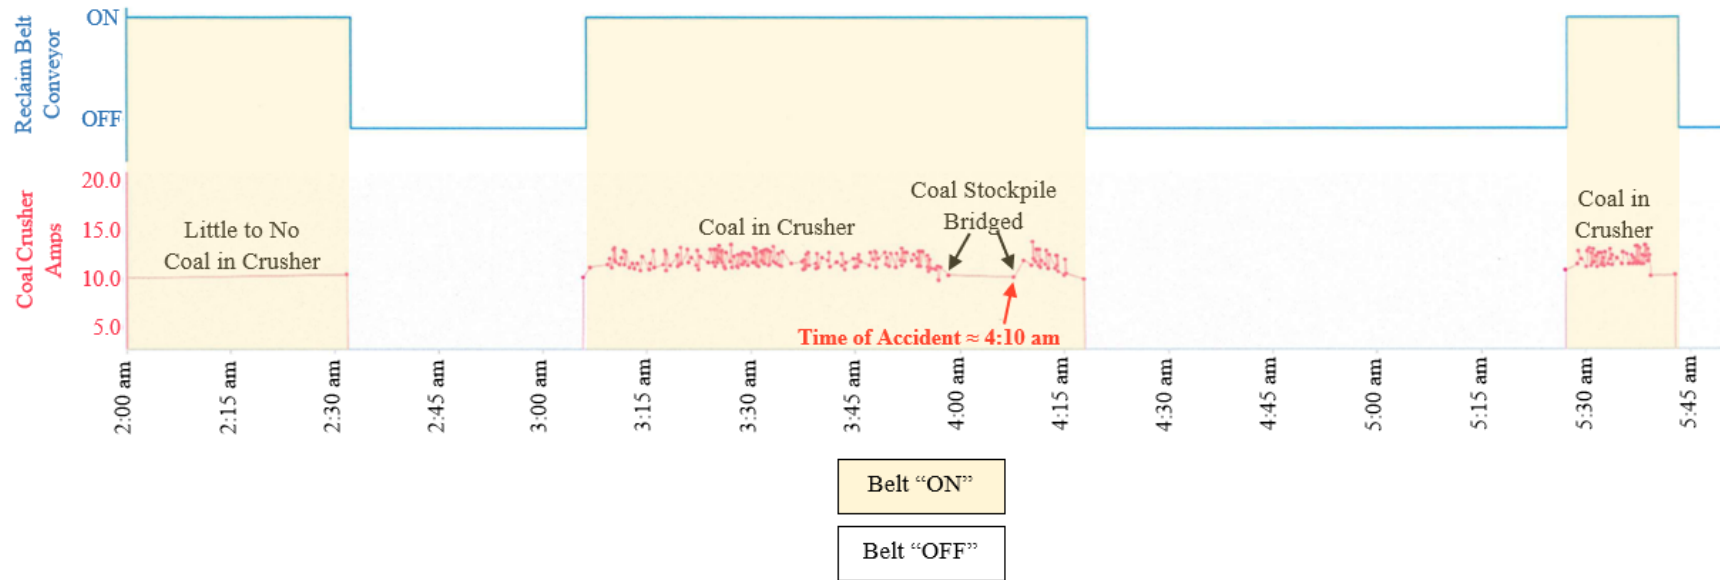
APPENDIX F – Belt Conveyor Data

The investigator obtained a printout of data from the Programmable Logic Controller (PLC), which shows the amperage (flow of electric current) of the crusher (see Appendix F). An increase in crusher amperage correlates to a loaded belt conveyor. The PLC data was used to: 1) corroborate interview statements, 2) determine the time when the coal bridged over the grizzly, and 3) determine the time that the accident occurred. The data indicates the coal belt was running and loaded with material at 3:20 a.m., which coincides with the conversation between Mitchell and Tackett. The amperage dropped at 4:00 a.m., indicating that the conveyor belt was not loaded, and coal had bridged over the grizzly. This time aligns with when Mitchell was heard asking Tackett if he was getting coal on the belt. At 4:10 a.m., the amperage increased. The investigator determined Mitchell walked over the bridged coal stockpile at this time, causing the bridge to collapse and engulf him.

Bottom Line (Red) represents the amperage reading from the crusher motor. When “ON” the amperage runs around 10 Amps with little to no material in the crusher. When the crusher receives material, the amperage readings will increase because of the additional stress placed on the motor.
