REPORT OF INVESTIGATION

Fatal Electrical Accident
September 1, 2022

Coalburg Tunnel Mine
Kanawha Eagle Mining, LLC
Winifrede, Kanawha County, West Virginia
ID No. 46-08993

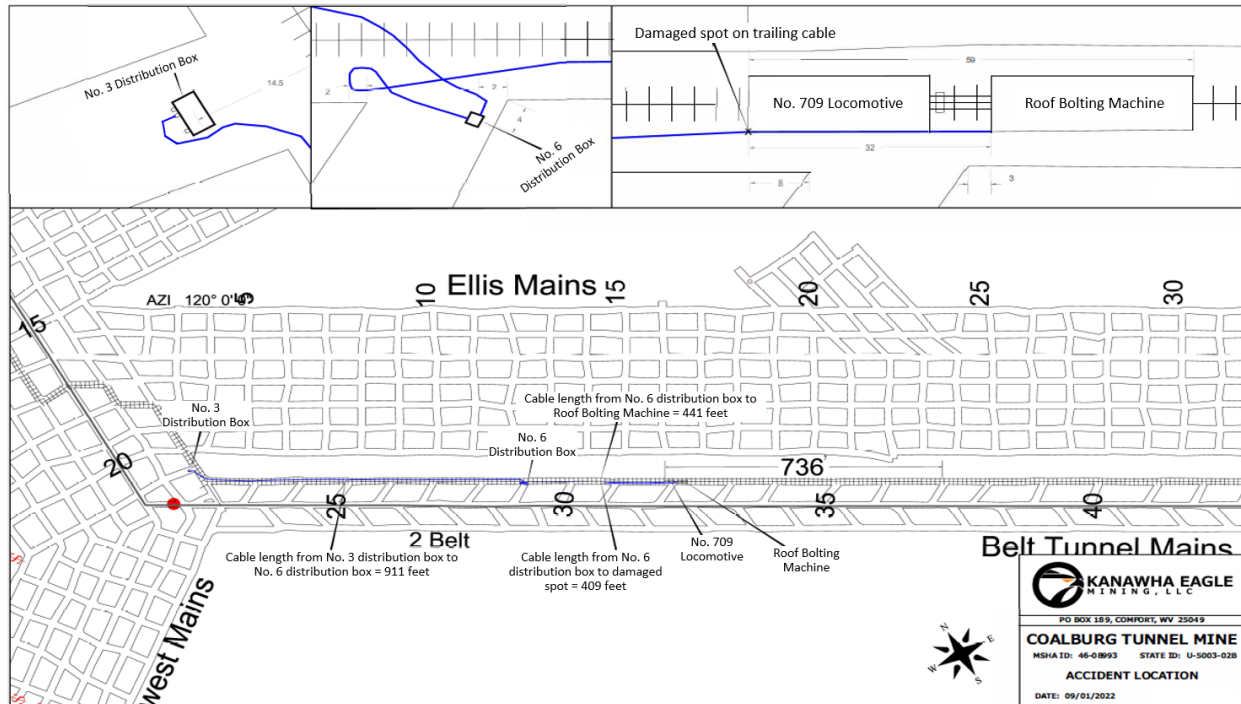
APPENDIX B – Drawing of Accident Scene

The accident occurred at the No. 32 crosscut of the No. 2 belt line in the track entry (see Appendix B).

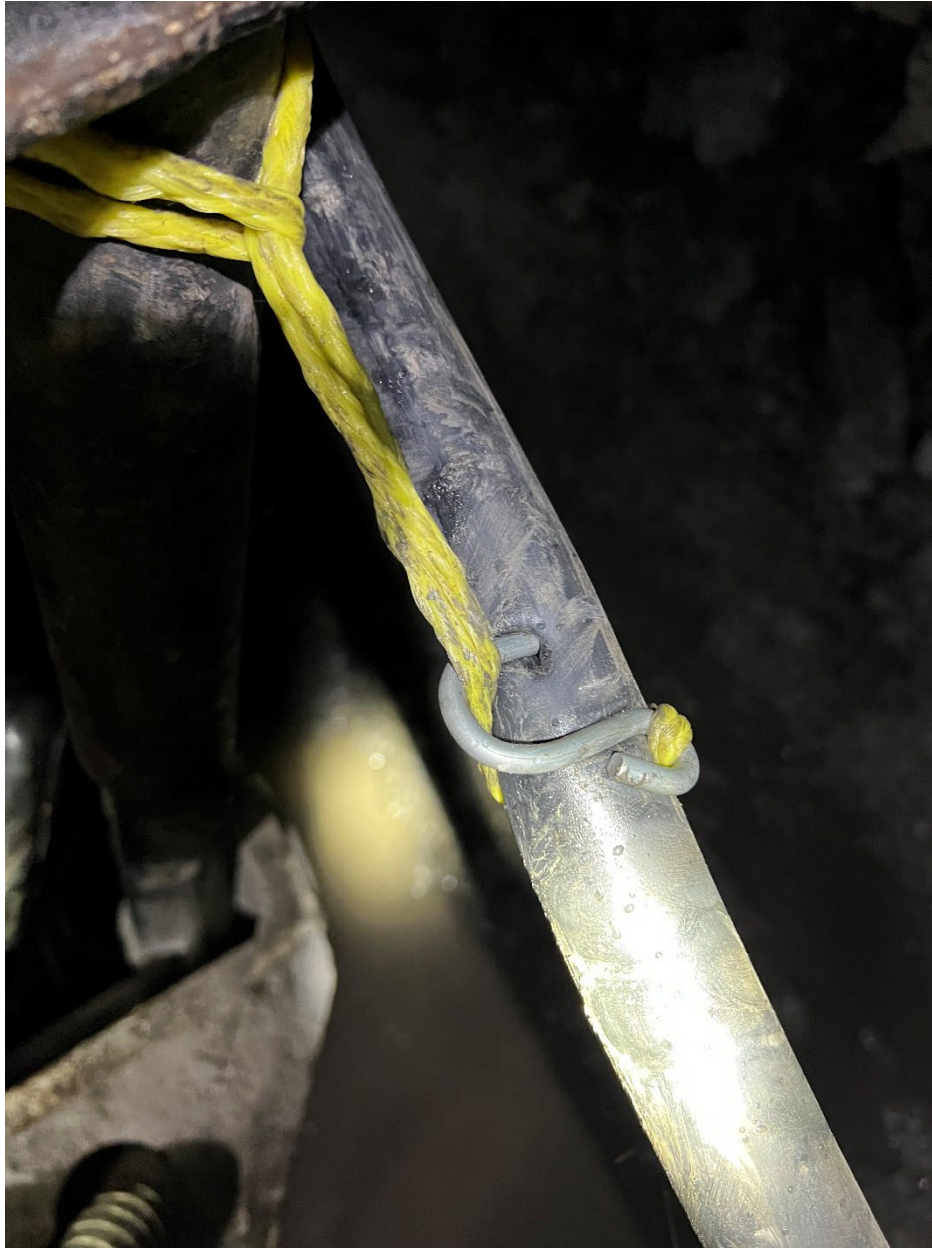
APPENDIX C – Trailing Cable Punctured by Metal S-Hook

The trailing cable supplying power to the roof bolting machine was a Tiger Brand No. 2 GGC 480-Volt Cable. Investigators examined all 700 feet of the trailing cable and found no other damaged areas besides that caused by the metal S-hook. The metal S-hook punctured the trailing cable's outer jacket and inner conductor insulation of the red phase lead, which contributed to the accident (see Appendix C). Cable pull straps were available for use at the time of the accident, however, these straps were not used (see Appendix D). Investigators determined that the red phase lead was energized with 290 volts, phase to ground (voltage measured between a phase lead and the neutral ground), at the time of the accident.

On September 1, 2022, a fatal accident occurred when a roof bolter contacted an energized 480-volt trailing cable. The mine operator did not fully protect the Fletcher DDR-13-A roof bolting machine's energized 480-volt AC cable from damage. A rope hanger, comprised of a nylon web cloth with a single metal S-shaped hook fastened to the end, was used to pull up the excess trailing cable and secured it to the No. 709 Brookville 12-Ton Locomotive Model 1260B's canopy. The metal S-shaped hook punctured the outer jacket of the trailing cable and inner conductor insulation of the red phase lead. The roof bolter contacted the energized metal S-shaped hook and received a fatal electrical shock.

Corrective Action: The mine operator developed and implemented a new written procedure for pulling trailing cables with a more suitable type of non-metallic pull rope, such as a cable pull strap, which fully protects the cable. The mine operator trained all miners on this new procedure.

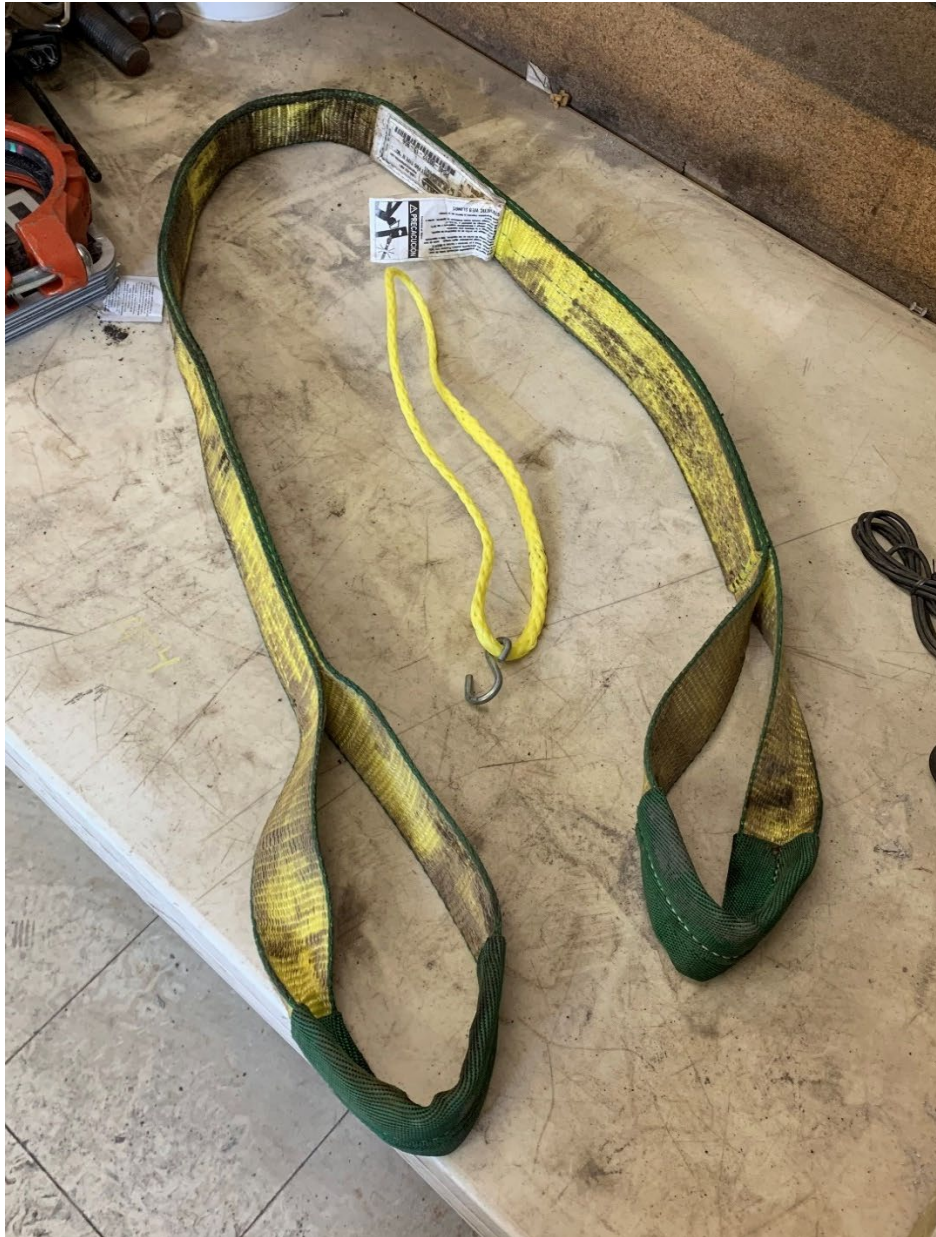
APPENDIX D – Cable Pull Strap

task training on the Brookville 12-Ton Locomotive Model 1260B. The mine operator provided two cable pull straps that were located on top of the No. 709 locomotive at the time of the accident but were not used. According to interviews, none of the miners had been trained on how to use the cable pull straps or told that metal hooks should not be used to pull the trailing cables.

Ball's task training did not include proper handling of the roof bolting machine's trailing cable using pull straps. Investigators determined that this lack of training contributed to the accident.

Corrective Action: The mine operator revised their training plan to include the new written procedure for pulling trailing cables and will provide this training to all miners before they handle energized cables.
