REPORT OF INVESTIGATION

Fatal Engulfment Accident
September 28, 2022

Spanish Springs
Pyramid Materials, Inc
Sparks, Washoe County, Nevada
ID No. 26-00803

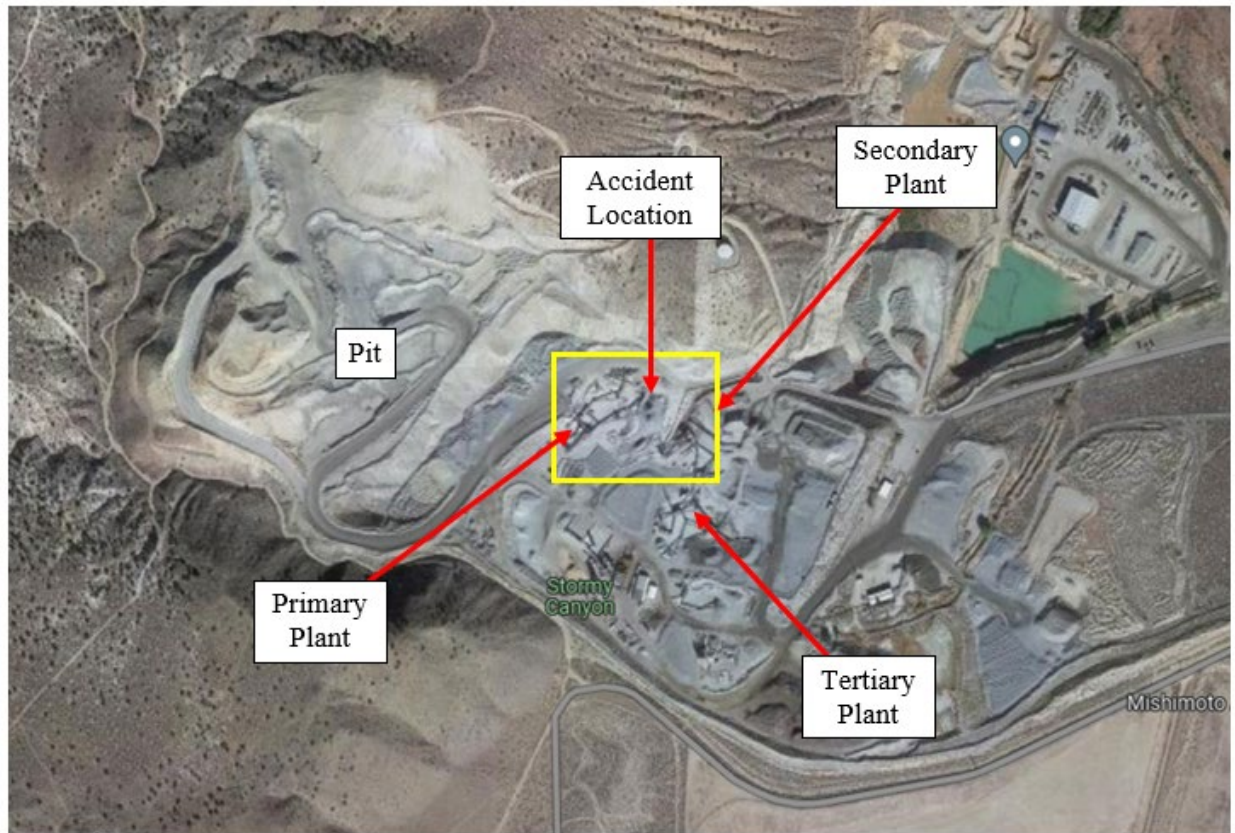
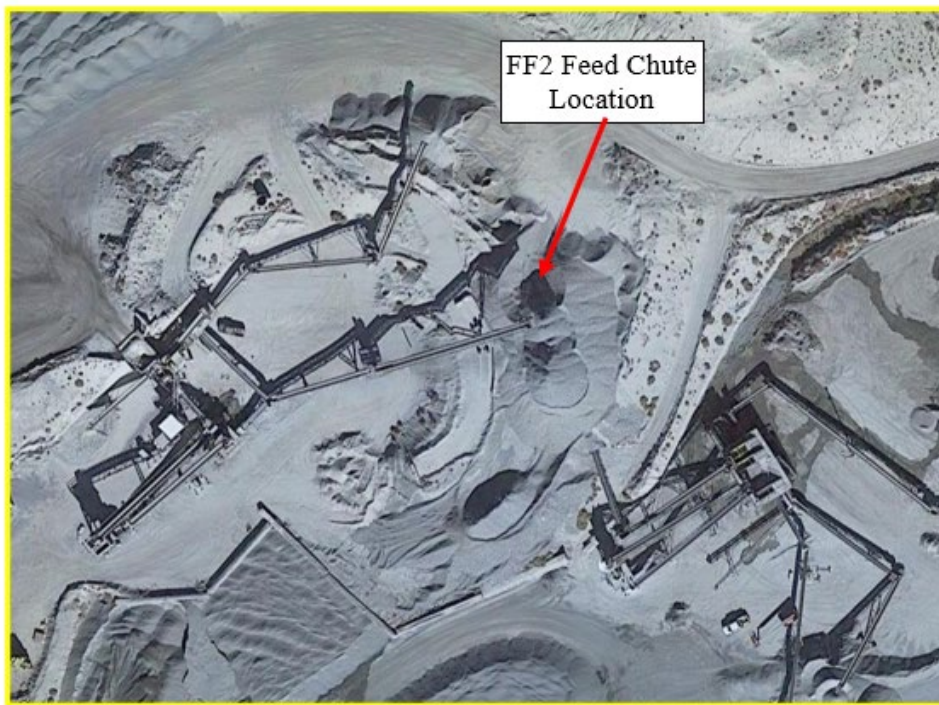
APPENDIX B – Aerial View of Spanish Springs

The accident occurred at the secondary plant stockpile feed area, at the aggregate fines stockpile above the FF2 feed chute (see Appendix B).

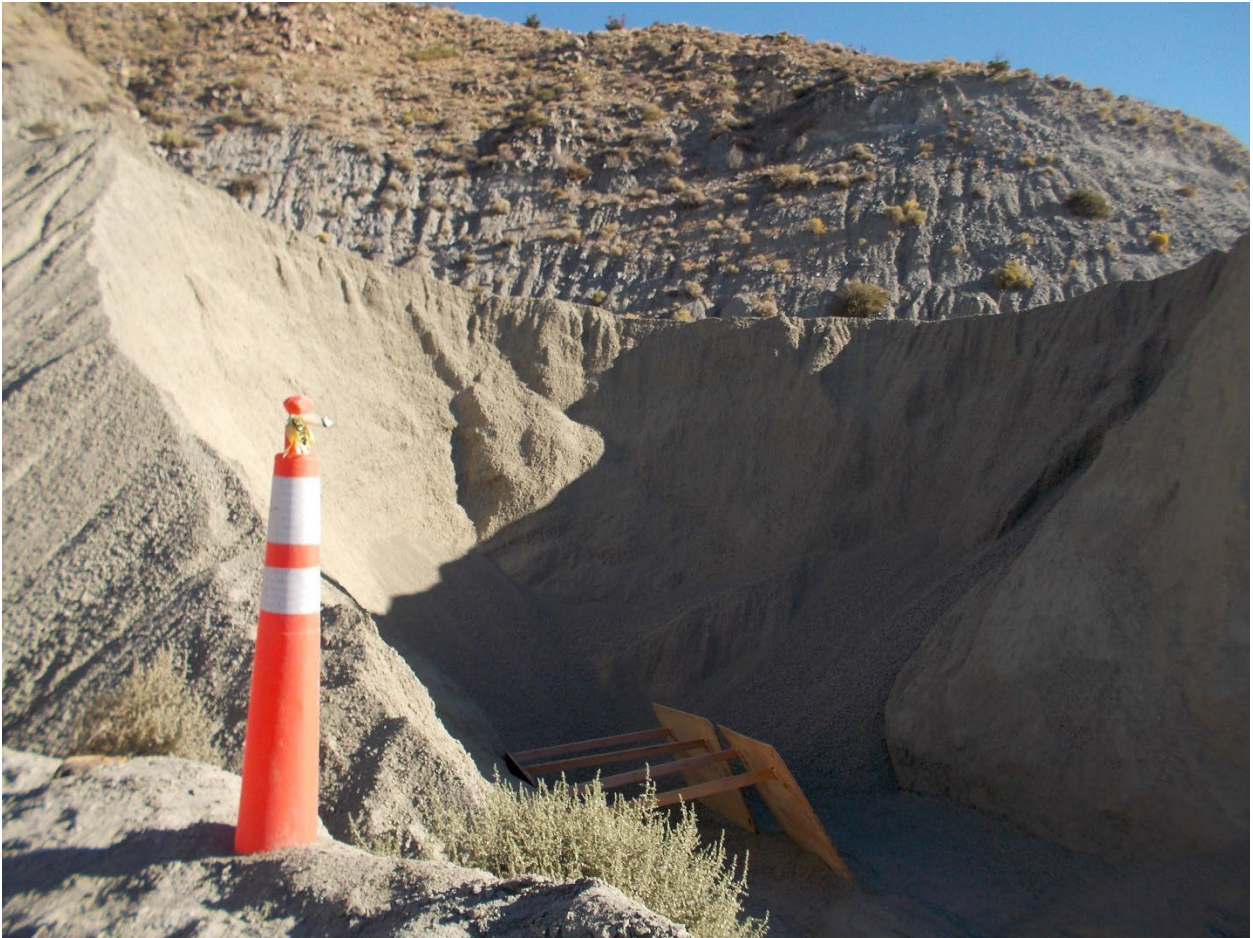
APPENDIX C – Location of the Accident

The aggregate fines stockpile had become larger than normal due to an increase of fine material from the pit and primary plant. Although the primary plant was not operating on the day of the accident, there was sufficient material in the stockpile from the primary plant to operate the secondary plant. The investigator measured the stockpile at 21 feet high on the east side and 28

feet high on the west side (see Appendix C). The slopes of the stockpile were nearly vertical. Based on interviews and a review of examination records, the investigator determined that the mine operator did not conduct a workplace examination of the secondary plant stockpile feed area before work began in that area. Miners stated that they regularly did not conduct workplace examinations and Scott Meyers, Superintendent, stated that management was not reviewing the workplace examination records. An adequate workplace examination would have identified the large, over-steepened stockpile. The investigator determined that not performing a workplace examination contributed to the accident. The investigator also determined that not trimming the stockpile to prevent hazards contributed to the accident.

Corrective Action: The mine operator developed and implemented a new written COSP that includes working around feeders, identifying engulfment hazards, and trimming stockpiles. The mine operator trained miners who will work around the feeders and stockpiles on the new COSP.
