REPORT OF INVESTIGATION

Surface  
(Construction Sand & Gravel)

Fatal Drowning Accident  
September 9, 2022

Barry Industrial Sand, Inc.  
Barry Industrial Sand, Inc.  
Vidor, Orange County, Texas  
ID No. 41-02392

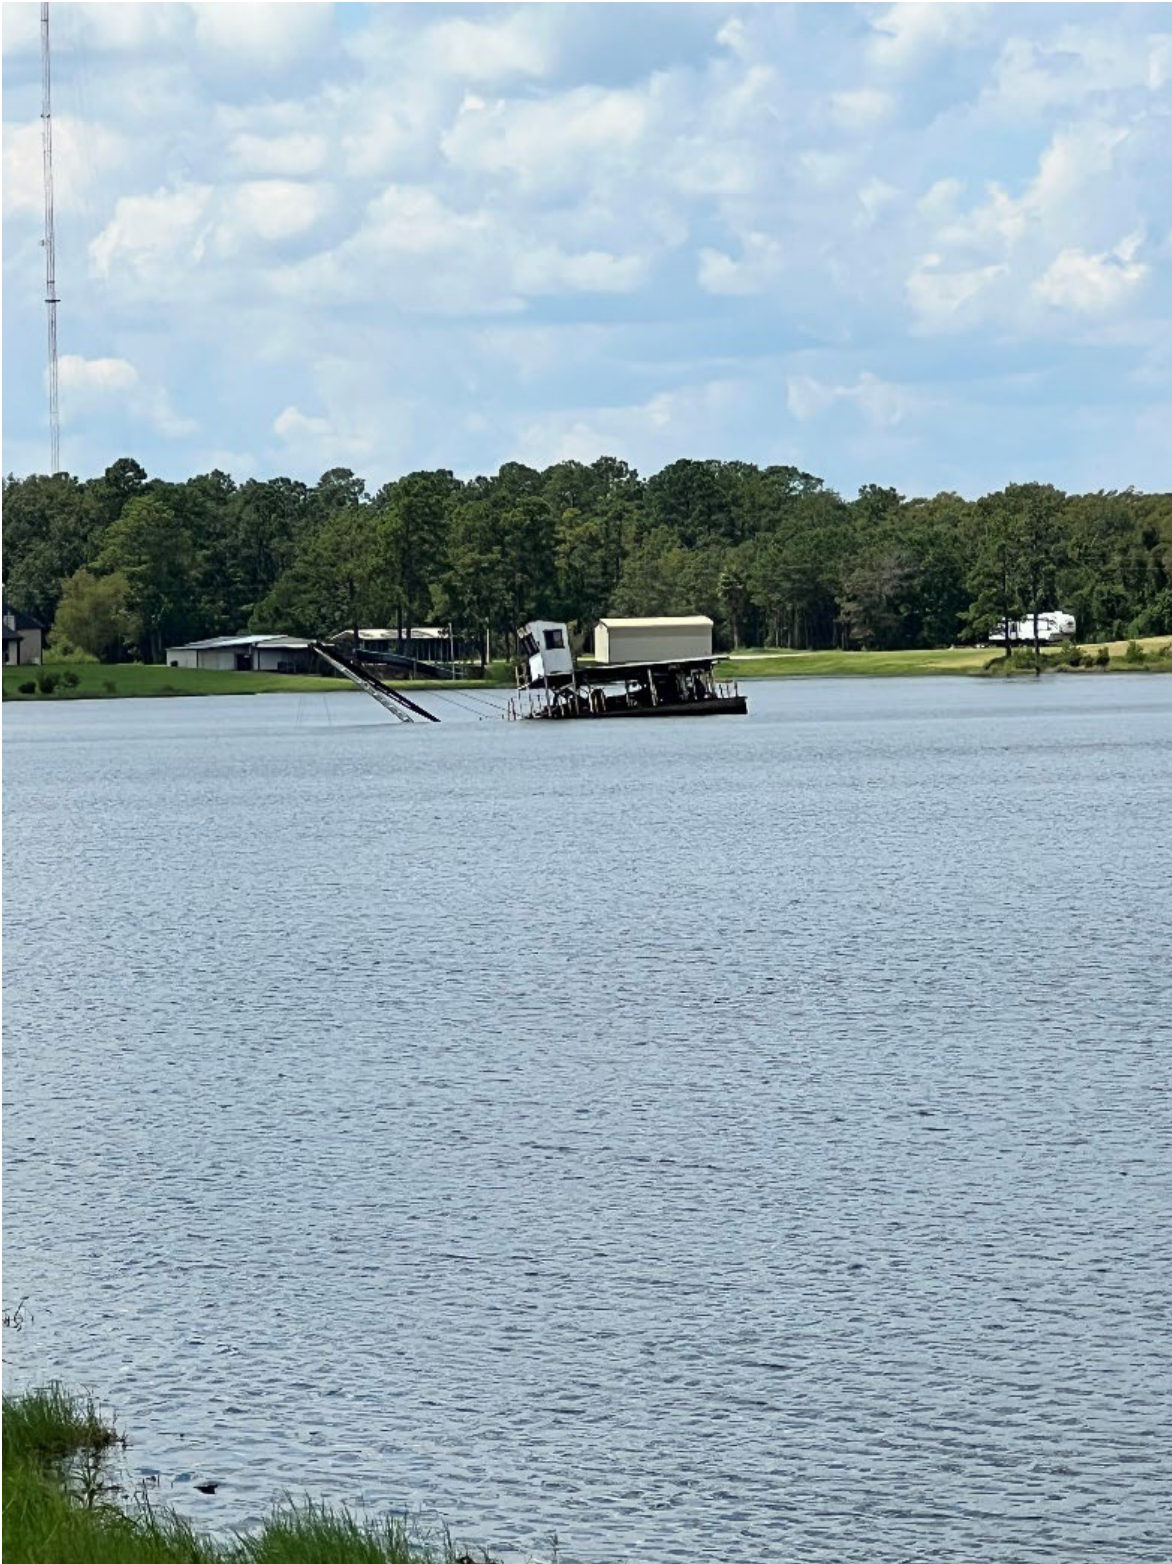
APPENDIX A – Photo of Dredge Listing to the Right

At 11:00 a.m., James Smith, Maintenance Worker for Boom Town R.V. Park, observed the dredge listing (leaning) to one side in the water (see Appendix A). Smith saw McMahon hastily coming down the control room stairs with fishing poles and other items and placing them into the boat. Smith stated that he did not see McMahon after that and could not hear the dredge motors running. Smith spoke with Justin Evans, Maintenance Worker for Boom Town R.V. Park, and they discussed the listing dredge and how they were no longer able to see McMahon. Evans and Smith retrieved two kayaks from Boom Town R.V. Park and traveled out to the dredge to check on McMahon. Evans arrived at the boat that was located approximately 25 feet east of the back of the dredge and did not see McMahon. Smith arrived at the dredge while Evans was checking the boat. Smith visually searched the dredge and did not see McMahon. Smith entered the water to try to locate McMahon and was unsuccessful. Evans traveled to the dredge and boarded it. Evans observed a cell phone, a pen, and over-the-counter medication on the back walkway of the dredge (see Appendix B). Evans walked around the dredge and did not find McMahon.

When the investigators arrived on the scene, the dredge was capsized. This was due to the mine operator's efforts to move the dredge to shore on September 10, 2022, prior to Barry contacting the DOLNCC. Based on interviews, investigators believe the listing of the dredge was caused by underwater material that fell on the dredge's lines during dredging activity.

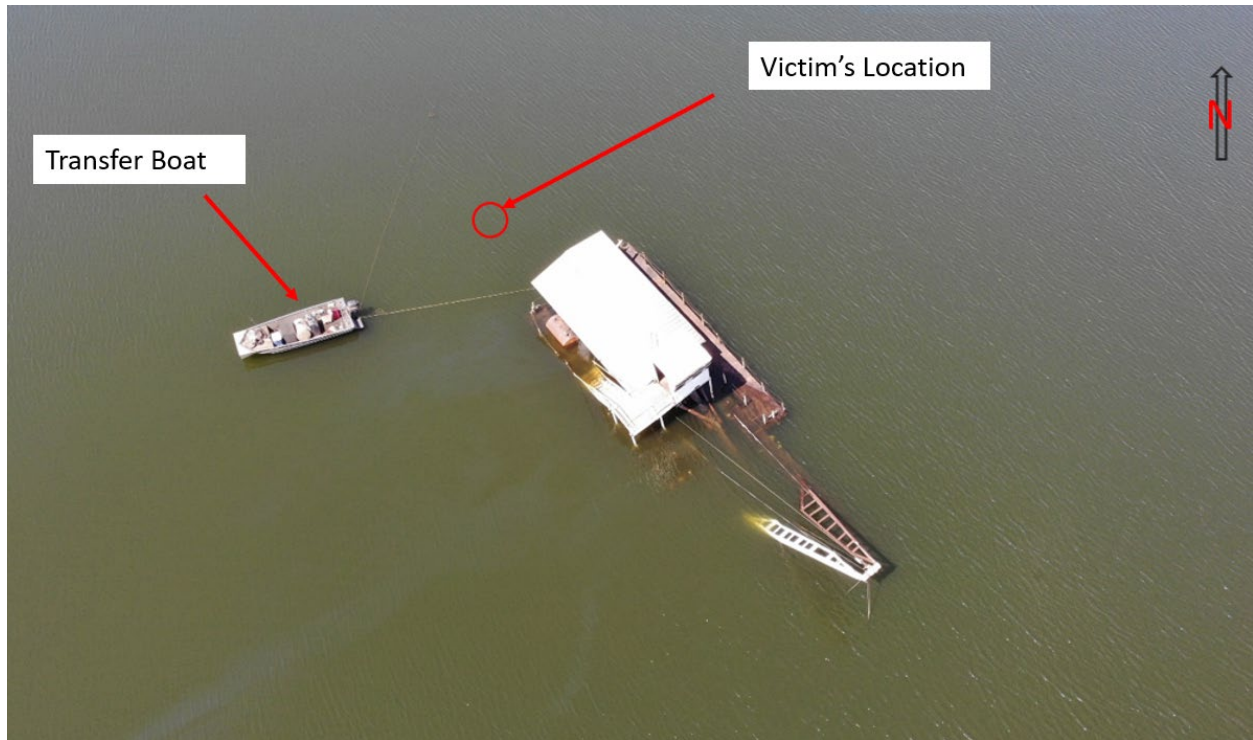
APPENDIX C – Aerial View of the Anchor Rope Attached to the Transfer Boat and Dredge

Smith and Evans went back to shore and told Shelly Merchant, Office Manager for Boom Town R.V. Park, that they could not locate McMahon. Also present for this discussion was Ramanda Dennison and Donna May, residents at Boom Town R.V. Park. According to interviews, May contacted Barry at approximately 11:45 a.m. At 1:58 p.m., Dennison called 911. At 2:36 p.m., Beaumont Fire Department arrived to search for McMahon using their boat and dive team. At 5:51 p.m., Beaumont Fire Department recovered McMahon approximately ten feet from the rear of the dredge in approximately 20 feet of water (see Appendix C). Rodney Price, Justice of the Peace Precinct 4, pronounced McMahon dead at 6:26 p.m.

A Weldcraft flatbottom boat was used to access the dredge. The boat was 18 feet in length, 6 feet wide, and equipped with a 75-horsepower outboard motor. On the day of the accident, fire department personnel found the motor on the boat not running, the boat fuel tank empty, the motor gear selector in neutral, and the ignition key in the 'on' position. They also found the anchor rope hooked around the outboard motor lower unit. Investigators concluded McMahon was attempting to remove the anchor rope from around the outboard motor when he fell from the rear walkway of the dredge into the water.

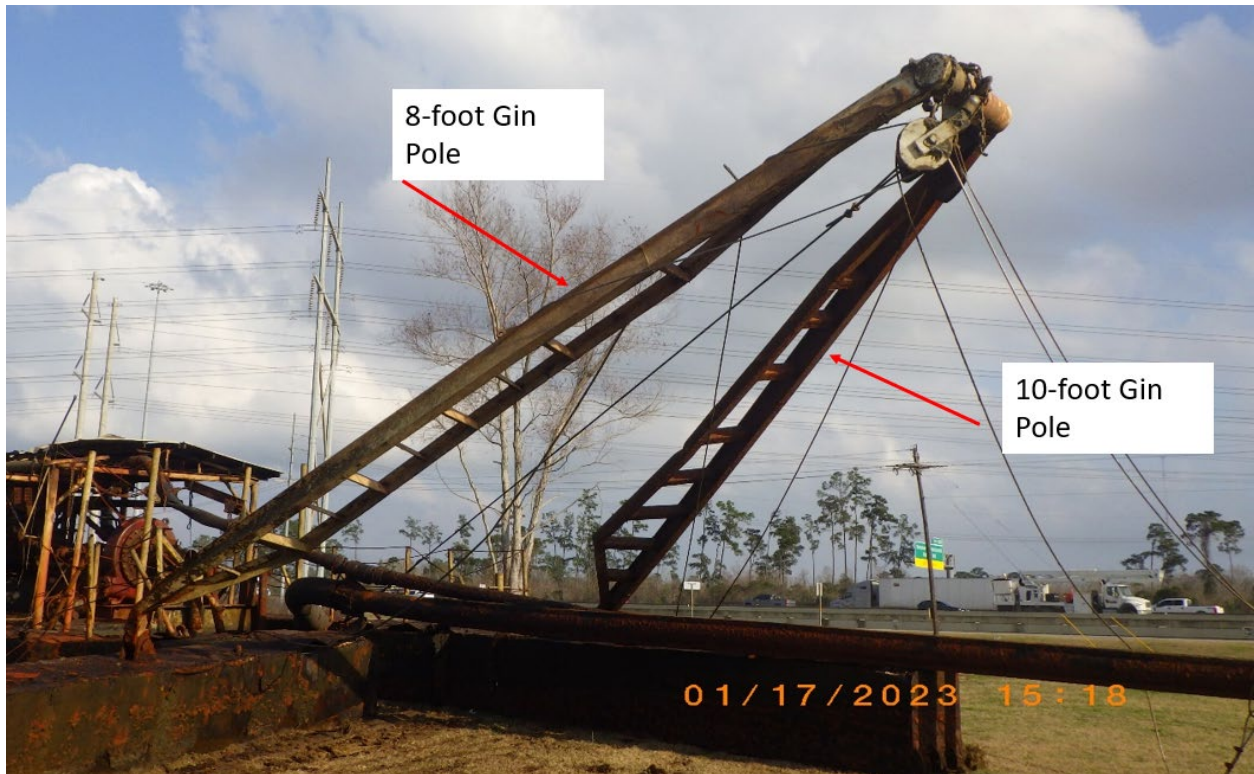
APPENDIX F – Gin Poles Used in the Dredge's A-Frame

The dredge's original pontoons measured 53 feet by three feet. In 2009, the mine operator added two additional pontoons, which each measured 32 feet by two feet. These additional pontoons, equipped with Styrofoam, were placed on the front of the dredge and on the inside of the original pontoons. During this time, the dredge was also modified with the addition of two A-frame gin poles to assist with the dredge's lines (see Appendix F). An anchor was used to hold the dredge in place. The anchor is attached to the dredge by an anchor rope. The anchor rope is approximately 30 feet in length and made of nylon.
