REPORT OF INVESTIGATION

Fatal Machinery Accident  
April 9, 2023

South Pittsburg Stone #2  
South Pittsburg Stone  
Orme, Marion County, Tennessee  
I.D. No. 40-03591

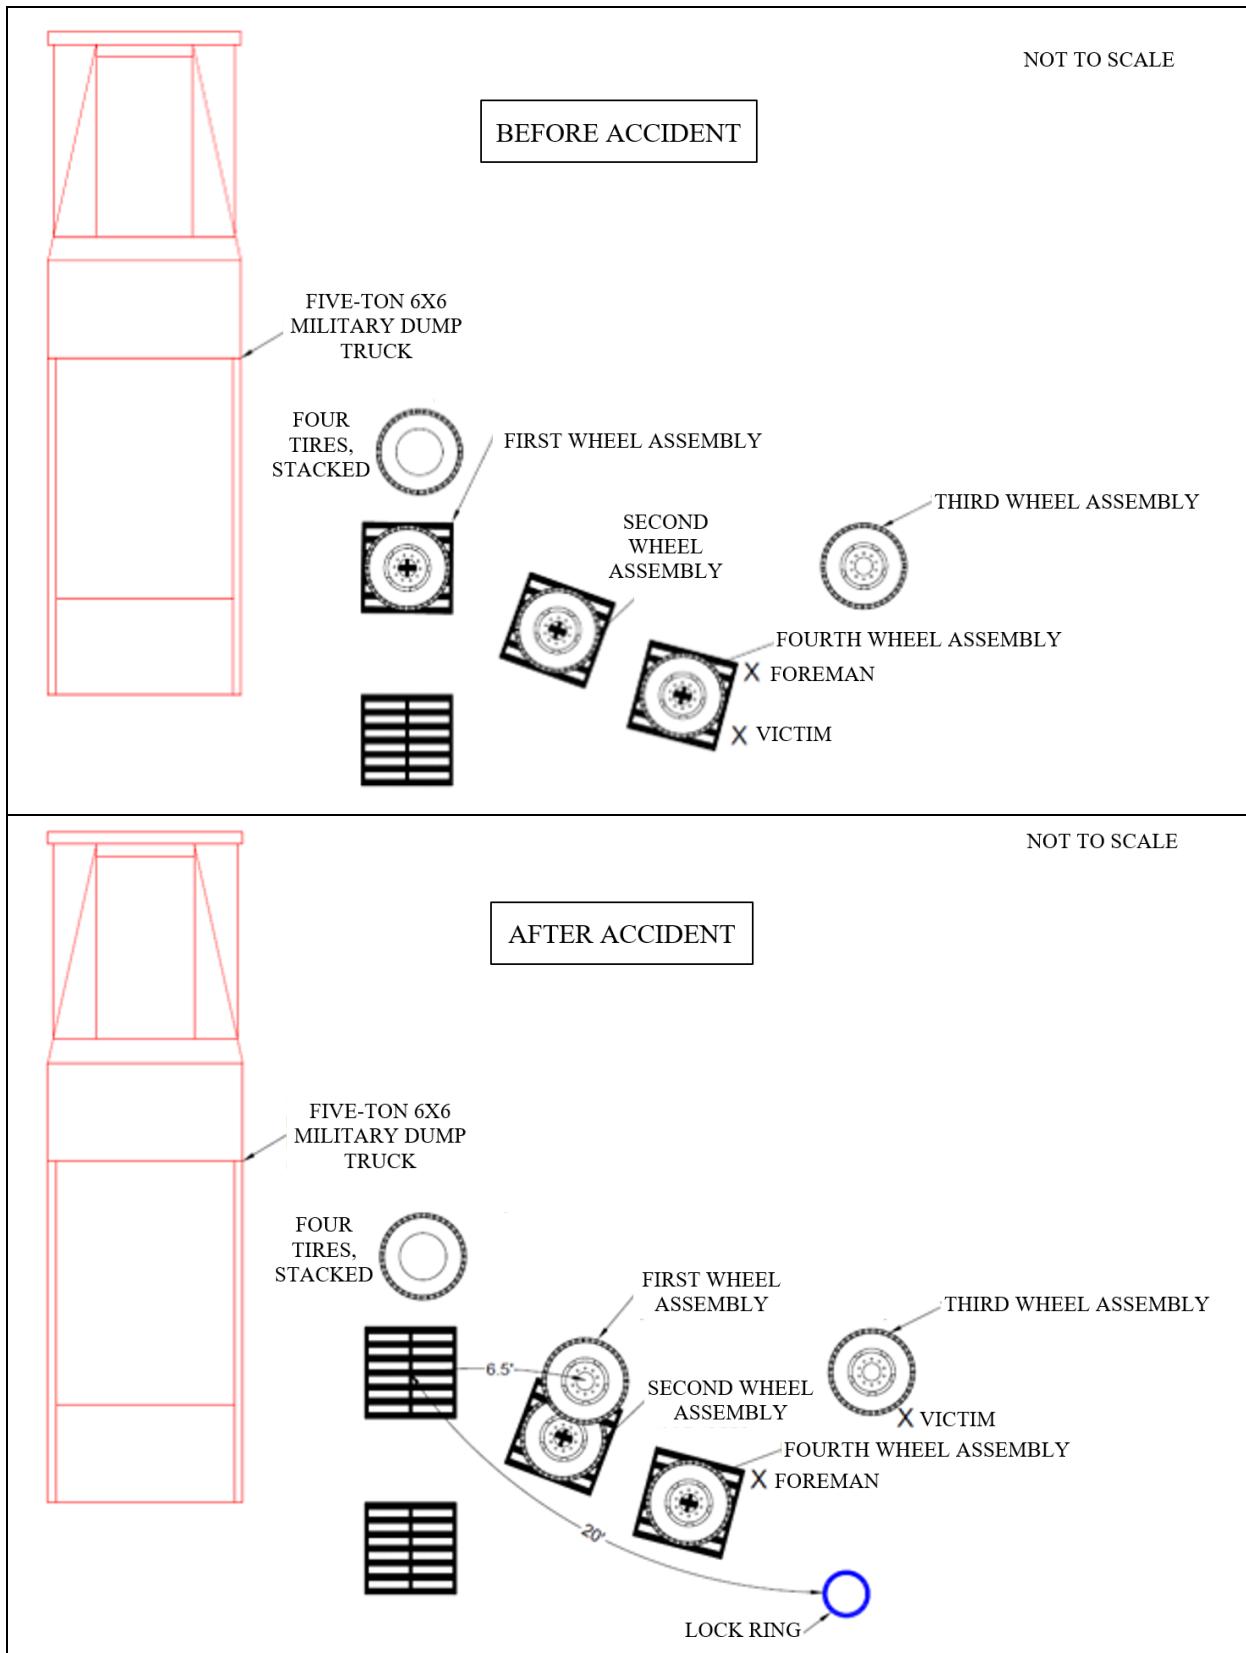
## APPENDIX A – Drawing of the Accident Scene

At approximately 7:00 a.m., Ortiz and Sales-Vasquez completed the first wheel assembly and placed it on a pallet lying flat with the lock ring side pointed up. By 10:00 a.m., Ortiz and Sales-Vasquez began working on the fourth wheel assembly, about 20 feet away from the first wheel assembly, when the first wheel assembly's lock ring dislodged, propelling the lock ring into the air. The lock ring flew into the air high enough for Ortiz and Sales-Vasquez to turn in the direction of the loud "pop" sound. The lock ring came down and struck Ortiz. Sales-Vasquez was within two feet of Ortiz when the accident occurred and stated that Ortiz died instantly. See Appendix A for a drawing of the accident scene.

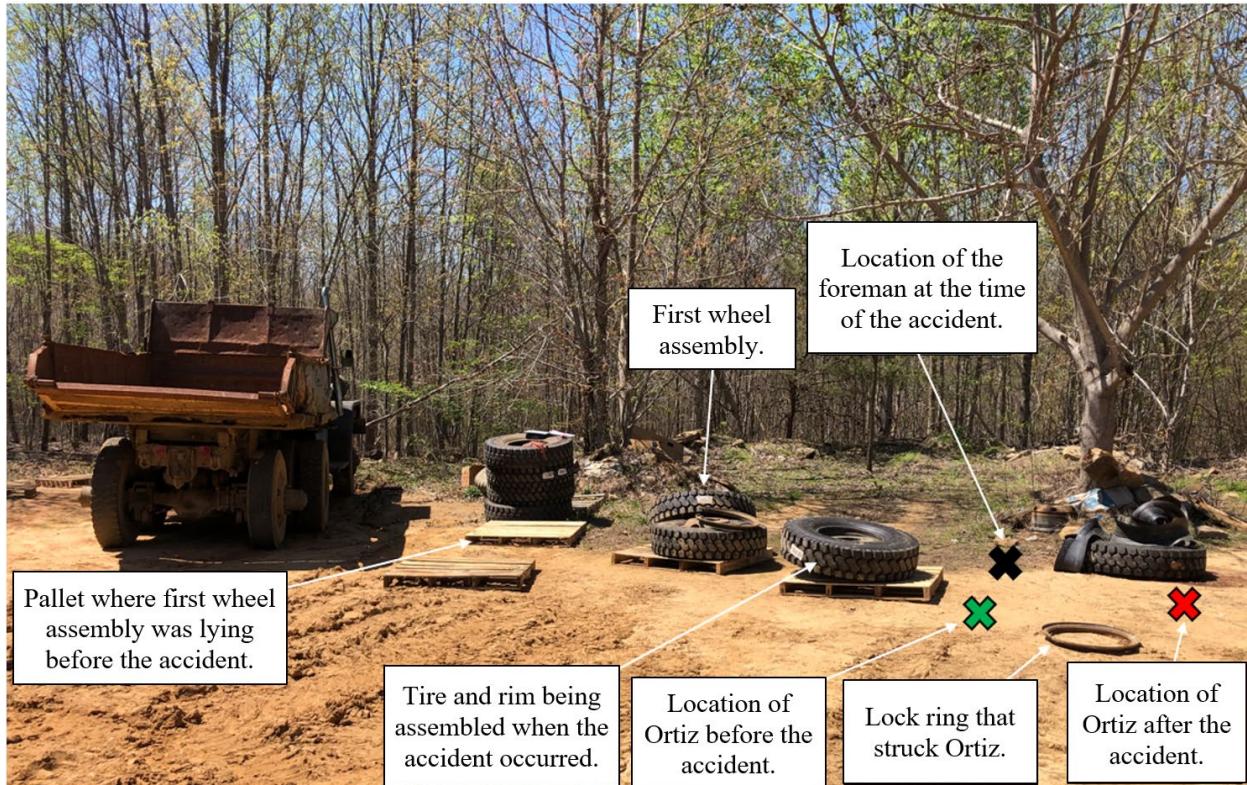
## APPENDIX C – Photograph of Accident Scene

The accident occurred at the outdoor staging area where miners conduct equipment repairs (see Appendix C).

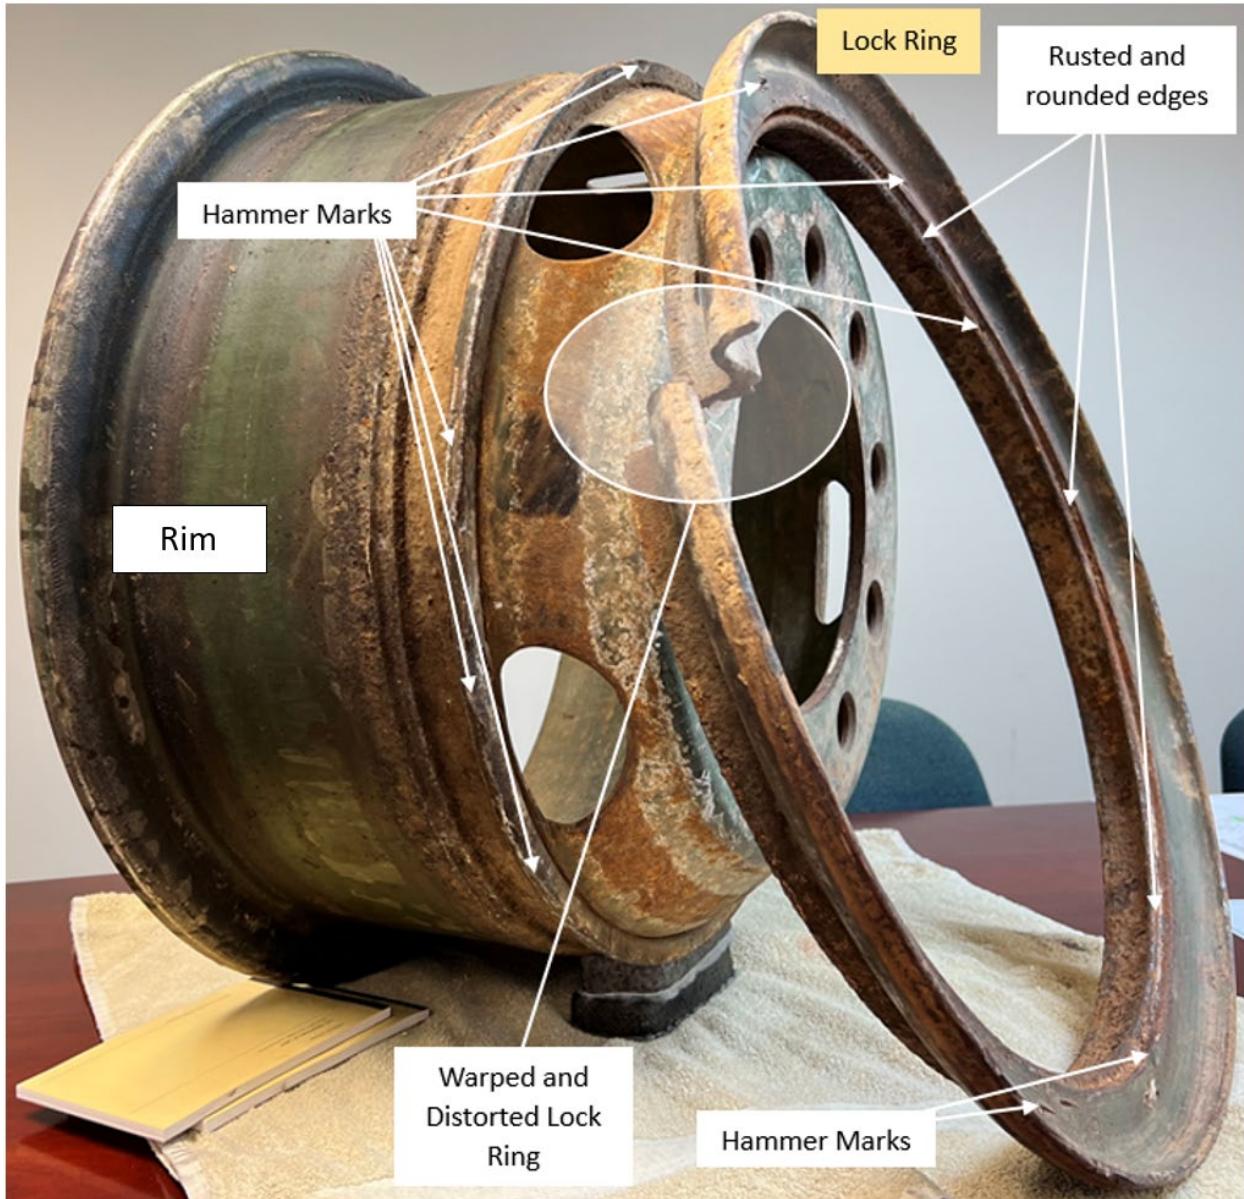
#### APPENDIX D – Two-Piece Wheel Rim with Lock Ring Defects

The tires being mounted were regrooved Firestone T831 Radials manufactured in 2006 for use on a five-ton 6x6 military dump truck. The rims used for mounting the tires were two-piece, 20-inch by 7.5-inch wheel rims with a lock ring that locks into a groove in the rim (see Appendix D). The identification markings on the rim were not legible, so the manufacturer could not be determined.

1. The rims were not verified to be compatible before mounting the tires. The manufacturer's markings on the rims were illegible and could not be verified. If the markings on any rim component cannot be determined, the part should be discarded.
2. Rust and rounded edges were observed on the interior of the lock ring, which prevented the lock ring from properly seating on the rim. Inconsistent gaps were observed around the circumference of the lock ring indicating it was not properly seated against the rim.

3. Damaged rim components that should have been discarded were used in mounting the tires. The ends of the lock ring were warped and distorted. The ends of the lock ring did not sit flat against the rim, preventing it from properly seating.

4. Improper tools were used while mounting the tires to the rims. Hammer marks were observed on the rims resulting in distortion of the locking mechanism. Only a proper rim mallet should have been used during the assembly.

The investigator determined that these defects were obvious and contributed to the accident. Sales-Vasquez did not perform a thorough examination of the rim before attempting to mount the tires. Sales-Vasquez should have been aware of the serious safety defects on the rim and should have taken corrective action to prevent the creation of a hazard to miners. During interviews, Sales-Vasquez stated that he should have removed the rust before using the rims. Sales-Vasquez also stated he was going to order a tire cage (restraining device) because he recognized the need, following this accident.

A wire brush or grinder should have been used to remove the rust and rounded edges on the lock rings before assembly.

Corrective Action: The mine operator removed all two-piece wheel rims with lock rings from the mine. All wheel assembly will be conducted by a tire technician off mine property. The mine operator adopted this policy in their Part 46 Training Plan.
