REPORT OF INVESTIGATION

Fatal Machinery Accident
August 24, 2023

MN Portable Wash 086 (A5567 Wash Plant)
Cemstone Products Company
Isle, Mille Lacs County, Minnesota
ID No. 21-03205

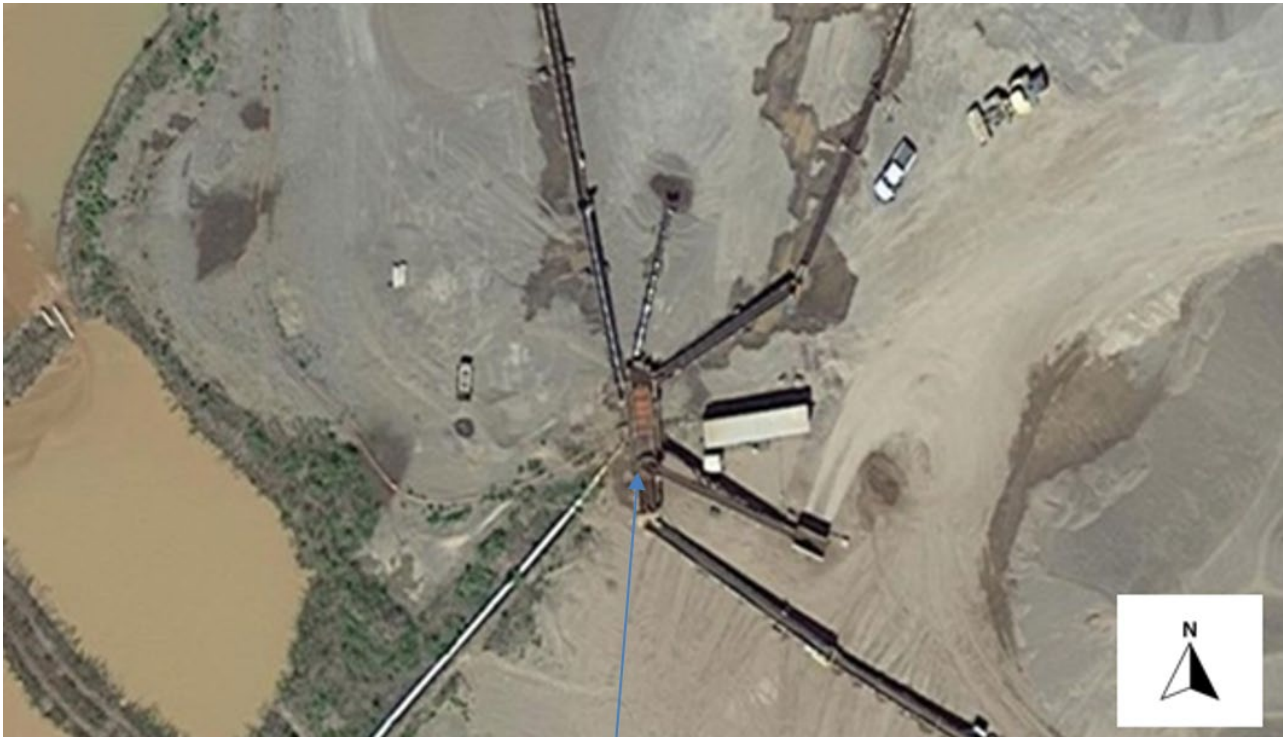
APPENDIX B – Aerial View of Wash Plant

The accident occurred at the KPI-JCI Astec Wash Plant, model number 6203-32LP. The plant is used to wash and size sand and gravel (see Appendix B).

Accident Site

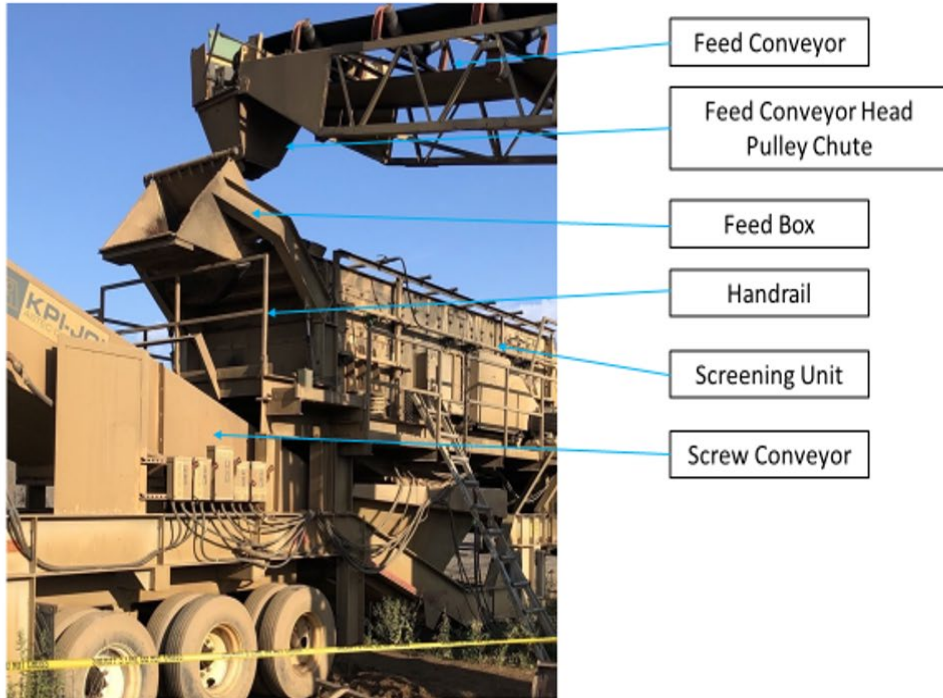
APPENDIX C – Wash Plant

According to interviews, Minenko instructed Karg to raise the feed conveyor because the head pulley chute was partially inserted into the feed box (see Appendix C). Karg started the generator supplying power to the plant and, using the feed conveyor system, began raising the feed conveyor. Minenko attempted again to remove the handrail section, placing himself directly behind the feed box. Karg stated that as soon as the feed conveyor head pulley chute cleared the feed box, the feed box fell, pinning Minenko to the handrail section.

The wash plant involved in the accident consisted of a feed box, a screen unit, a dewatering screw, and a belt conveyor (see Appendix C). KPI-JCI Astec Companies manufactured the plant screen and feed box. The feed box weighed approximately 2500 lbs. The feed box had two Hercules HTR-2010 hydraulic cylinders and a Simplex P160A series hydraulic pump to lower the feed box in a controlled manner for transport. The hydraulic pump had a manual handle to pressurize and extend the cylinders as well as a release screw to relieve pressure from the cylinders, allowing the operator to lower the feed box. KPI-KCI Astec Companies manufactured the dewatering screw. Argo Industries manufactured the frame of the plant.

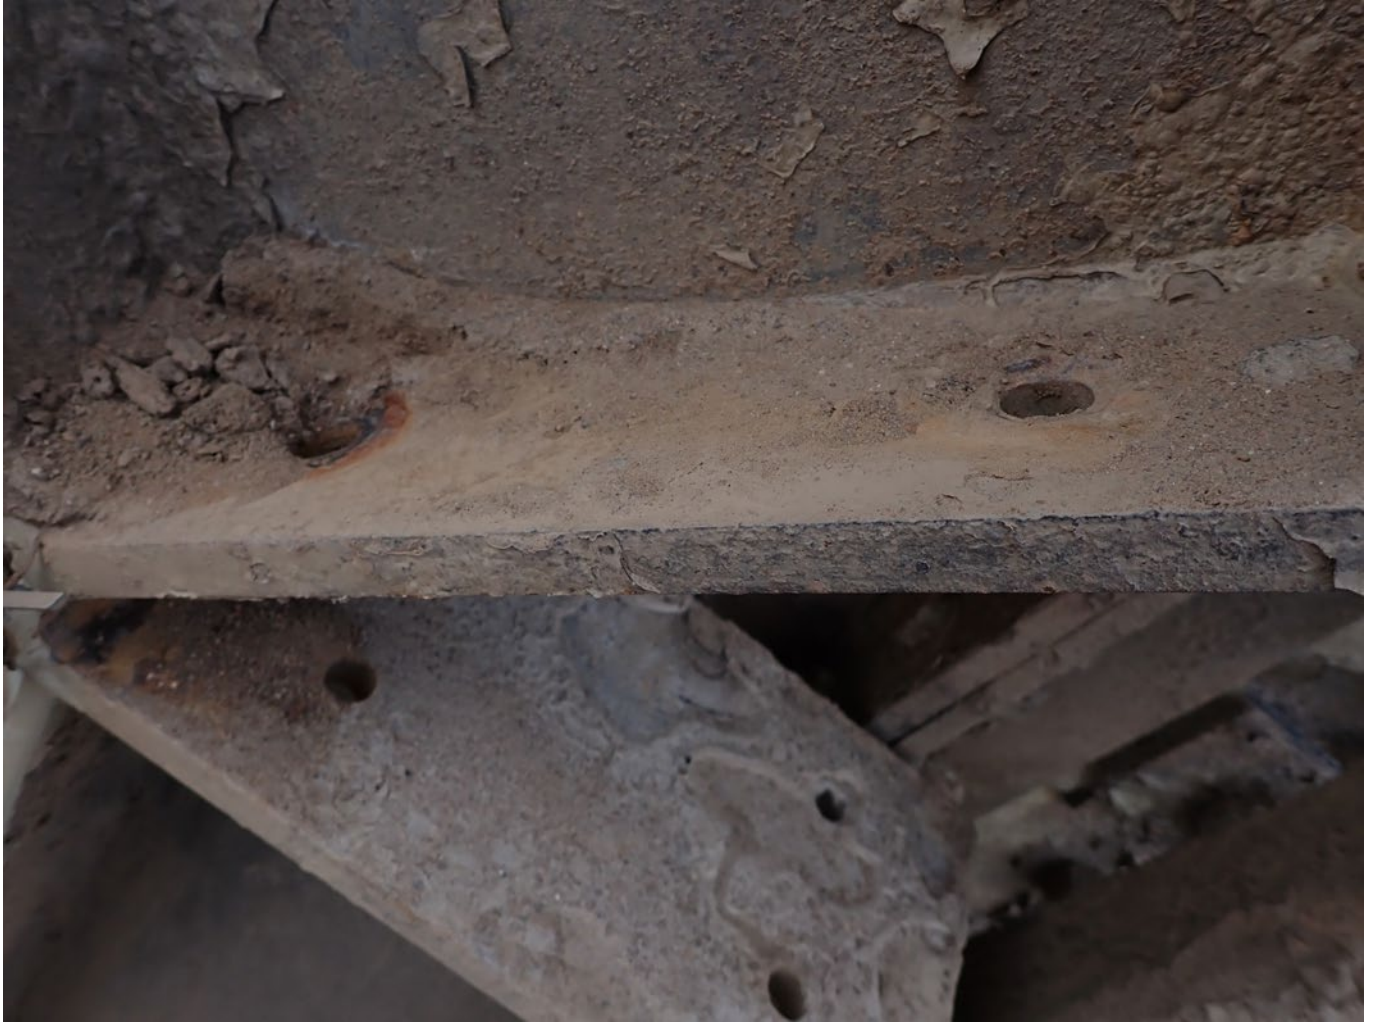
APPENDIX D – Bolts Used to Block Feed Box Removed

However, the mine operator did not ensure that the feed box was blocked against hazardous motion before the bolts securing the feed box to the frame were removed (see Appendix D). Investigators determined that this contributed to the accident.

1. Root Cause: The mine operator did not block the feed box against hazardous motion.

On August 24, 2023, a fatal accident occurred at this mine when a wash plant feed box dropped, pinning a miner between the feed box and a handrail. The mine operator did not block the feed box against hazardous motion before removing the bolts that secured the feed box to the frame.

Corrective Action: The mine operator will remove the Simplex P160A hydraulic pump and two Hercules HTR-2010 cylinders. The mine operator will raise or lower the feed box with a crane.
