REPORT OF INVESTIGATION

Fatal Powered Haulage Accident
August 30, 2023

No. 4 Mine
Warrior Met Coal Mining, LLC
Brookwood, Tuscaloosa County, Alabama
ID No. 01-01247

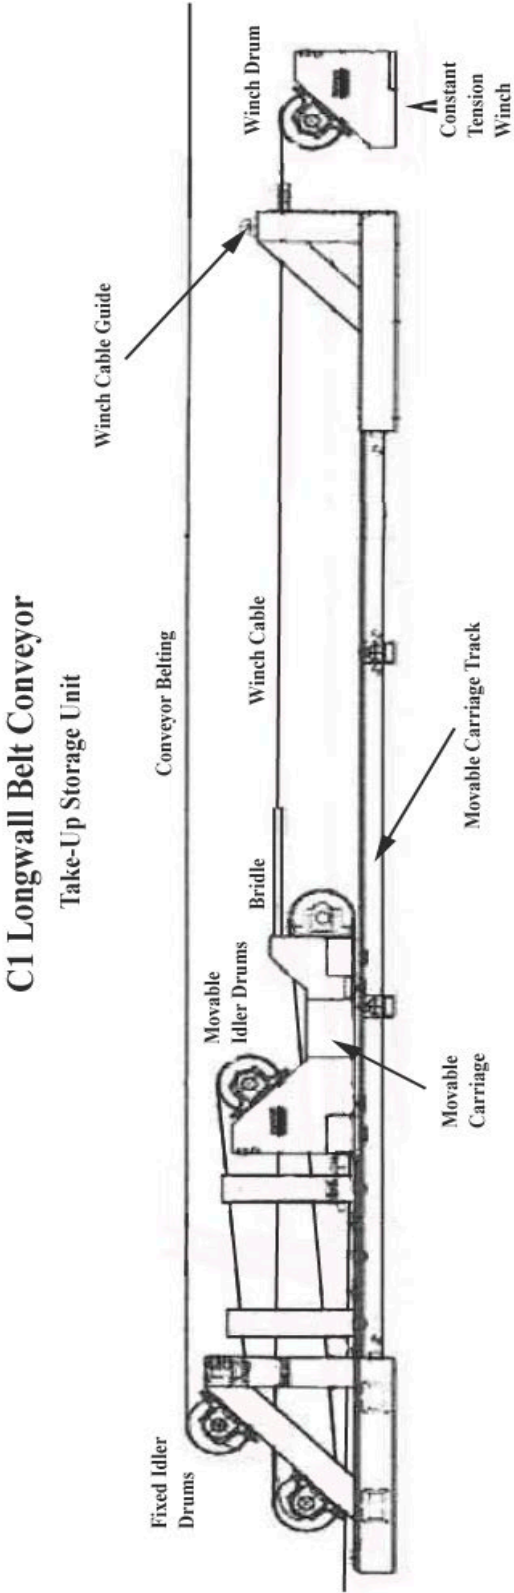
APPENDIX A – Belt Take-Up Illustration

On August 30, 2023, at 6:00 a.m., Haley arrived at the mine to work on repairs to the take-up located on the C1 Longwall section (see Appendix A). The crew working with Haley on these repairs consisted of: Zumarcus Archibald, Belt Repairman; Jerren Lewis, Belt Repairman; Tucker Cochran and James Duffey, New Miners at No. 4 Mine; James Alich, Laborer for BMC Services; and Zachary Knotts, Foreman for BMC Services.

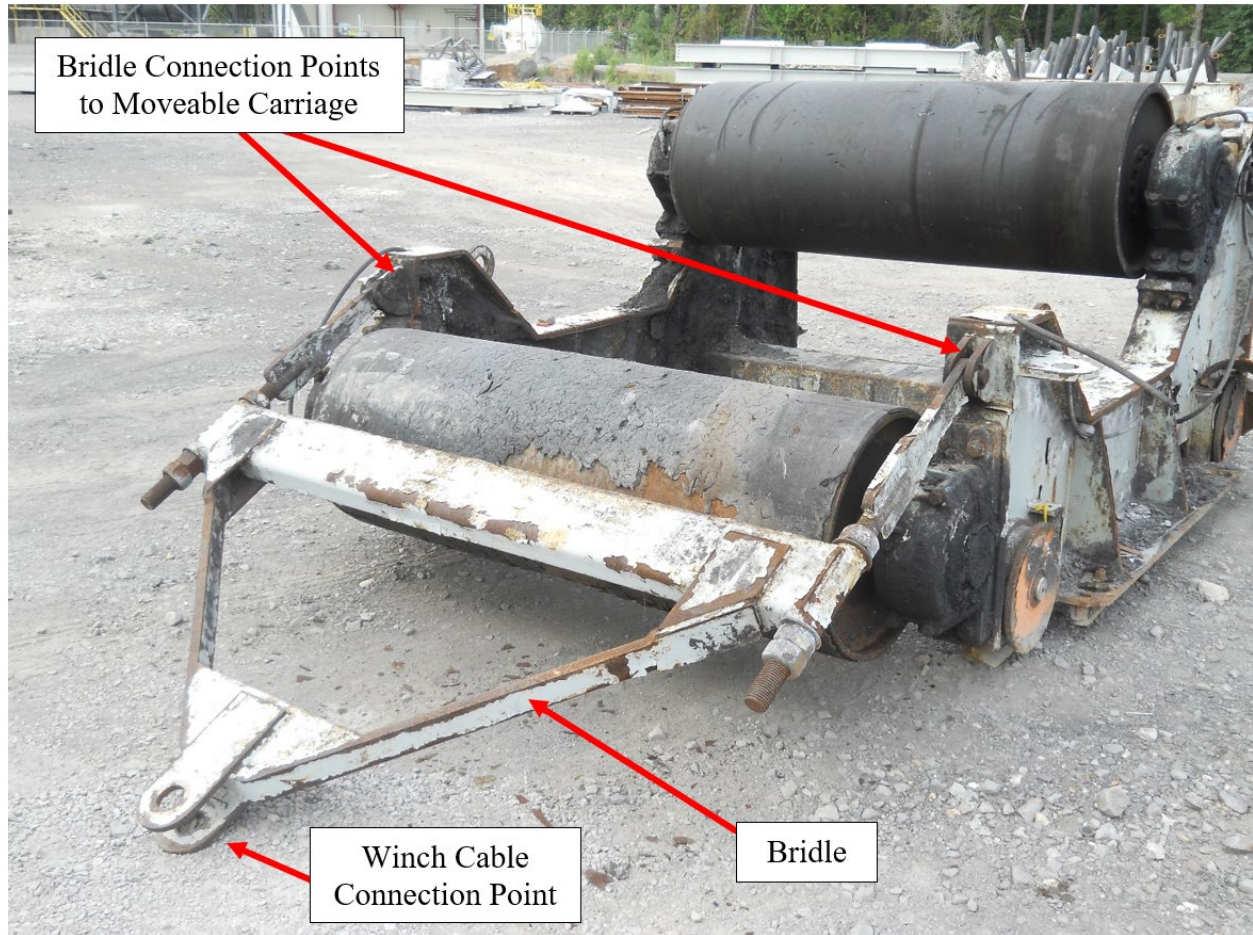
APPENDIX B – Similar Movable Carriage with Bridle

According to interviews, at approximately 6:50 a.m., the bridle connecting the constant tension winch cable (winch cable) to the carriage broke free at the attachment points to the carriage (see Appendix B). Due to the sudden release of stored tension in the winch cable, the bridle recoiled through the guards, breaking the guards loose and striking the miners. After regaining his composure, Alich realized the guards had him pinned underneath, along with Haley, Archibald, and Lewis. Alich heard the take-up winch running and realized the bridle and winch cable were pulling the guards along the beltline.

Approximately four weeks before the accident, the pin in the bridle at the winch cable connection on the take-up unit slipped out of the bottom eye at the connection point. This caused the winch cable to pull out of the bridle, bending the top eye at the connection point and the bridle upward due to the force exerted by the winch, and causing the winch cable to backlash on the winch cable drum. The mine operator untangled and inspected the winch cable and heated the top of the bridle with a torch to hammer it back down parallel to the bottom, aligning the holes for a pin. Instead of the mine operator repairing the top eye at the connection point to reinstall a pin from the manufacturer, the mine operator installed a different pin, approximately twice the length of the original pin provided by the manufacturer. The longer pin protruded several inches below the bottom of the bridle.

Investigators determined the damage created by the longer pin contacting the track frame weakened the bridle attachment connections and contributed to the accident. MSHA Technical Support took representative sections of the bridle for laboratory testing and evaluation, and the findings were consistent with those of the MSHA investigators. Specifically, laboratory testing found:

- 1) The link bars in the bridle met the minimum strength requirements for ASTM A36 steel.
- 2) Differences in pinhole size and the extent of the steel yielding caused the winch cable tensile load to unevenly transfer to the bridle and resulted in an imbalanced loading of the link bars. These differences were the result of the incident where the tow bar caught on a track cross-member prior to the accident.

- 3) The unequal load distribution caused the track-side link bar to receive more of the belt tension load, which caused the track-side link bar to fracture first and release from the mobile carrier.

- 4) The damage to the walk-side link bar was consistent with lateral loading and tensile overload, which would have occurred after the failure of the track-side link bar.

- 5) The walk-side link bar was unable to carry the full belt tension load of 33,800 pounds following the fracture of the track-side link bar; therefore, the walk-side link bar was fractured, failed, and released from the mobile carrier.

Corrective Action: The mine operator: 1) installed a new bridle on the moveable carriage. The new bridle is provided with gussets, which prevent the bridle from dropping down and contacting the track frame of the take-up when there is slack in the winch cable, 2) installed a two-inch diameter plasma rope to the moveable carriage and bridle to prevent the bridle from breaking free if the connections break again, and 3) developed and implemented a written policy prohibiting any miner from being in the belt conveyor entry between the belt drive and take-up winch when the belt conveyor is intentionally started or stopped, to reduce exposure.

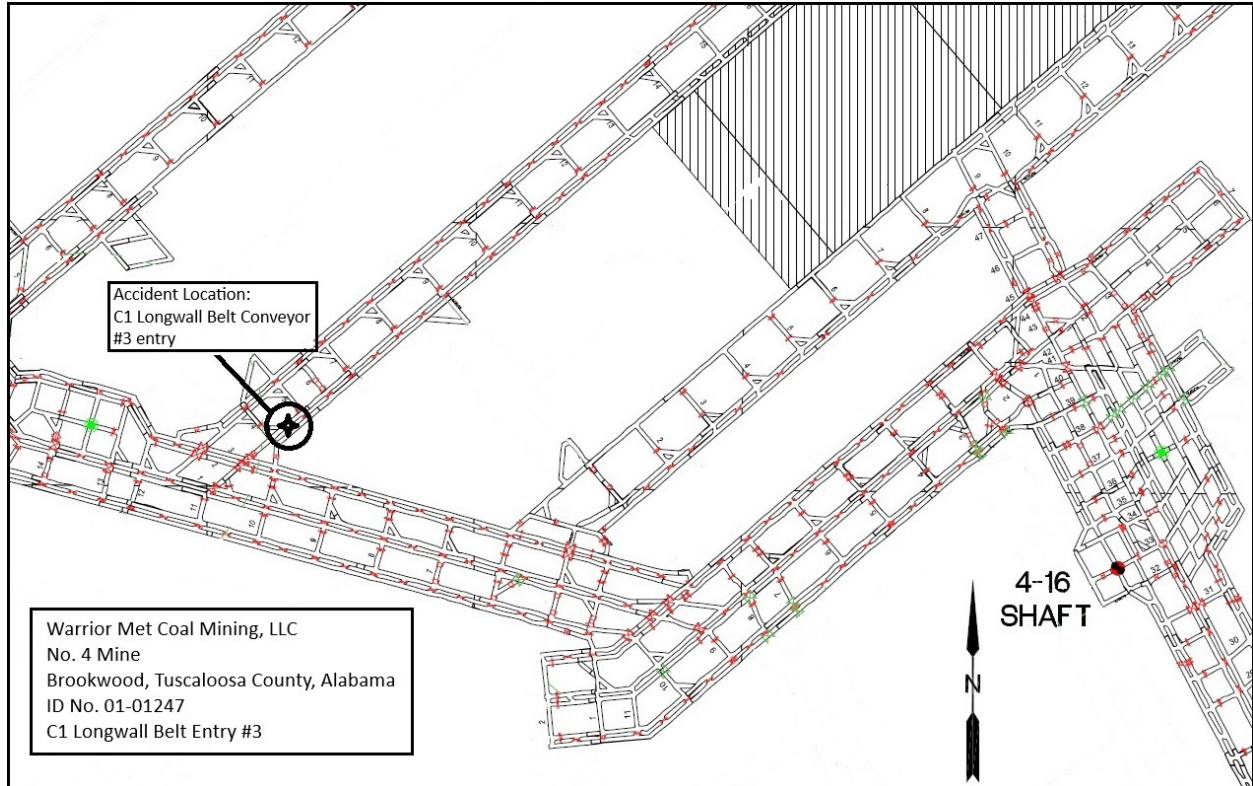
APPENDIX D – Location of Accident Scene

The accident occurred underground at the C1 Longwall belt conveyor #3 entry, belt take-up/storage unit (see Appendix D).
