REPORT OF INVESTIGATION

Fatal Slip or Fall of Person Accident
August 4, 2021

Marfork Coal Company - Marfork Environmental (S463)
Whitesville, West Virginia

Marfork Processing
Marfork Coal Company, LLC
Whitesville, Raleigh County, West Virginia
ID No. 46-08374

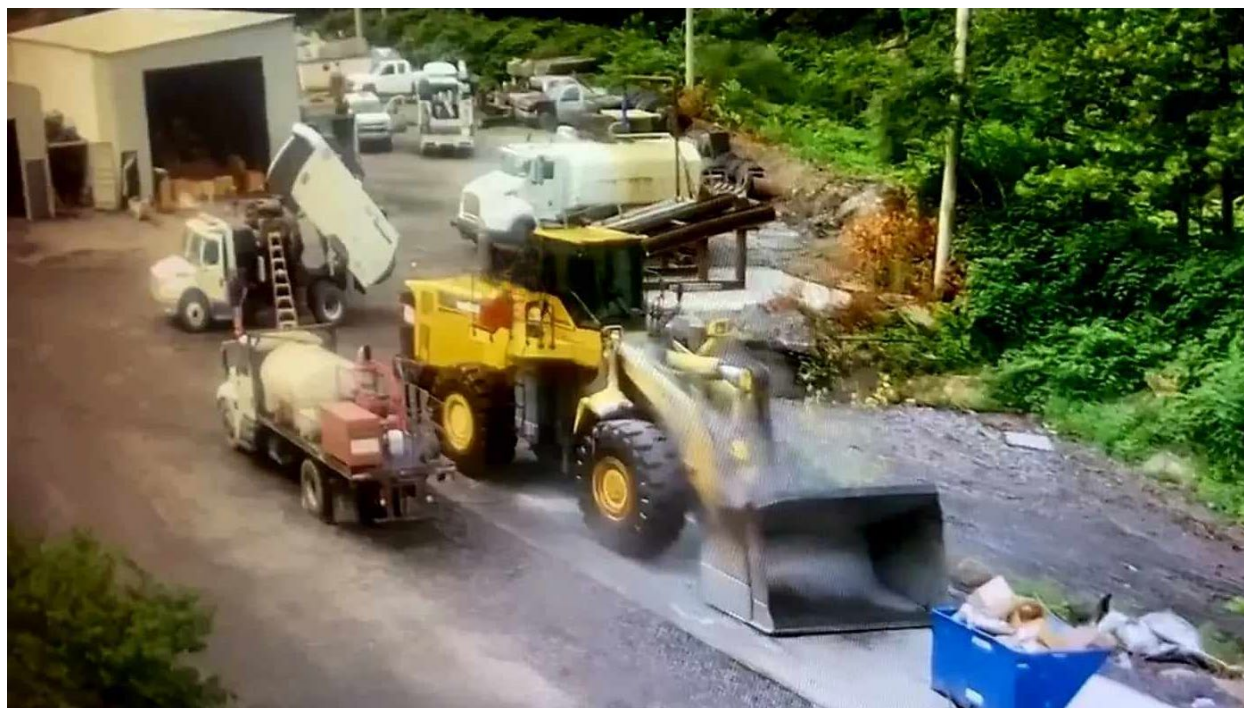
APPENDIX C – Accident Scene

The accident occurred at the Marfork Environmental maintenance yard steam pad (see Appendices B and C).

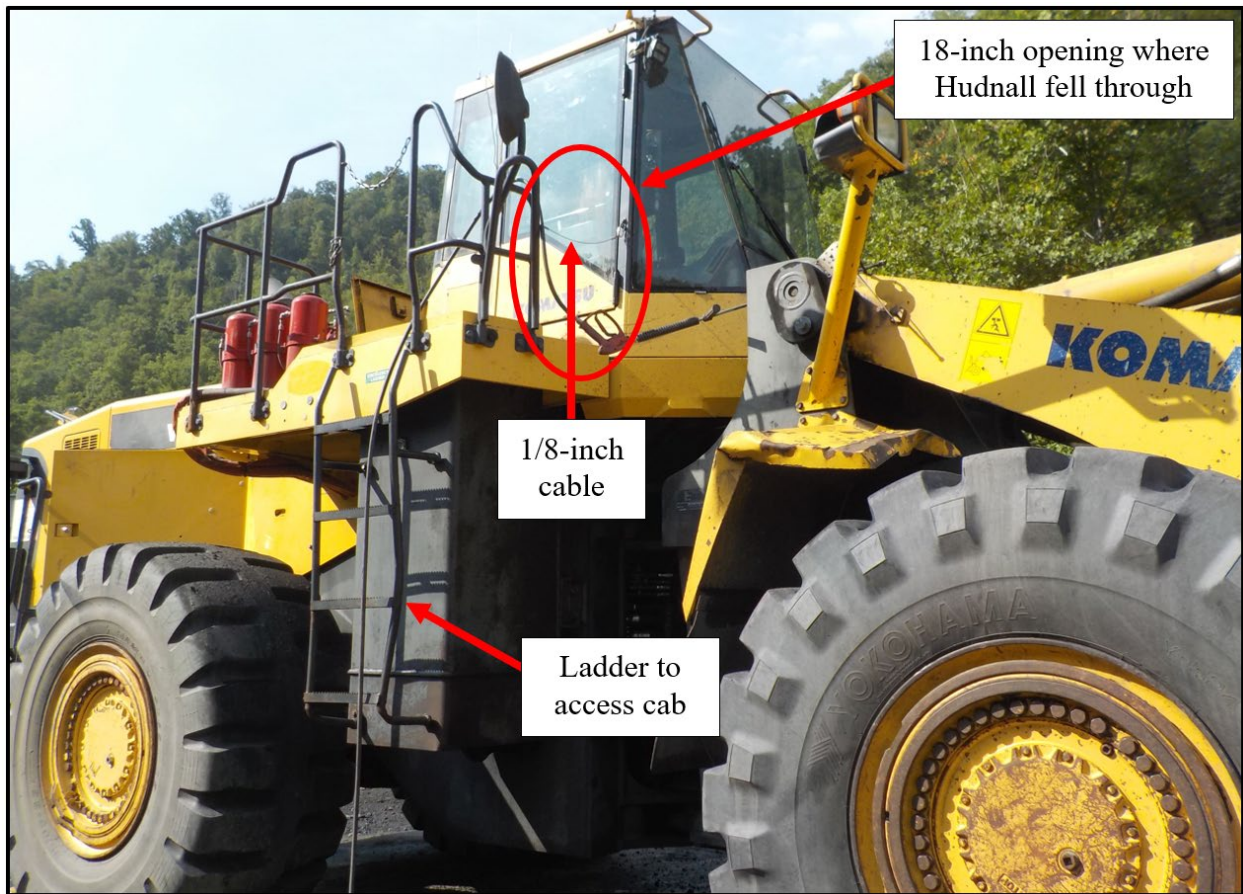
APPENDIX D – Komatsu WA 600-6 Wheel Loader

The front-end loader involved in the accident was a Komatsu WA 600-6 Wheel Loader. The front-end loader's handrails are 39½ inches high with two chains across the opening where a ladder provided access from the ground to the cab. The height of the handrails decreased to 25½ inches as the handrails approached the cab of the front-end loader. There was an 18-inch opening between the handrails and the cab when the cab door was closed. The opening had a 1/8-inch cable 17 inches off the deck (see Appendix D). This opening is designed by the manufacturer to provide maintenance access. Investigators determined the handrails were original from the manufacturer and were not modified by the contractor. Investigators examined the front-end loader and found no defects that contributed to the accident.

Marfork Environmental's fall protection policy at the time of the accident required fall protection to be worn when there was a danger of falling. A fall hazard was created by the 18-inch opening and an absence of handrails or other guarding features for the entire length of the walking deck on the front-end loader. Fall protection was provided and available but was not used to perform the task. The contractor did not ensure Hudnall wore fall protection where there was a danger of falling. Investigators determined that this contributed to the accident.

Corrective Action: The contractor developed and implemented a new written procedure and equipment modification to protect miners from falling. The mine operator trained miners on the procedure and modification which includes:

- A. Fall protection equipment, consisting of a full-body harness or full-body vest type harness with an anchored lanyard, must be worn when working in the following circumstances:
 - 1. Within six feet of a ledge or opening that lacks safety rail protection
 - 2. Working in precarious positions at any elevation, such as working while leaning, working inside an approved bucket, basket, man-lift, chute, bin, and all overhead hoist doorways or access points
 - 3. While performing work in an elevated position with exposure to falling five feet or greater
- B. The contractor installed an additional handrail that closed the gap between the factory handrail and cab. The company has performed the same modification on all other front-end loaders with a similar opening.
