REPORT OF INVESTIGATION

Fatal Machinery Accident
August 4, 2022

Wooten Sand & Gravel, Inc.
Wooten Sand & Gravel, Inc.
Fouke, Miller County, Arkansas
ID No. 03-01975

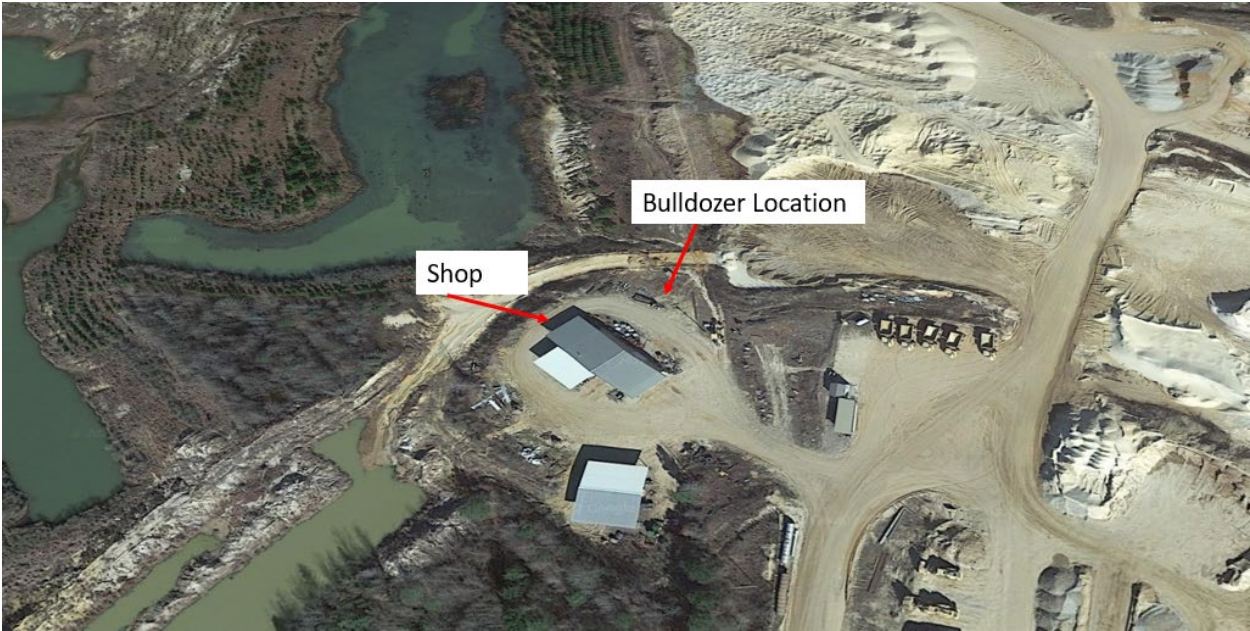
APPENDIX B – Aerial View

The accident occurred outside the south side of the maintenance shop (see Appendix B). The bulldozer was moved into the maintenance shop bay area on August 2, 2022, to perform preventative maintenance. Prior to the accident, the bulldozer was parked on a concrete slab at the side bay door with the bulldozer's blade resting on a steel pipe inside the maintenance shop bay.

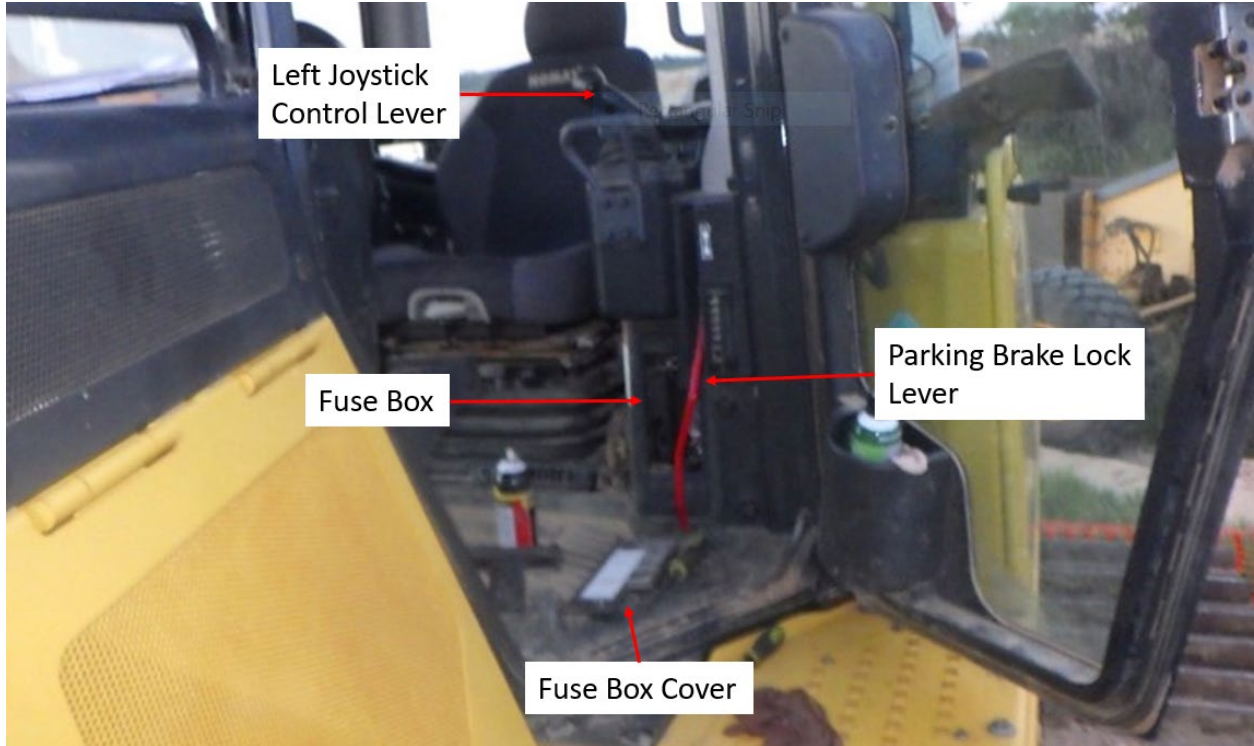
APPENDIX C – Left Joystick Control Lever, Fuse Panel, and Fuse Panel Cover

According to interviews and an examination of the scene, when Davis found Wooten Sr., the bulldozer was idling in reverse, the parking brake was not set, and the control lever for the left joystick was raised. The parking brake lever for the left joystick must be raised to access the fuse panel. The fuse panel cover on the front left side of the seat assembly was removed and laying on the floor of the bulldozer (see Appendix C). No fuses were missing and the internal cover that exposes the fuses had not been removed. Evidence indicates Wooten Sr. was positioned on the bulldozer's left track, looking into the fuse panel, when he inadvertently pushed the left joystick back, placing the bulldozer in reverse. The bulldozer movement caused Wooten Sr. to fall on the track, where he was dragged back to the rear of the bulldozer, and run over by the bulldozer.

Grappe and the investigators inspected the fuse panel cover (see Appendix C), and determined access to the fuse panel was obstructed when the parking brake lever was partially engaged.

Corrective Action: The mine operator developed and implemented new written procedures that require all miners to: 1) set the parking brake on mobile equipment when parked and when repairs or maintenance is being performed, and 2) block or use other means to prevent unintended motion of mobile equipment should testing or activation be required to the extent that adjustments or testing cannot be performed without motion or activation.
