REPORT OF INVESTIGATION

Fatal Powered Haulage Accident
December 6, 2022

Viburnum #35 Casteel Mine
The Doe Run Company
Bixby, Iron County, Missouri
ID No. 23-01800

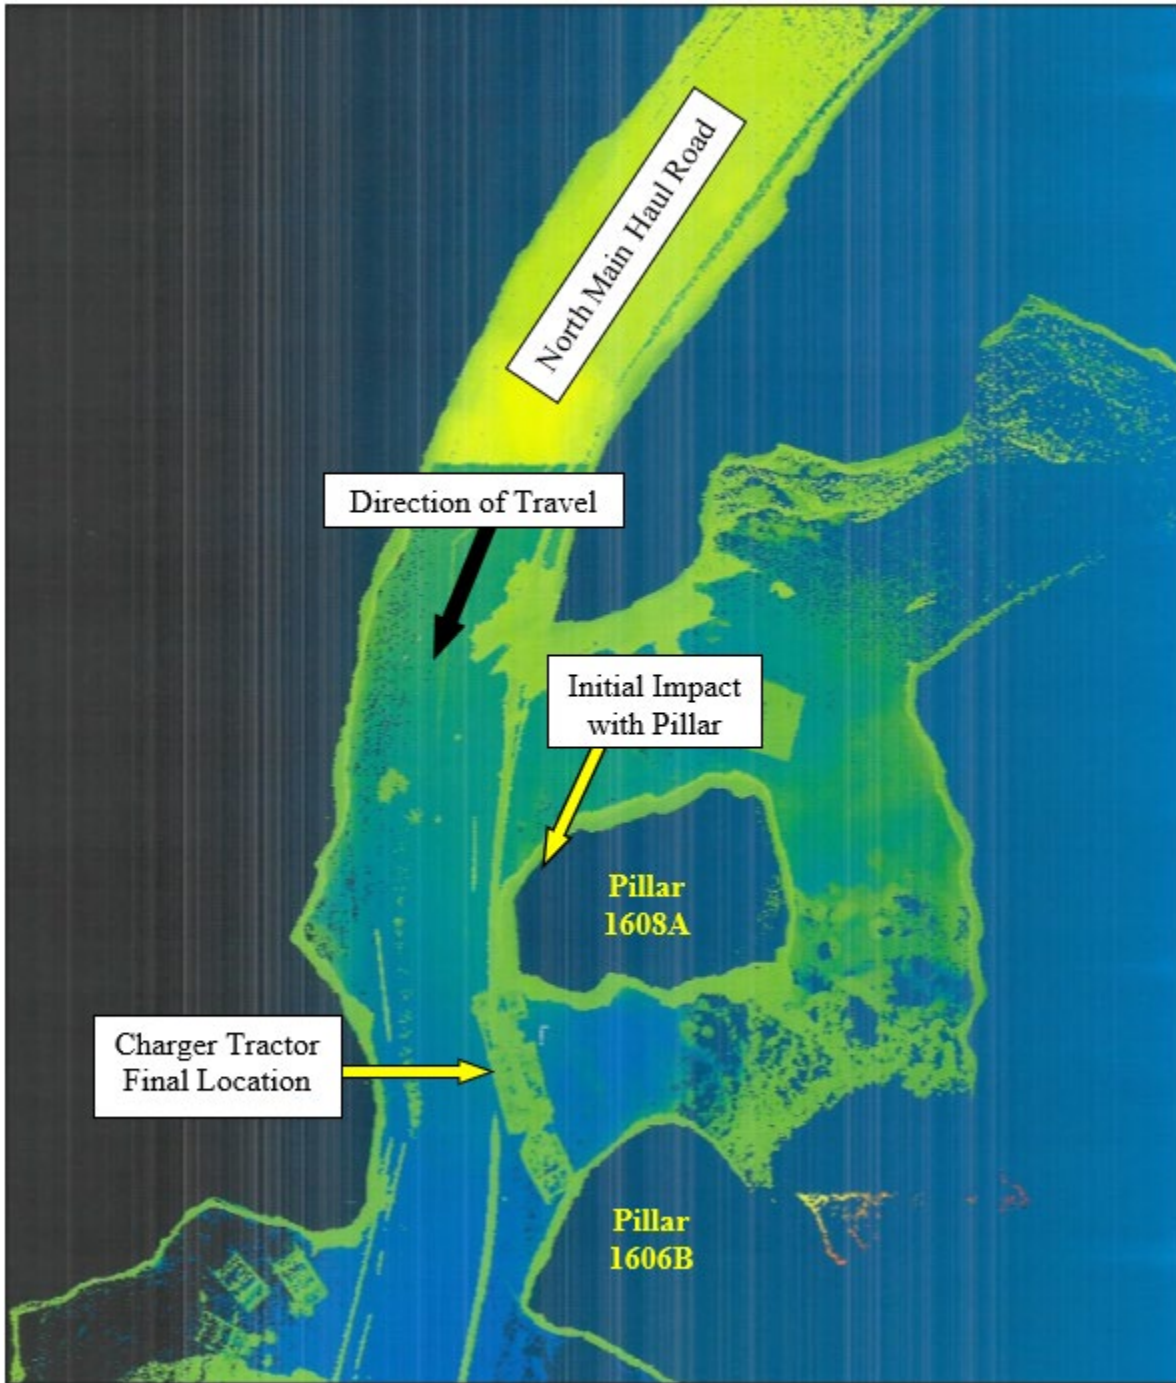
APPENDIX A – Accident Location

Based on interviews, at approximately 1:30 p.m., Lincoln left the main shop and drove to the North Main Haul Road when he noticed the charger tractor on the east side of the road, stopped against the 1606B pillar (see Appendix A). At 1:35 p.m., Lincoln found Barton under the charger tractor with the charger tractor running and in gear. Lincoln placed the charger tractor in neutral, shut the engine off and assessed Barton's condition. Lincoln could not find a pulse on Barton and immediately ran to a pager phone to call for help.

The accident occurred near the intersection of the 1608A pillar and the 1606B pillar on the North Main Haul Road (see Appendix A).

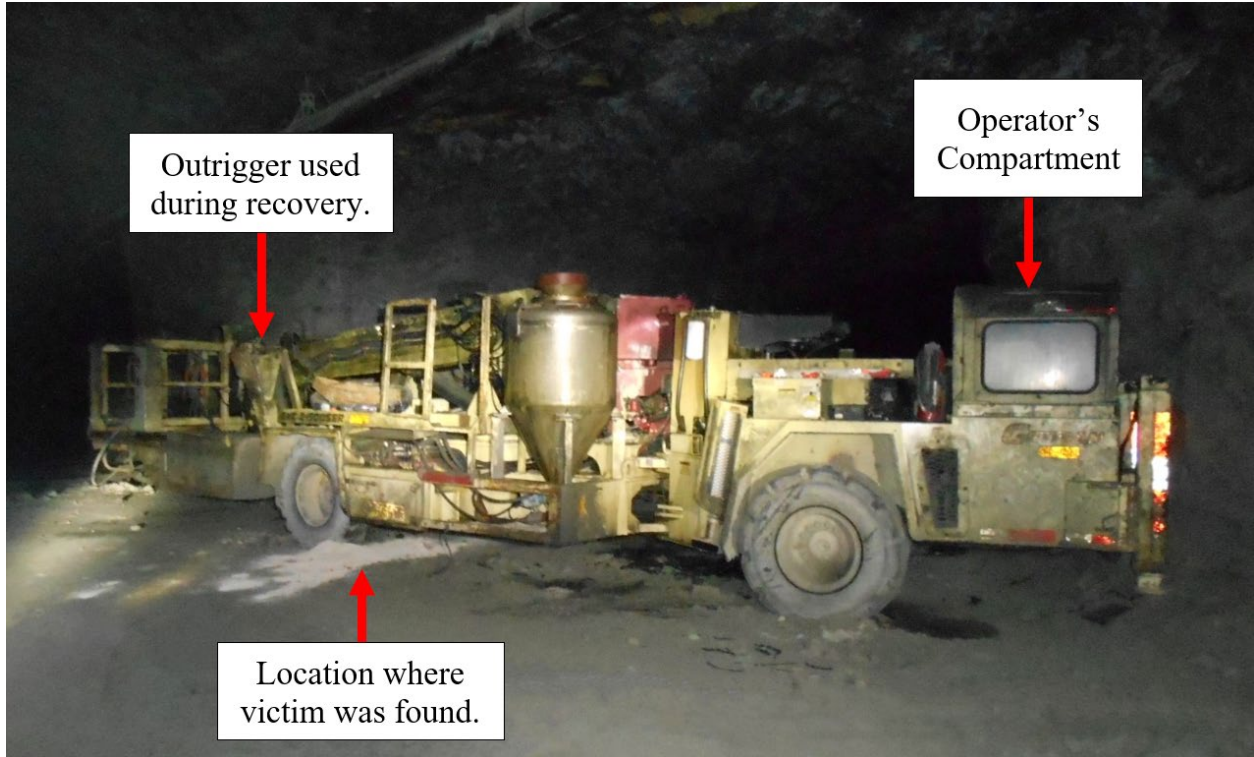
APPENDIX C – Getman A64 ExC 2-500SER

The charger tractor involved in the accident was manufactured in 2013 by Getman, Model No. A64 ExC 2-500SER, Serial No. 020-096, Company No. 02-03 (see Appendix C). The charger tractor had a certified rollover protective structure (ROPS), and a falling object protective structure (FOPS). Investigators examined the steering components, tires, braking system, and operator's compartment, and did not find any defects that would have contributed to the accident.

Investigators inspected the seat belt and found no defects. Investigators determined that Barton was not wearing the seat belt at the time of the accident. The mine operator had a policy requiring miners to wear seat belts while operating mobile equipment.

A fatal accident occurred on December 6, 2022, when a charger tractor struck a pillar, causing the charger tractor operator to be thrown from the charger tractor and then crushed by the rear tire. The mine operator did not ensure that the charger tractor operator maintained control of the Getman A64 ExC 2-500SER, Company No. 02-03, Serial No. 020-096, while it was in motion.

Corrective Action: The mine operator set up a training area on the surface of the mine to train new miners on mobile equipment prior to entering the underground portion of the mine. The mine operator retrained all experienced charger tractor operators on mobile equipment and safe operating habits.

Corrective Action: The mine operator held safety meetings with all miners to retrain them on policies and requirements regarding seat belt use, equipment pre-operational inspections, and workplace examinations. Additionally, the mine operator inspected the seat belts on all mobile equipment for excessive wear and other damage.
