REPORT OF INVESTIGATION

Surface  
(Industrial Sand)

Fatal Machinery Accident  
December 16, 2022

Signal Peak Silica of Atascosa  
SP Silica of Atascosa, LLC  
Poteet, Atascosa County, Texas  
ID No. 41-05317

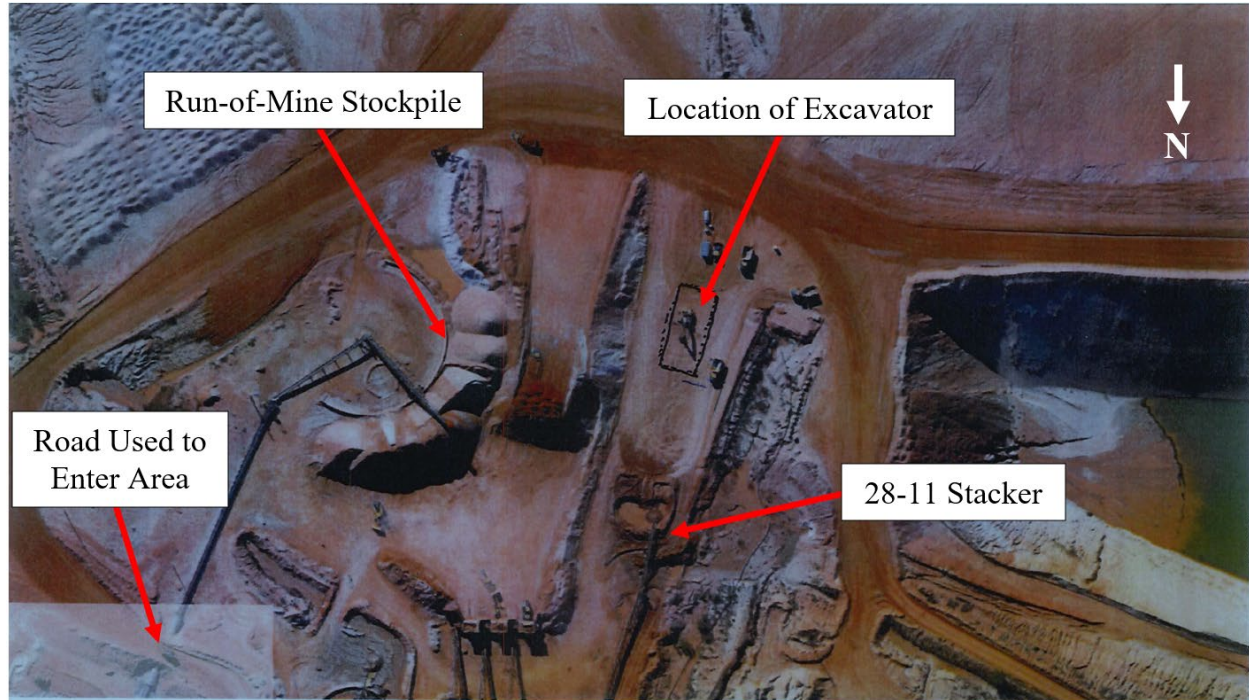
## APPENDIX B – Aerial View of the Accident Scene

The accident occurred south of the 28-11 stacker belt, west of the run-of-mine stockpile (see Appendix B). The mine operator used this area to stage the hydraulic excavator.

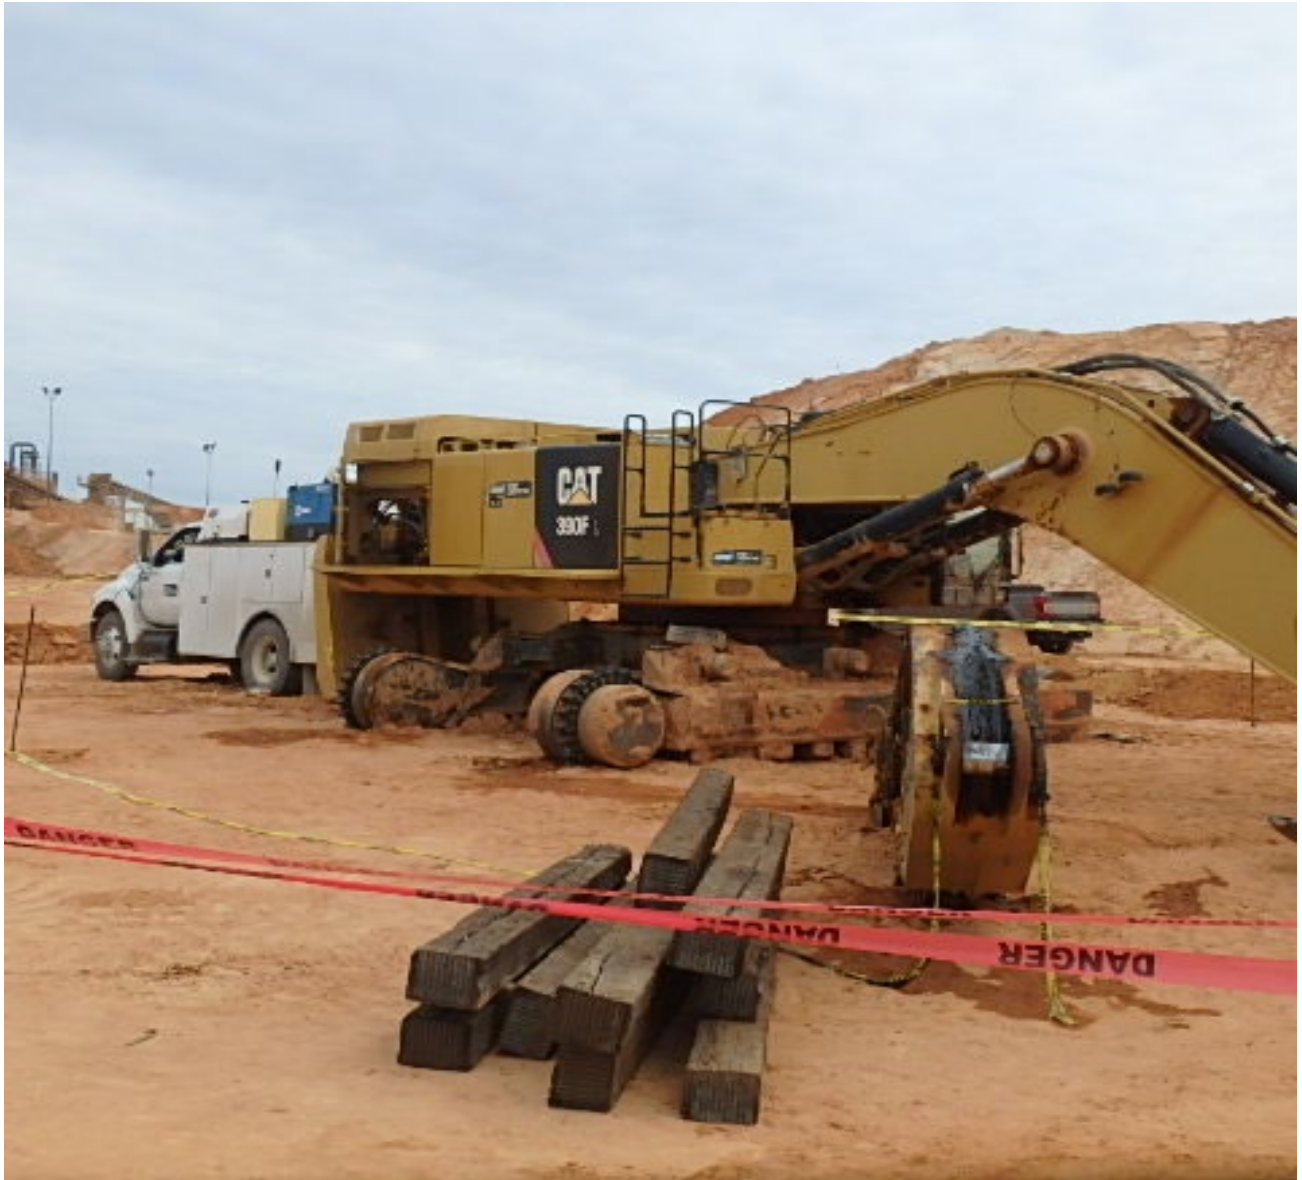
APPENDIX C – Photograph of the Equipment

The hydraulic excavator involved in the accident is a Caterpillar 390F Excavator (see Appendix C). Investigators found a copy of the manufacturer's operating manual in the cab of the hydraulic excavator, containing step-by-step instructions to remove the 27,227 lb. counterweight.

Investigators, along with representatives of Holt CAT, an authorized Caterpillar heavy equipment and engine dealer, examined the hydraulic excavator and found that two anchor bolts were missing from the counterweight. These missing bolts are important parts for supporting the counterweight during the assembly and disassembly process. The Caterpillar representatives replaced the anchor bolts and other parts damaged during the accident and were able to disassemble the counterweight without any issues. The Caterpillar representatives found no other defects that contributed to the accident. Investigators determined that Hild did not engage the lift cylinder on the excavator to block the counterweight from hazardous motion prior to removal of the final mounting bolt, which contributed to the accident.
